August 2022  
FL937A  
NHTSA #22V-394  
Transport Canada #2022-288

## Subject: Freightliner Steering Assembly U-Joint Pinch Bolts

**Models Affected: Specific model year 2023 Freightliner 108SD, 114SD, and Business Class M2 vehicles manufactured February 1, 2022, through May 13, 2022.**

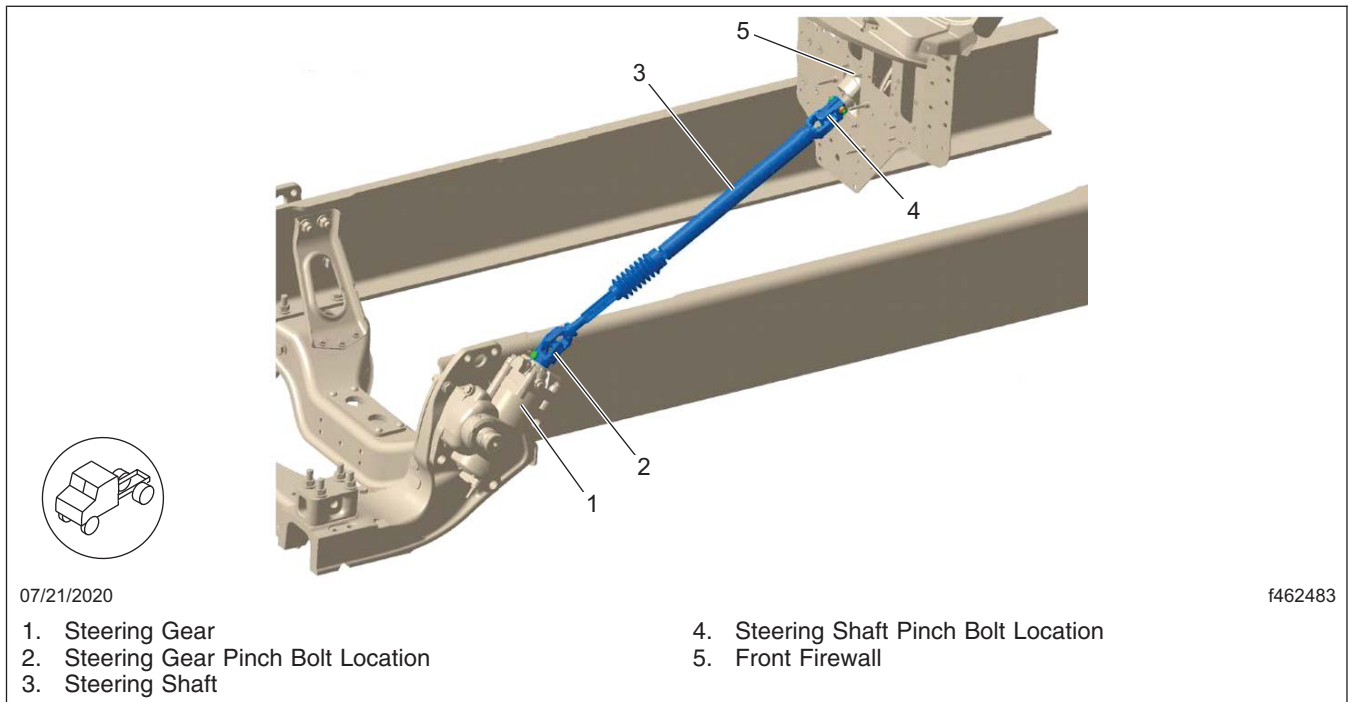
**Fig. 3, Steering Assembly**

1. Open the hood.
2. Locate the universal joint of the steering shaft at the front of the firewall. See [Fig. 3](#) and [Fig. 4](#).
3. Check the connections between the steering column and the steering shaft at the front of the firewall, and the nut to pinch bolt connection. See [Fig. 4](#).

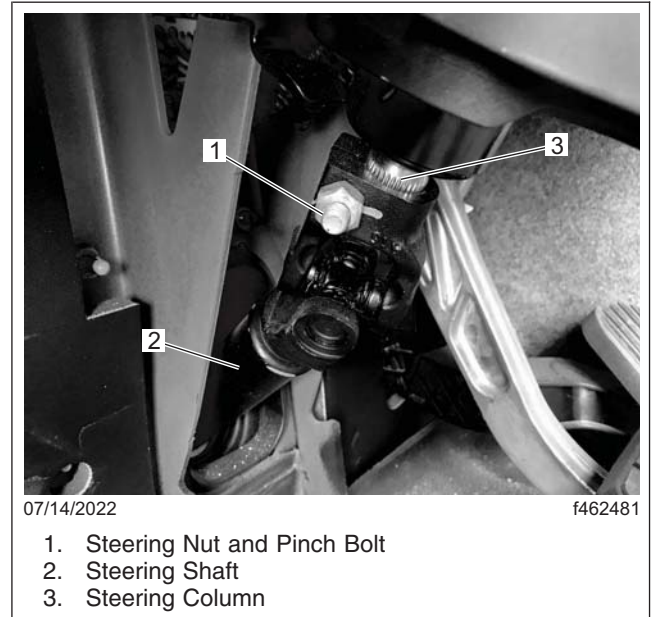
Fig. 1, Steering Pinch Bolt Location

4. Inspect the nut to pinch bolt connection. There must be bolt threads exposed beyond the nut as shown in [Fig. 1](#).

**NO** → **DO NOT** drive the vehicle. Have it immediately towed to the nearest DTNA dealership for repair.

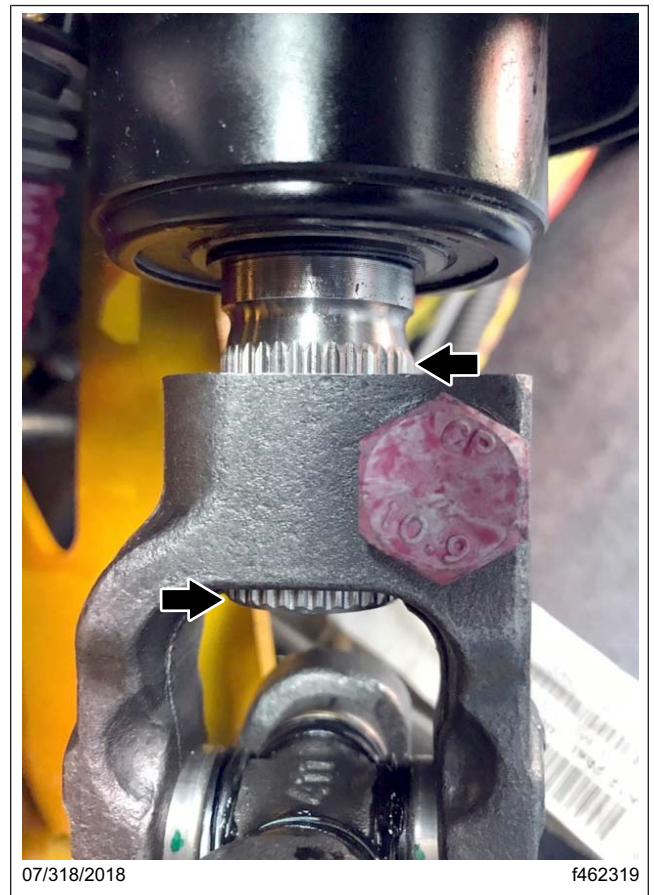
Fig. 2, Steering Shaft Splines

5. Inspect the exposed splines of the steering shaft connection as shown in [Fig. 2](#). It may be necessary to turn the steering wheel to gain adequate visibility of the splines.

If the steering shaft splines are not visible on both sides of the bolted connection, **DO NOT** drive the vehicle. Have it immediately towed to the nearest DTNA dealership for repair.

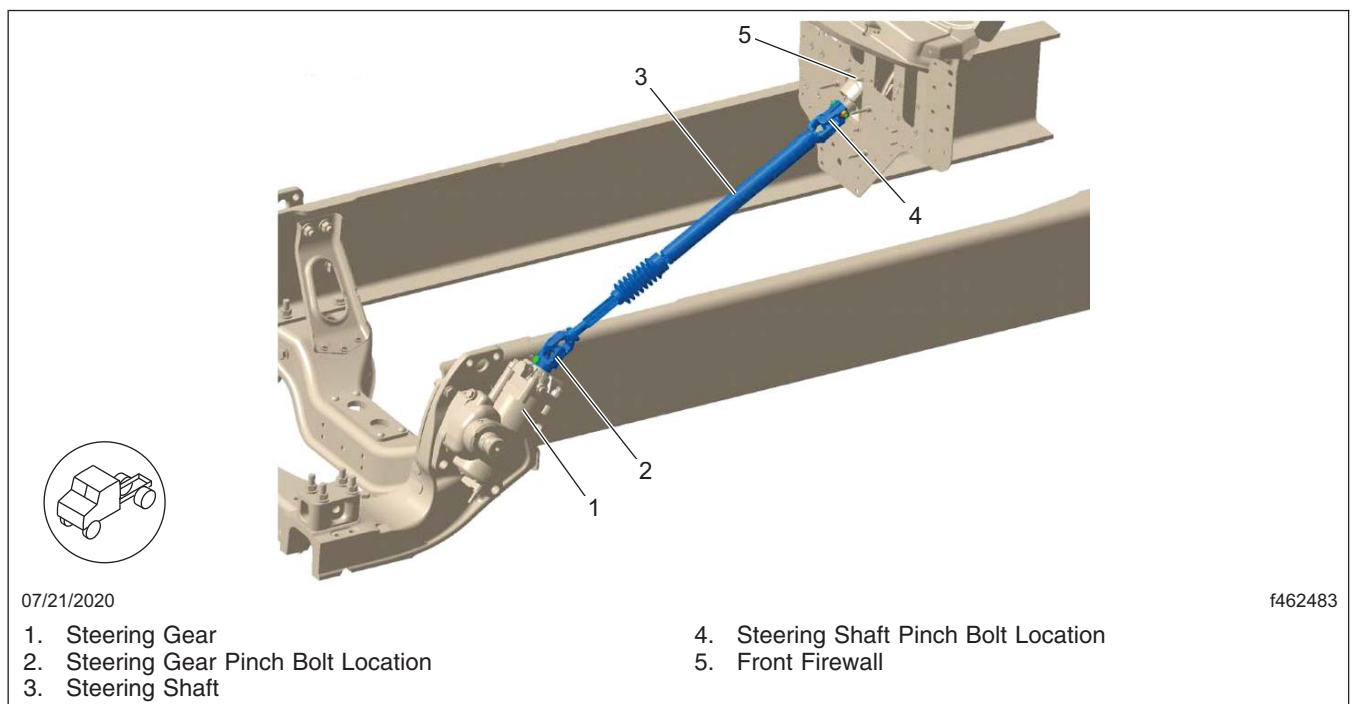
**Fig. 3, Steering Assembly**

1. Locate the universal joint at the steering gear. See [Fig. 3](#) and [Fig. 5](#).
2. Check the connections between the steering shaft and the steering gear, and the nut to pinch bolt connection. See [Fig. 5](#).

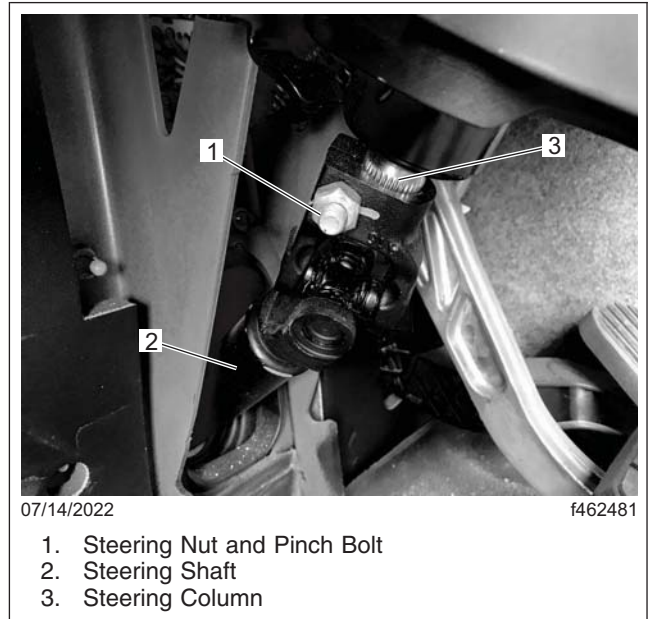
Fig. 1, Steering Pinch Bolt Location

3. Inspect the nut to pinch bolt connection. There must be bolt threads exposed beyond the nut as shown in [Fig. 1](#).  
Are the bolt threads visible?  
**YES** → Go to the next step.  
**NO** → **DO NOT** drive the vehicle. Have it immediately towed to the nearest DTNA dealership for repair.
4. Inspect the exposed splines of the steering shaft connection as shown in [Fig. 2](#). It may be necessary to turn the steering wheel to gain adequate visibility of the splines.  
If the steering shaft splines are not visible on both sides of the bolted connection, **DO NOT** drive the vehicle. Have it immediately towed to the nearest DTNA dealership for repair.  
If the steering shaft splines are exposed on both sides of the bolted connection, the vehicle may be driven to the nearest DTNA dealer for the formal inspection and to complete the recall.

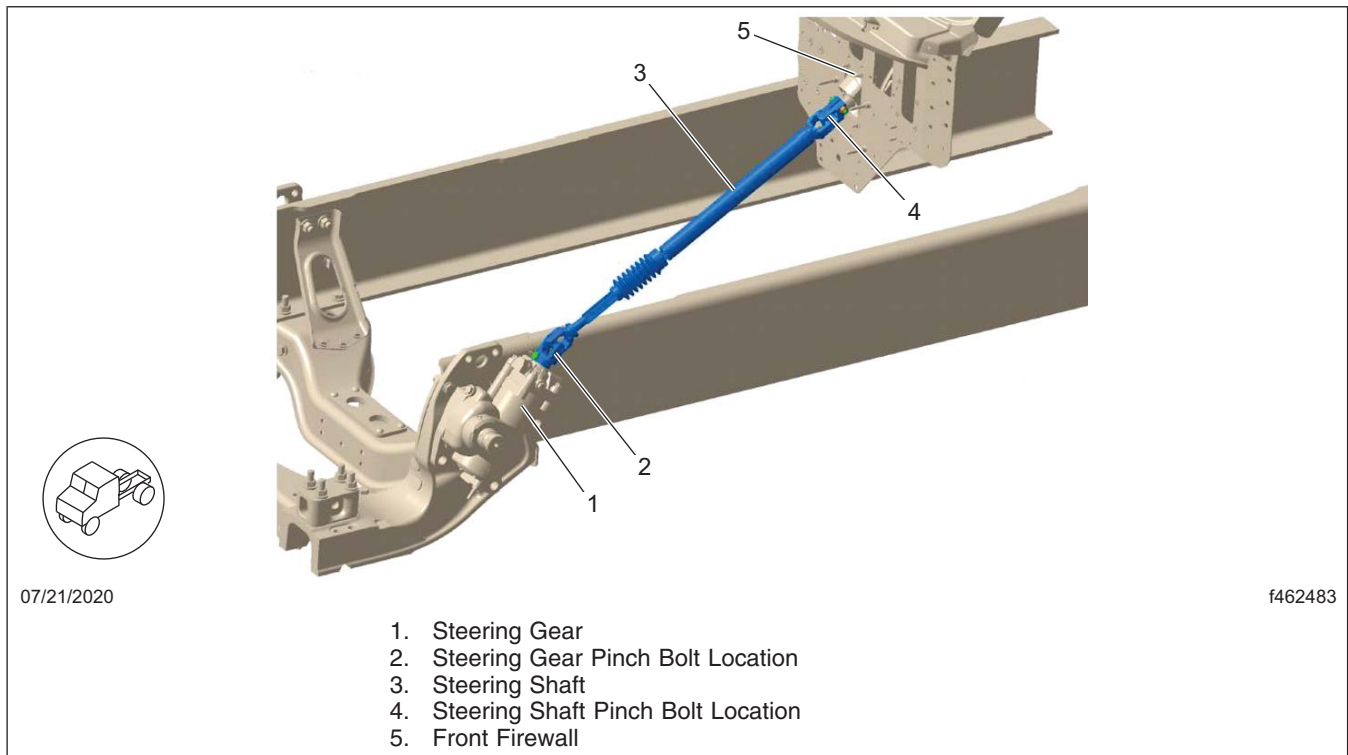
Fig. 7, Steering Assembly

1. Open the hood.
2. Locate the universal joint of the steering shaft at the front of the firewall. See [Fig. 7](#) and [Fig. 8](#).
