**SUBJECT:** **NEW VEHICLE DEMONSTRATION / DELIVERY HOLD**  
**Compliance Recall 22C13 – Supplement #1**  
 Certain 2022 Model Year Aviator and Explorer Vehicles  
 Inspect Engine Frame Rail Assembly

**REF:** **Compliance Recall 22C13**  
 Dated: August 19, 2022

**NEW VEHICLE DEMONSTRATION / DELIVERY HOLD – Supplement #1**  
**Compliance Recall 22C13**  
Certain 2022 Model Year Aviator and Explorer Vehicles  
Inspect Engine Frame Rail Assembly

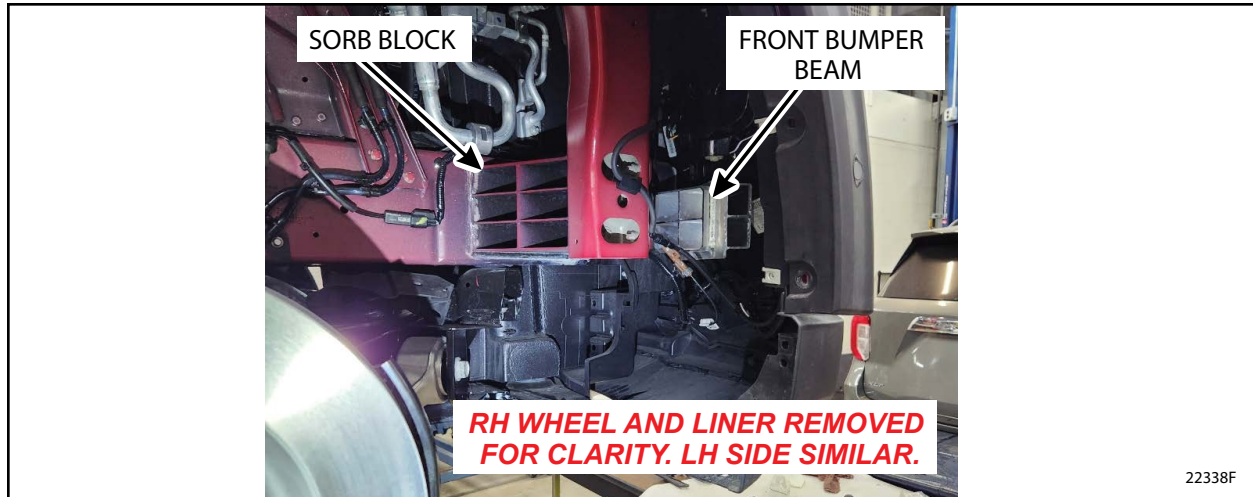
**FIGURE 5**

**14. Locate the SORB block (located directly behind the front bumper beam.) See Figure 5.**

**17. Contact SSSC for further approval to replace the front side member. Once approved, return the hardness tester and order the required parts through normal part ordering process, refer to dealer bulletin. Proceed to step 18.**

**18. Replace the front side member(s) that failed the hardness test. Refer to WSM Section 501-27.**

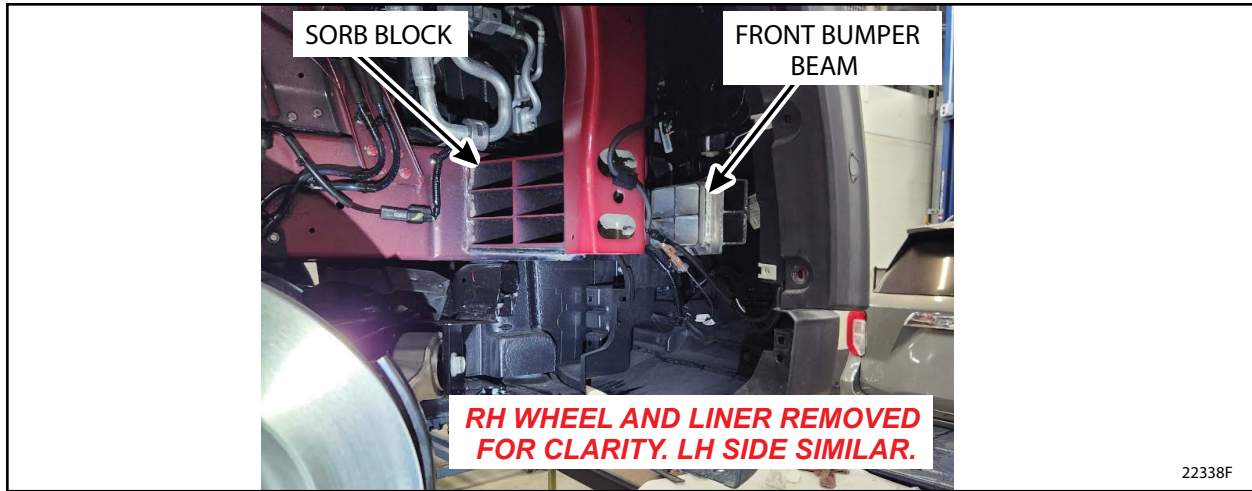
**FIGURE 14**

**38. Locate the SORB block (located directly behind the front bumper beam.) See Figure 14.**

**41. Contact SSSC for further approval to replace the front side member. Once approved, return the hardness tester and order the required parts through normal part ordering process, refer to dealer bulletin. Proceed to step 42.**

**42. Replace the front side member(s) that failed the hardness test. Refer to WSM Section 501-27.**
