# Safety Recall

## Code: 20DS

<b>Subject</b>	Fuel Tank Internal Vent Pipe															
<b>Release Date</b>	November 15, 2022															
<b>Revision Summary</b>	Updated parts and claiming information with additional exhaust clamp part number															
<b>Affected Vehicles</b>

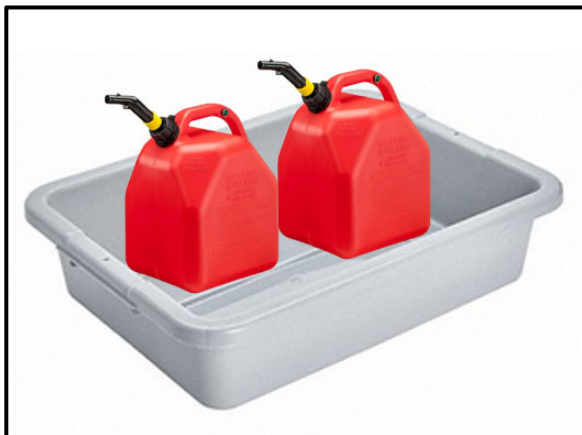
- Add **FRESH** fuel in the amount indicated in the chart above.
- Use a gas station closest to the dealer.
- If possible, use a known good fuel pump that does not switch off prematurely.
- Drive to and from the gas station as moderately as possible.
- \*Refer to the ELSA Repair Manual if fuel requires removal.
- The refueling must be done accurately, with a maximum deviation of +/- 0.1 gallons (0.4 L)
- Park the vehicle in the workshop overnight in order to acclimate to the indoor ambient temperature.
- The ambient temperature of the workshop area where the test is to be performed must be above 68° F (20°C).
- The vehicle must be parked on a level surface or with the right rear of the vehicle at the lowest point.
