Product Safety Recall

N222378380 Rear View Camera Intermittent or Inoperative

Release Date: January 2023

Condition	General Motors has decided that a defect which relates to motor vehicle safety exists in certain 2020-2021 model year Cadillac XT5, XT6, and GMC Acadia vehicles equipped with the optional Surround Vision feature. The rear view camera in these vehicles may fail or function intermittently. If the rear view camera is not functioning properly, rear visibility is reduced, increasing the risk of a crash during a backing event.
Correction	Dealers will replace the affected coaxial cables.

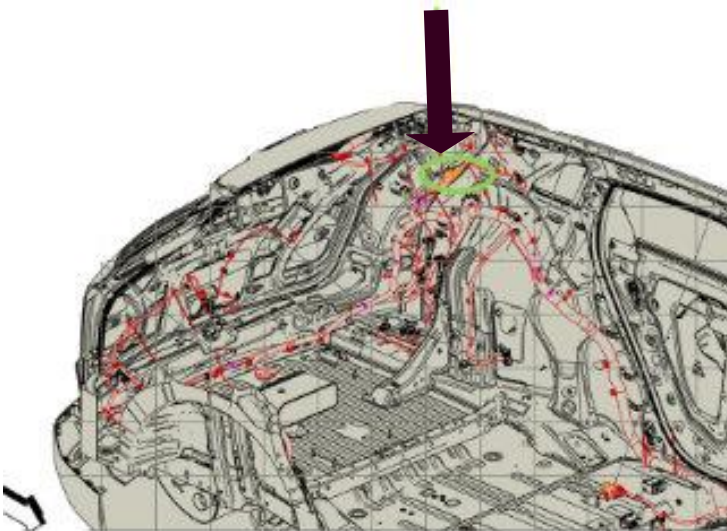
6244006

Note: The existing coax cable is bundled within the body harness. The service coax cable will be routed next to the body harness. The terminals must be removed from the existing coax cables to ensure they are not used in future repairs.

Note: XT5 vehicles equipped with RPO DRZ have an additional coax connection at X307 located in the left upper rear quarter panel area. Disable the existing coax and install the new coax as described in the steps below.
