Safety Recall

Code: 13i4

Subject Engine Connecting Rod

Release Date November 18, 2022

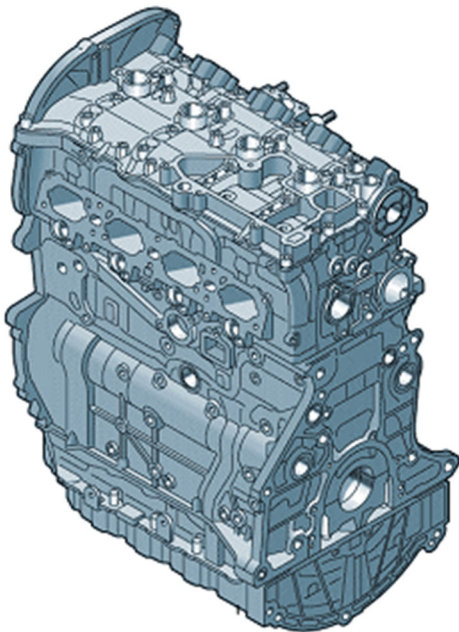
- Take clear photos of the filter and filter housing showing excessive metal particles.
- Create a TAC WEB Ticket and upload the photos to the TAC case.
- **Select “13i4 / 13i5 Review” as the Concern Type.**
- The consultant will review the photos and provide direction.

- If consultant advises that the engine DOES NOT require replacement:
 - Replace oil filter and seal again.
 - Torque housing to 25 Nm.
 - Proceed to Section D.
- If consultant advises that the engine DOES require replacement:
 - Replace complete engine according to the ELSA Repair Manual: *Repair manual > Engine > 4-Cylinder Direct Injection (2.0L, 4V, EA 888 Gen III, Turbocharger, Chain Drive) > 10 Engine Assembly > Engine, Removing and Installing*
 - Adhere to all warnings outlined in the repair manual.
 - Reference ELSA Repair Manual for special tools.
 - Proceed to Section D
