WARRANTY BULLETIN SAFETY CAMPAIGN

October 31, 2022 Subject: **Front Fenders Electrical Harnesses May Be Loose – Potential Loss of Power**

No. **2023-1**

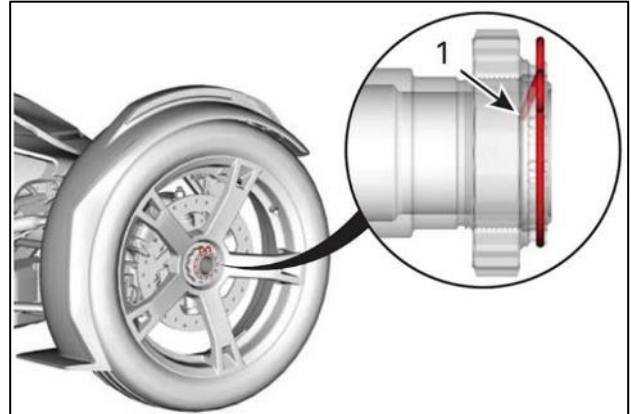
1. Folded end pointing inside the drive axle

Failure to install the RED locking clip and/or not applying the proper torque to the wheel nut may cause the loss of a wheel.

7. Tighten the nut to the nominal value, then tighten further to align the hole.

NOTICE Never untighten the nut to align the RED locking clip hole.
