GROUP	MODEL
Safety Recall Campaign	2008-2009MY Sportage (KM)
NUMBER	DATE
SC253	December 2022

SAFETY RECALL CAMPAIGN

HECU INSPECTION/REPLACEMENT AND FUSE REPLACEMENT (SC253)

This bulletin provides information relating to the inspection and, if necessary, replacement of the Hydraulic Electronic Control Unit (HECU) in the 2008-2009MY Sportage (KM) vehicles produced from August 9, 2007 through May 13, 2009 that were previously recalled under Kia's Campaign SC138. In addition, the two (2) '40A' fuses for the HECU circuits will be replaced with new '30A' and '20A' fuses to prevent an over-current condition in the HECU's electrical circuit board to mitigate the risk of a fire. An engine compartment fire originating from the area of the HECU may occur while the subject vehicle is being driven or while parked after replacement of the HECU connector cover under the previously launched SC138 recall. Although the exact cause is unknown, it is believed that an internal electrical short circuit can occur from foreign substances remaining on the printed circuit board. Follow the procedure outlined in this publication to inspect the HECU and its wiring harness and connectors for proper function

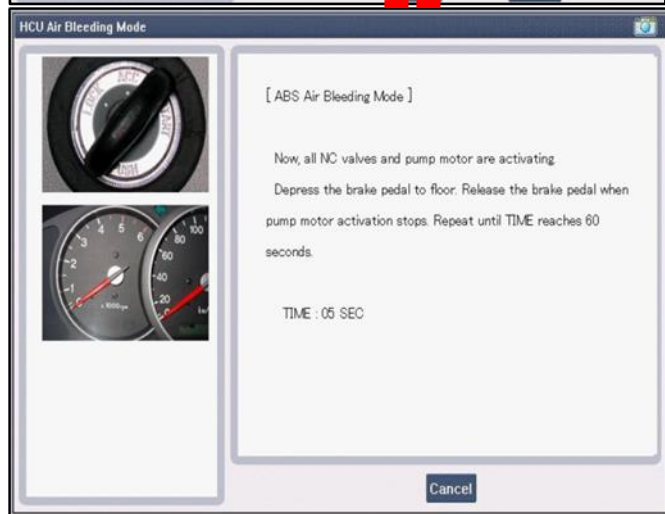
Do not exceed the maximum operating time (60 seconds) of the ABS motor with the KDS to prevent the motor pump from burning.

9. Follow instructions on screen, except keep pedal depressed until 'test cycle completed' message shows.
