GROUP	MODEL
Safety Recall Campaign	2017-2018MY Niro HEV (DE HEV)
NUMBER	DATE
SC256	January 2023

### POWER RELAY ASSEMBLY (PRA) OR HV MAIN RELAYS

### INSPECTION / REPLACEMENT (SC256)

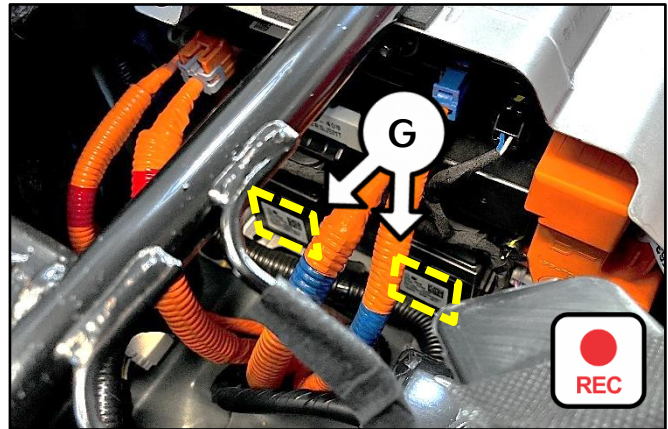
- 4b. Continue recording video by moving to display both HV main relay labels (G).
- 4c. Stop recording video after both HV Main Relay labels were displayed.

The VIN and relay labels **MUST** be **clear** and **legible** in the video. If the labels cannot be clearly read, the warranty claim may be subject to charge back.
