# Safety Recall

## Code: 90V2

**Subject** Gateway Control Module

**Release Date** January 20, 2023

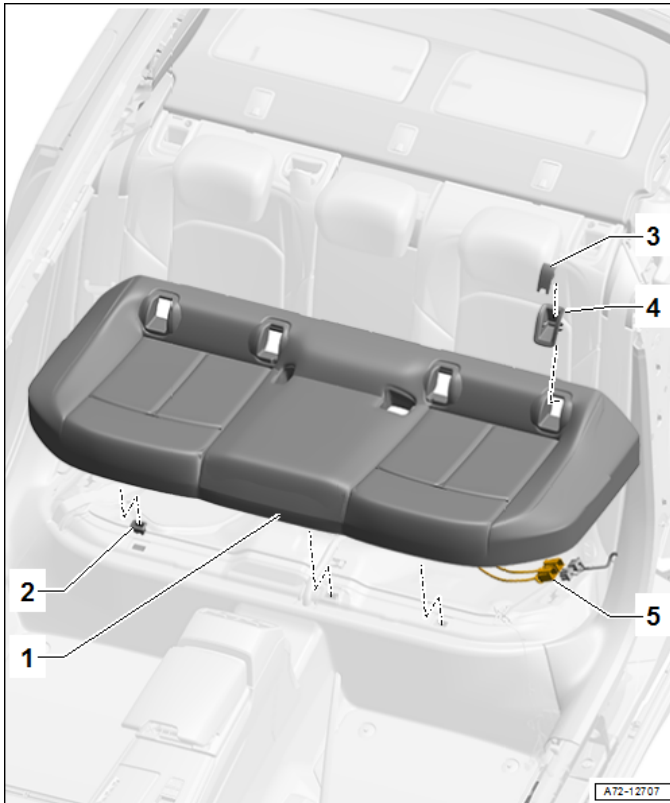
### Remove rear seat bench:

- See ELSA Repair Manual: *Repair manual > Body > Seats > 72 Seat Frames > Rear Seats > Rear Bench Seat, Removing and Installing*
