SR23-82

BAD GPS CONNECTION AT THE VECU CONTROL UNIT 9700 (B13R)

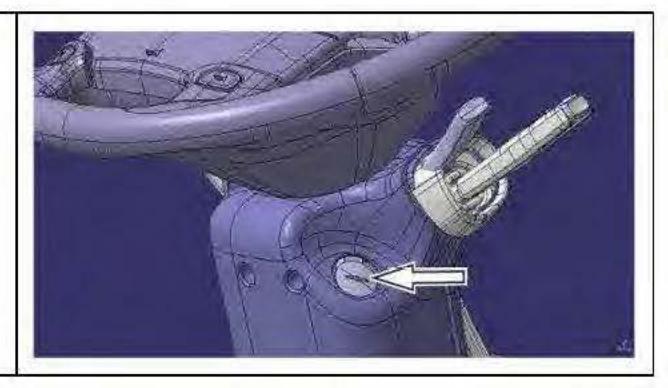
### 1. Turn OFF the vehicle

Turn OFF the vehicle electrical system, by turning the ignition switch to the OFF position.
