PRODUCT CAMPAIGN BULLETIN

APPLICABILITY: 2004-2005 Impreza (including WRX)

NUMBER: WRF-23

SUBJECT: Improper Air Bag Inflator Installation

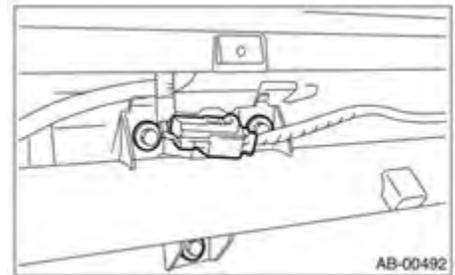
- Disconnect the airbag module harness connector from the support beam bracket.
- Remove the 3 retaining bolts and **CAREFULLY** remove the airbag module from the vehicle and place it on a clean cloth to protect the dash trim surface portion from damage.
