PRODUCT CAMPAIGN BULLETIN

APPLICABILITY: 2019-2022 Crosstrek Hybrid

NUMBER: WRD-23R

SUBJECT: 12V Inverter Connector Corrosion

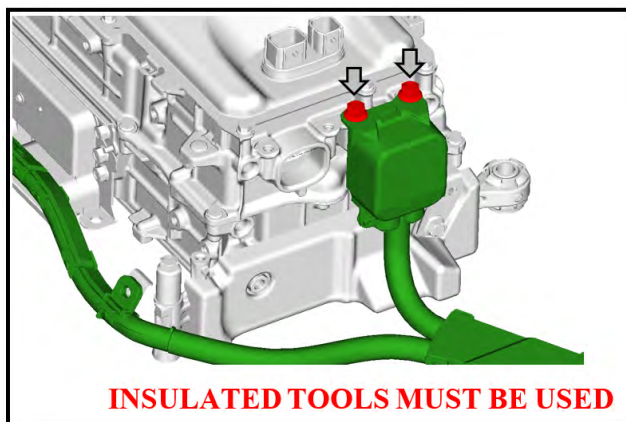
STEP 11: Remove the two mounting bolts for the HV air conditioning cable. The HV air conditioning cable can then be removed and discarded.

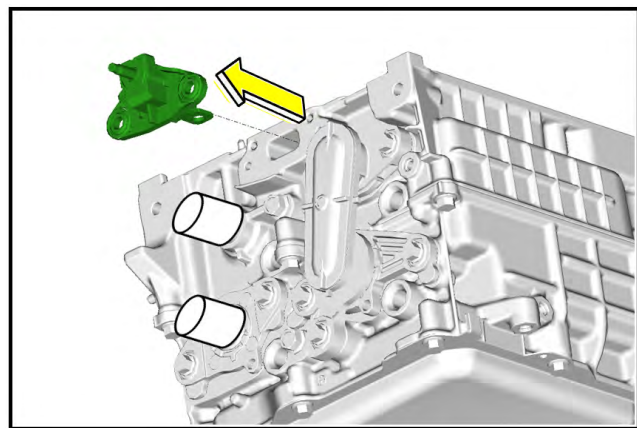
Once the mounting bolts are removed, pull the terminal away from the case to remove.

CAUTION: Confirm the original seal is removed with the terminal and is not left inside the case.

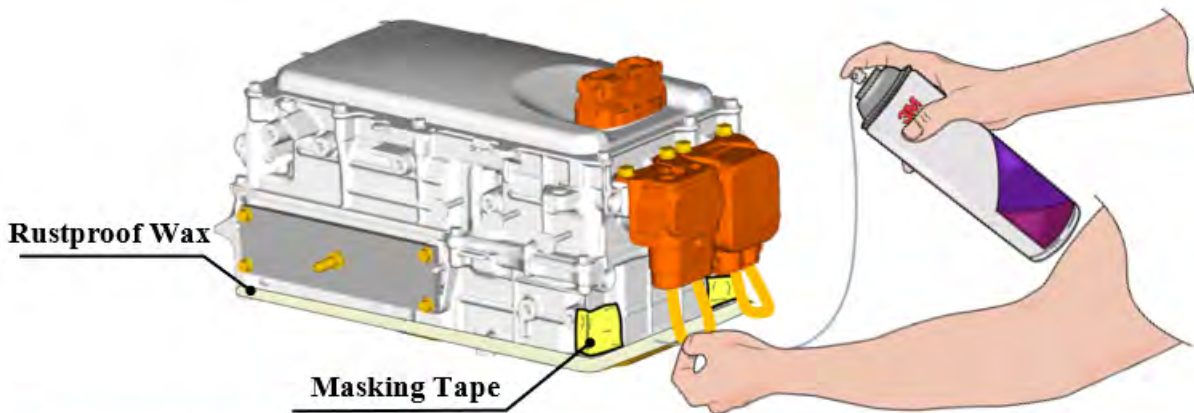
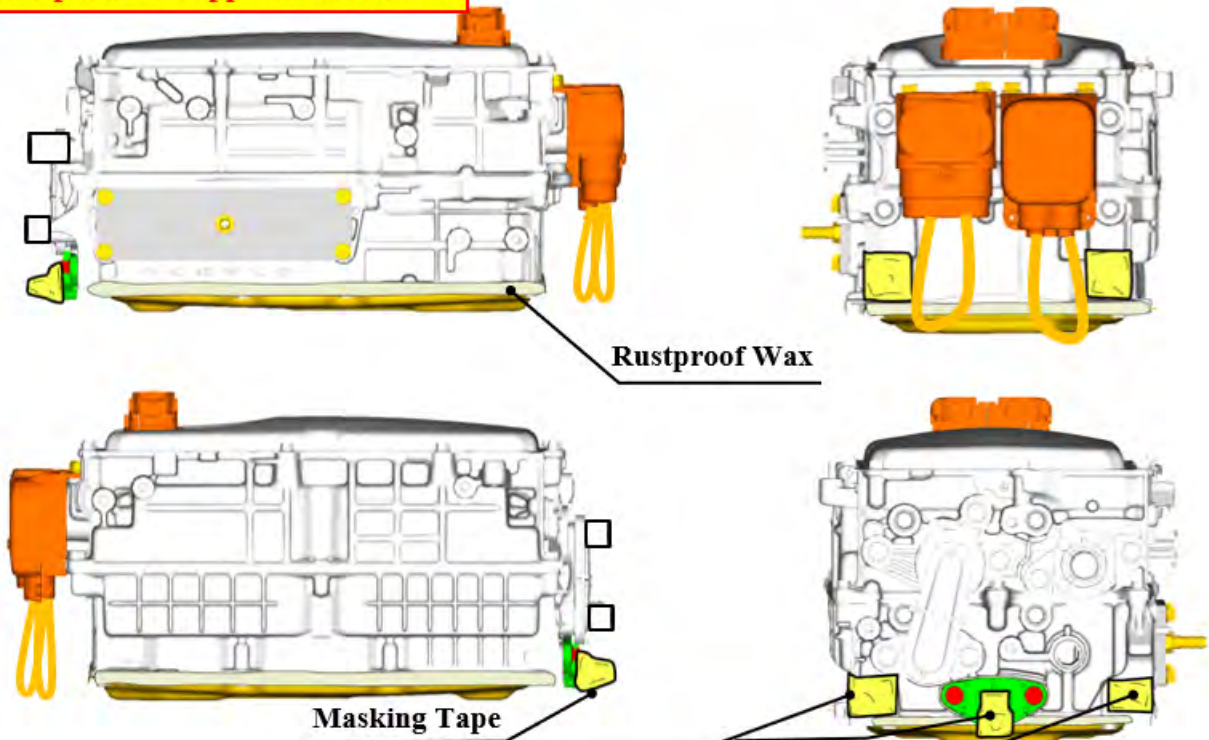
Rustproof wax application location

STEP 46: Apply masking tape to the mounting surfaces of the front and rear brackets. Cover the 12v terminal with masking tape. Apply the rustproof wax (3M Cavity Wax Plus) to the contact area of the inverter lid and case. Spray the area by moving the nozzle at a rate of about 50mm (2 inches) per 1 second. Perform two full rotations of application.

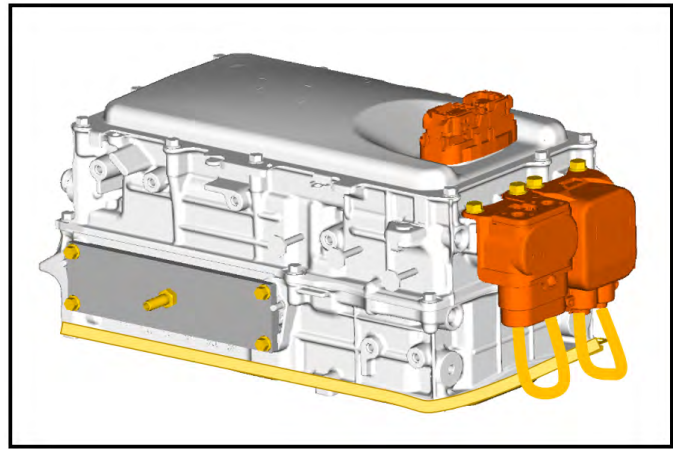
STEP 47: Confirm there is a sufficient application of the rustproof wax. Remove all leakage testing tools and masking tape.

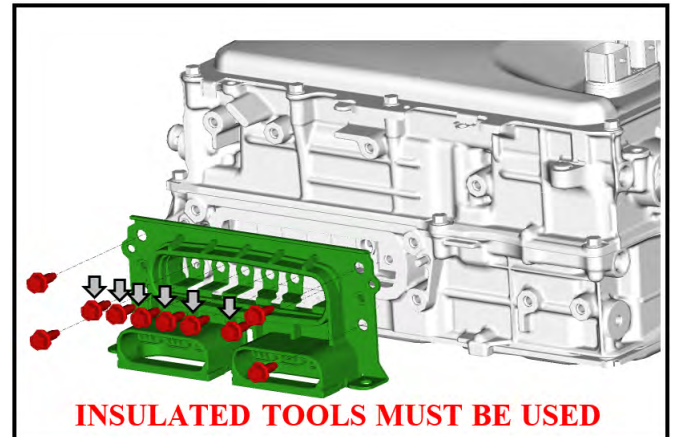
STEP 48: Install the motor cable terminal block. Torque the four outer bolts in an X-pattern to 7.5Nm (5.5ft-lbs). Torque the inner six bolts to 7.5Nm (5.5ft-lbs).

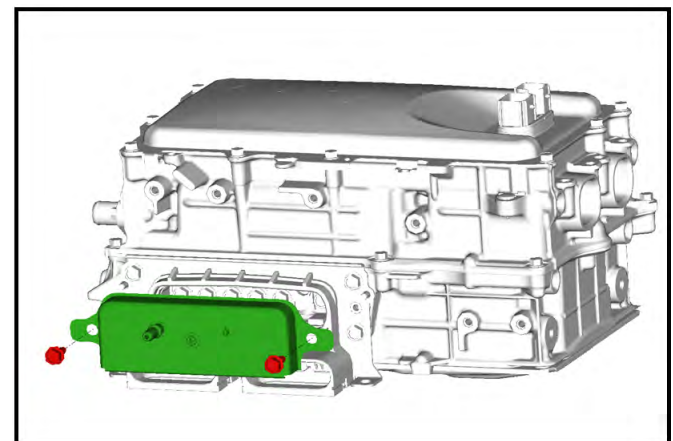
STEP 49: Install the terminal block cover. Torque the mounting bolts to 7.5Nm (5.5ft-lbs).

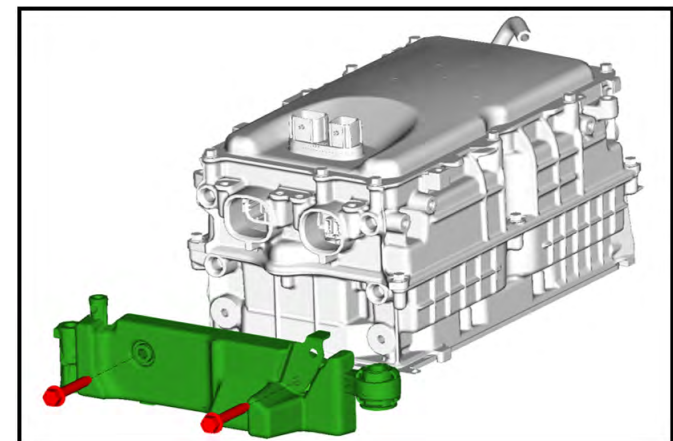
STEP 50: Install the front inverter/converter bracket and insulator. Torque the two mounting bolts to 18Nm (13.3ft-lbs).

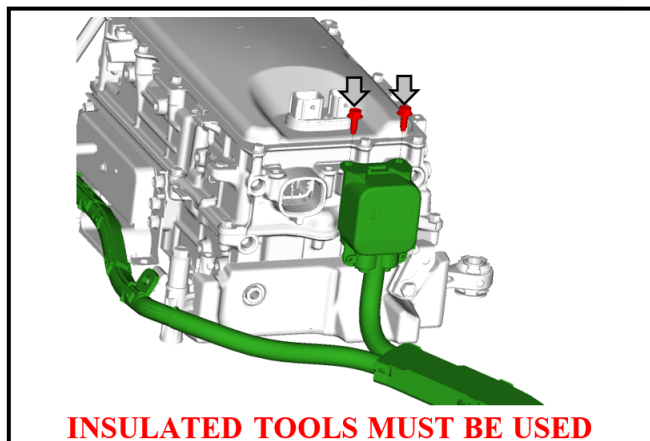
STEP 51: Connect the NEW HV air conditioning cable. Tighten the two mounting bolts to 7.5Nm (5.5ft-lbs).

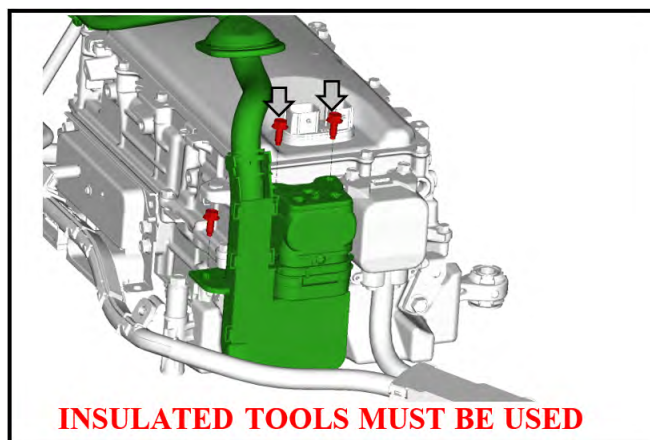
STEP 52: Connect the main battery cable. Torque the three mounting bolts to 7.5Nm (5.5ft-lbs).

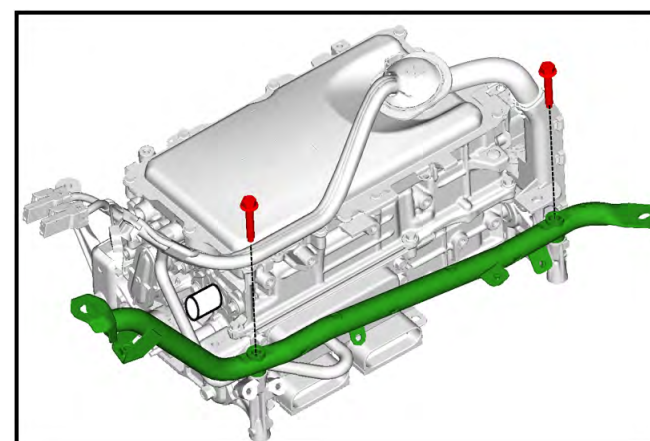
STEP 54: Install the inverter stay using the two original mounting bolts. Torque the mounting bolts to 18Nm (13.3ft-lbs).

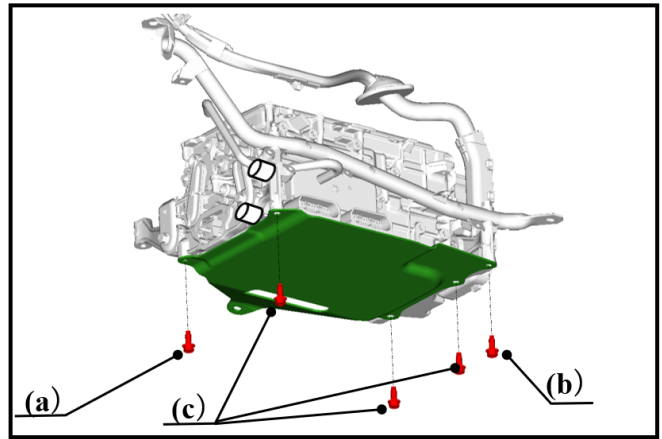
STEP 55: Reinstall the inverter protector with the original mounting bolts in the following order.

Torque the mounting bolts in the same order to 18Nm (13.3ft-lbs).

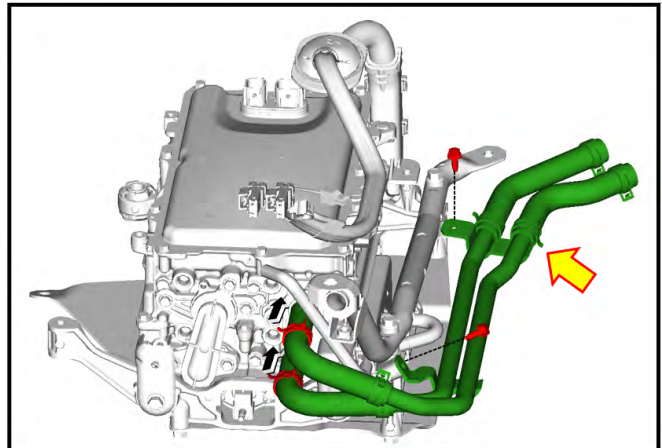
STEP 56: Removed the rubber caps from the water pipe. Reinstall the coolant hoses and clamps. Reattach the water pipe to the inverter/converter assembly using the original mounting bolts. Torque the bolts to 7.5Nm (5.5ft-lbs).

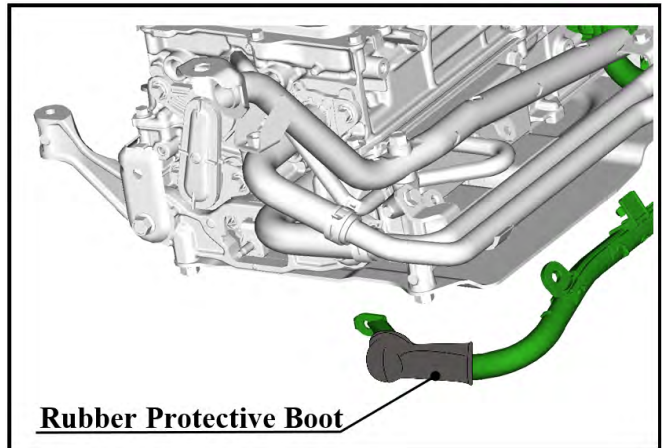
STEP 57: Route the HV air conditioning cable through the NEW rubber protective boot.

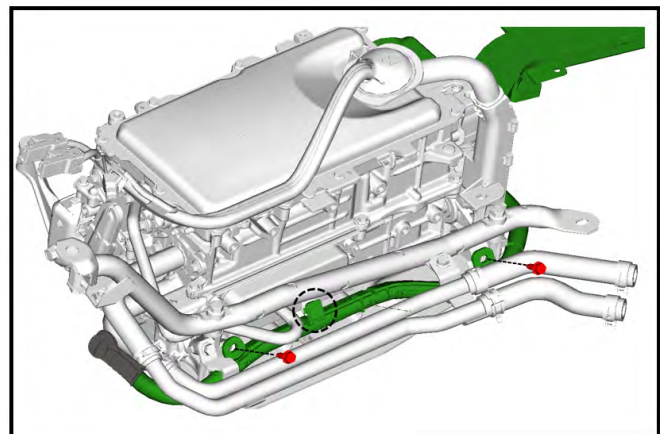
STEP 58: Secure the HV air condition cable to the inverter/converter using the original bolts and the new retaining clip. Torque the bolts to 7.5Nm (5.5ft-lbs).

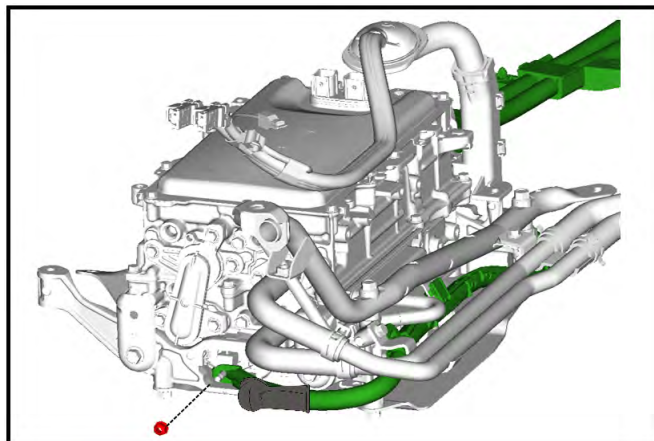
STEP 59: Connect the HV air conditioning cable to the 12v terminal. Torque the NEW nut to 7.5Nm (5.5ft-lbs).

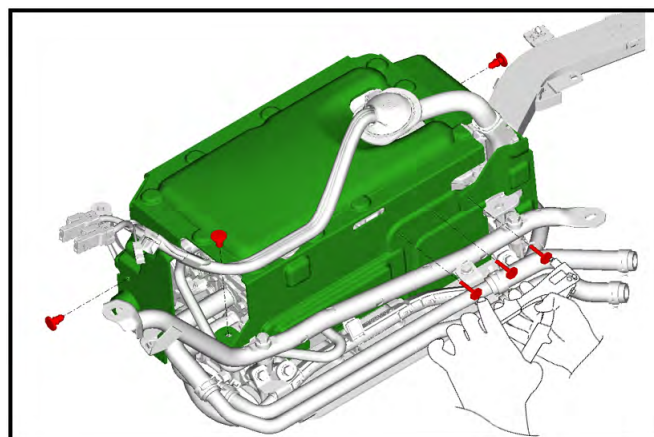
STEP 61: Install the inverter/converter with the three original retaining clips, three original rivet spacers, and three NEW rivets.
