**PRODUCT CAMPAIGN BULLETIN**

**APPLICABILITY:** 2019-2022 Crosstrek Hybrid

**NUMBER:** WRD-23R

**SUBJECT:** 12V Inverter Connector Corrosion

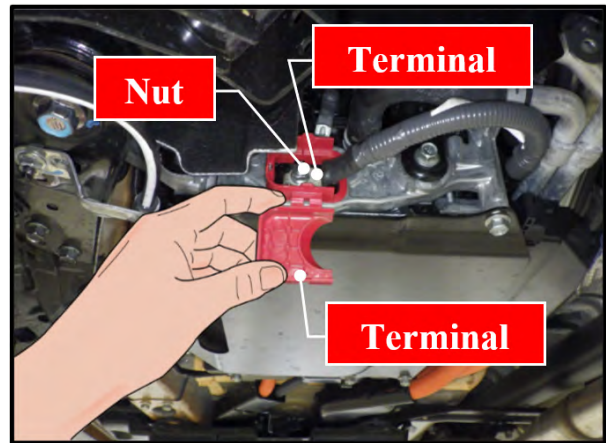
**STEP 8:** Open the terminal cap cover. Remove the 12v terminal nut. The terminal nut is a one-time use part and must not be reused.

**CAUTION:** Some vehicles may have a protective rubber boot installed in place of the terminal cap. If found, remove and discard the rubber boot.
