**PRODUCT CAMPAIGN BULLETIN**

**APPLICABILITY:** 2019-2022 Crosstrek Hybrid

**NUMBER:** WRD-23R

**SUBJECT:** 12V Inverter Connector Corrosion

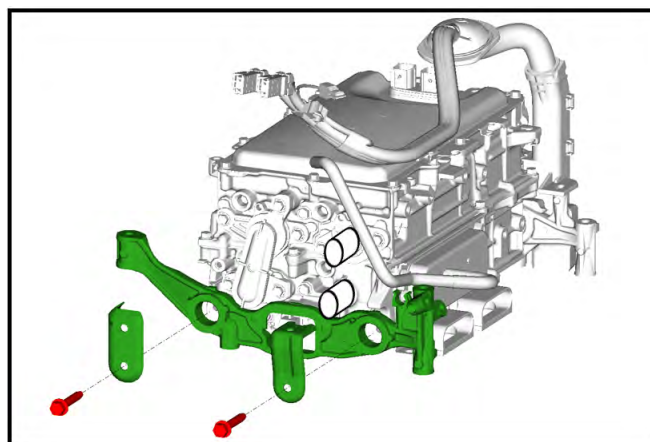
**CAUTION: DO NOT drop or hit the new mounting bracket. This can cause the painted surface to be damaged compromising its corrosion protective strength.**

**STEP 53:** Install the NEW inverter rear bracket using NEW mounting bolts. Torque the mounting bolts to 18Nm (13.3ft-lbs).

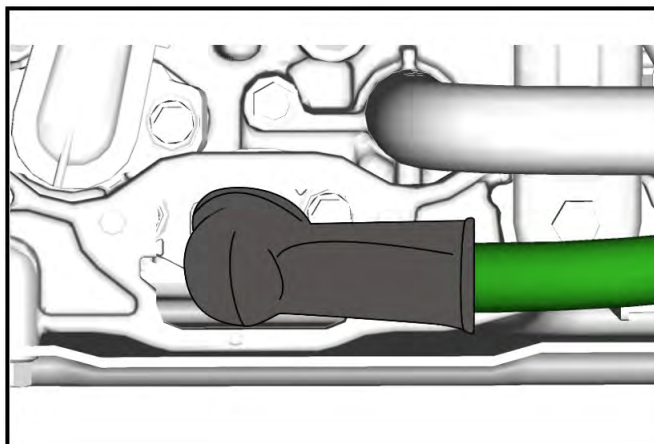
**CAUTION:** Confirm the 12v terminal is completely covered by the rubber cap. The terminal **MUST** not be exposed.

**STEP 60:** Attach the new rubber cap to the 12v terminal.

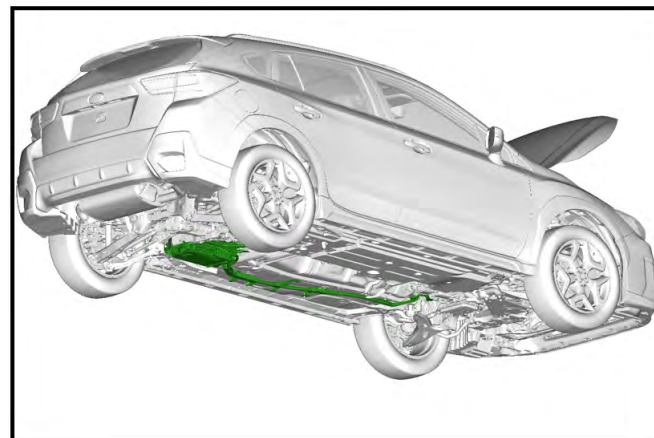
**CAUTION:** Three Bond 1207F requires 24 hours to become fully cured. The vehicle **MUST** not be exposed to heavy moisture such as car wash, rain, and snow until this 24-hour cure time complete.

**STEP 62:** Reinstall all parts in the reverse order of disassembly.
