SAFETY RECALL

Communication #: T-23-01

Model Year(s): 2022–2023

SUBJECT: ALTERNATOR REPLACEMENT

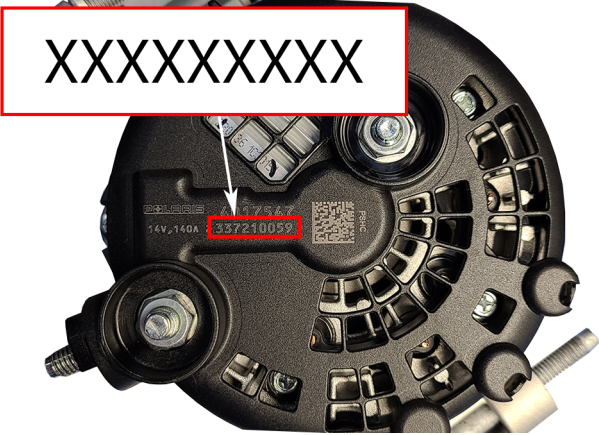
REQUIRED ALTERNATOR SERIAL NUMBER	
<p>Record the NINE DIGIT serial numbers on the <i>NEW</i> alternator for warranty claims processing. Claims filing will not be permitted without the <i>NEW</i> alternator serial number.</p>

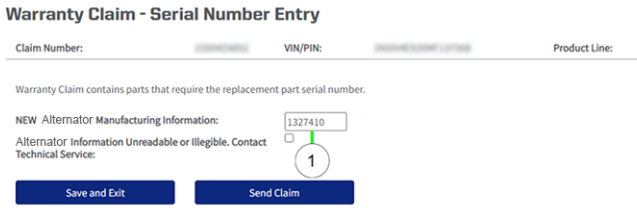
<p>Enter the <i>NEW</i> alternator serial number when filing a claim.</p>

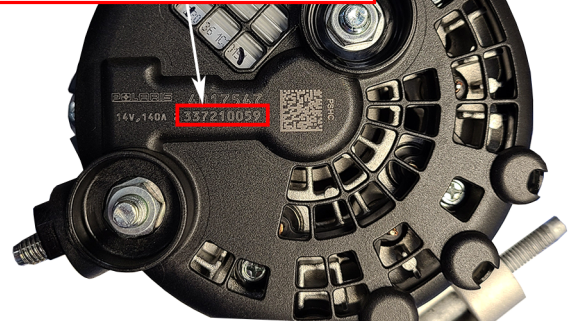
Before installing the new alternator, record the **NINE DIGIT** serial number on back of the **NEW** alternator. The serial number will not be clearly visible once installed. The serial number is required for warranty claim submission.
