Remedy available for
 2021 - 2023 (WL) Jeep Grand Cherokee L
 2022 - 2023 (WL) Jeep Grand Cherokee

SAFETY RECALL

Intermediate Shaft

Reference: 58A / NHTSA 23V-352

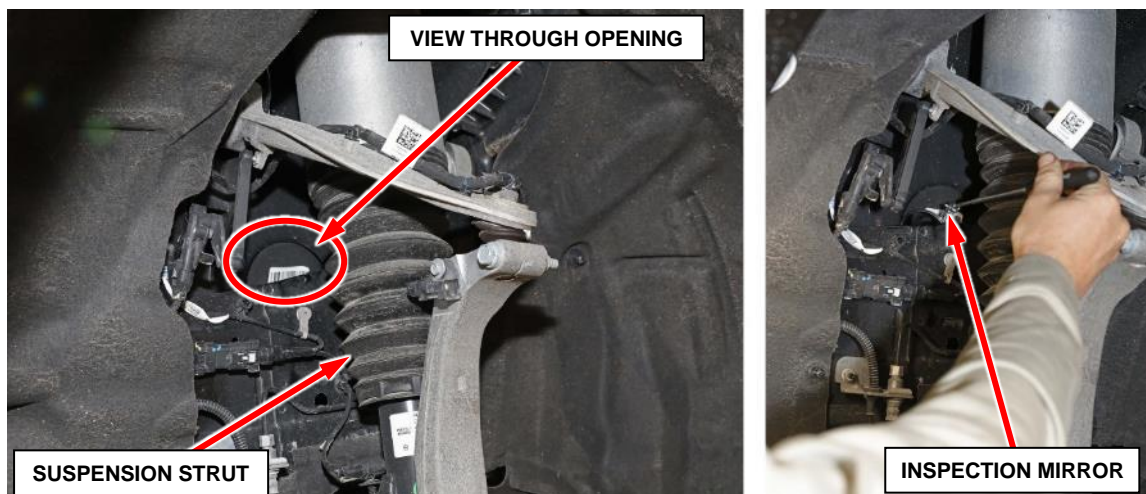
Figure 1 – Inspection Access Location

- a) Raise and support the vehicle.
- b) Remove the front wheel assembly from the same side of the vehicle as the steering column.
- c) Inspection access to the steering U-joint coupling through opening as shown (Figure 1).

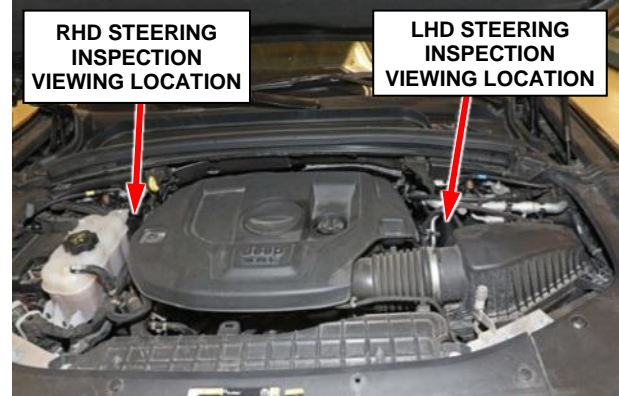
Figure 2 – Inspection Access Location

Inspection may be performed from under hood in engine compartment for vehicles equipped with the following (Figure 2):

- 3.6L Engine (Sales Code ERC) with RHD or LHD steering.
- 5.7L Engine (Sales Code EZH) with LHD steering.
- 2.0L Turbo Engine (Sales Code EC1) with RHD steering.

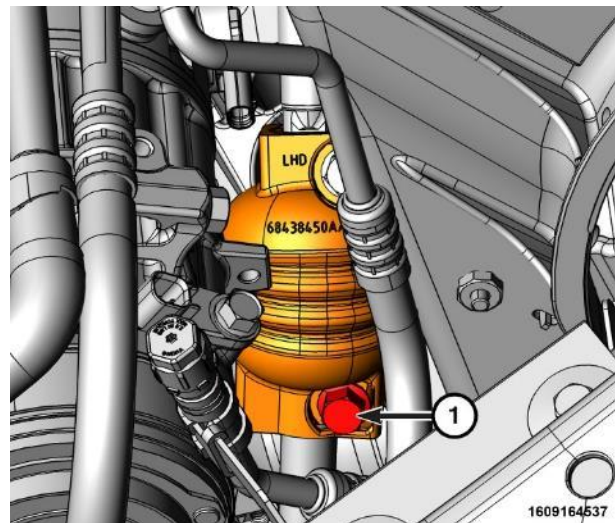
Figure 22 – U-Joint Coupling

6. U-joint coupling replacement is **ONLY** necessary if bolt thread in previous step were damaged. If bolt threads were **NOT** damaged, skip this step for U-joint coupling replacement (Figure 22).

- a) Grasp the I-shaft near the U-joint coupling then slide the I-shaft back into itself releasing it from the U-joint coupling (Figure 23).
- b) Remove and **DISCARD** the lower steering column shaft coupling pinch bolt (1) (Figure 22).
- c) Remove and **DISCARD** the U-joint coupling from the steering gear shaft.
- d) Obtain a **NEW** U-joint coupling and install it to the steering gear shaft.
- e) Obtain a **NEW** pinch bolt and install it in the U-joint coupling lower hole (1) then tighten the bolt to 45 N·m (33 Ft. Lbs.) (Figure 22).
- f) Slide the I-shaft back into the U-joint coupling inserting the I-shaft fully into the U-joint coupling as far as it will go. The white plastic clip will act as a stop (Figure 23).
- g) Proceed to the next step of the repair procedure.

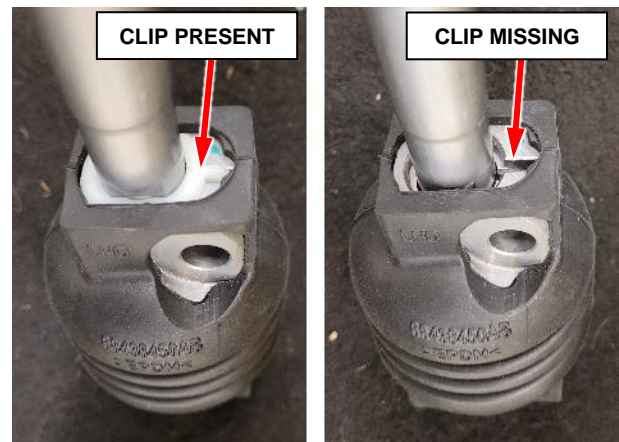
Figure 24 – White Plastic Clip

6. Do **ANY** of the identified conditions (a-c) exist:
- a) Bolt is NOT fully tightened flush to U-joint coupling.
 - b) White plastic clip is MISSING.
 - c) Intermediate shaft is NOT fully inserted into the U-joint coupling.

7. Is the white plastic clip present or missing from the U-joint coupling? (Figure 24)

- **White Plastic Clip Present:** Continue to next step of repair procedure.
- **White Plastic Clip Missing:** Obtain a **NEW** white plastic clip and follow these instructions.

- Grasp the I-shaft near the U-joint coupling then slide the I-shaft back into itself releasing it from the U-joint coupling (Figure 23).
- Install the white plastic clip to the U-joint coupling (Figure 24).
- Slide the I-shaft back into the U-joint coupling inserting the I-shaft fully into the U-joint coupling as far as it will go. The white plastic clip will act as a stop (Figure 23).
- Proceed to the next step of the repair procedure.
