PRODUCT CAMPAIGN BULLETIN

APPLICABILITY: 2021MY Crosstrek
 2022MY Forester
 2021-23MY Legacy
 2021-23MY Outback

NUMBER: WRQ-23R

SUBJECT: Safety Recall – Transmission Inhibitor Switch Replacement

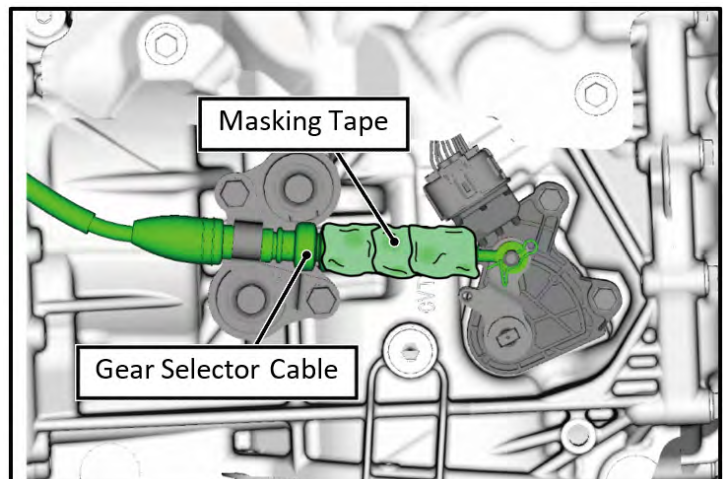
STEP 7: Cover the rubber gear selector cable boot with masking tape to prevent any damage during the next steps. Refer to the Work Tips Video at 00:00.

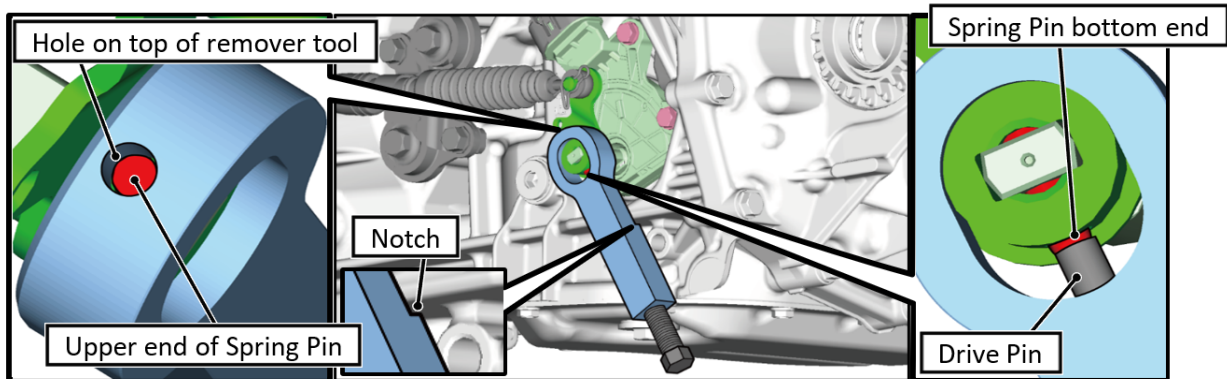
STEP 9: Install the pin removal tool over the spring pin located on the gear selector arm. The notched side should be facing the transmission case. Slowly turn the threaded portion clockwise by hand until the driving pin of the tool is aligned with the spring pin.

CAUTION: CONFIRM the drive pin and the hole located on the top of the removal tool are aligned with the spring pin. Any applied pressure without proper alignment may cause damage.

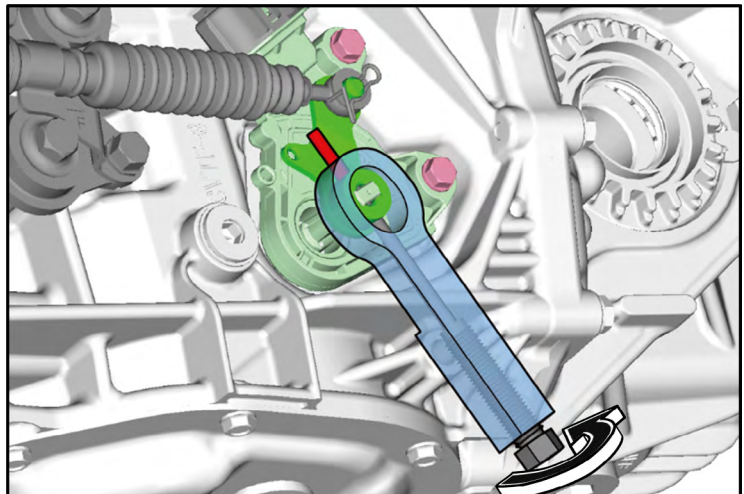
STEP 10: Using **HAND TOOLS ONLY**, tighten the threaded portion of the removal tool until the spring pin is fully removed. Discard the spring pin once it is fully removed. **DO NOT** reuse the spring pin.

STEP 11: Loosen the removal tool and remove it from the shifter arm.

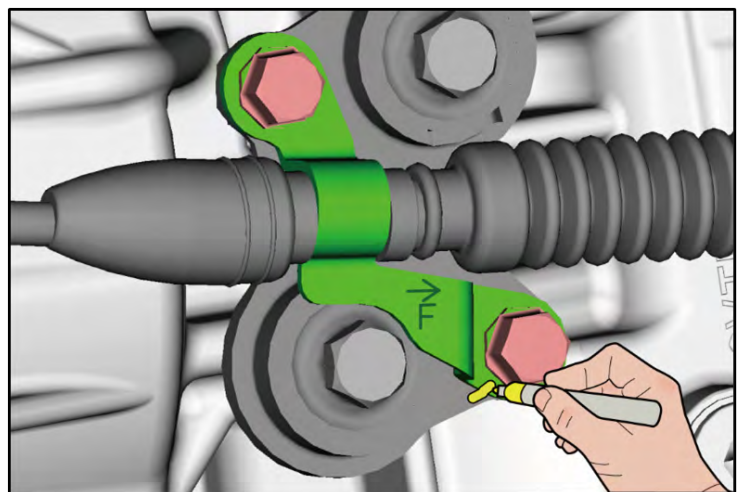
STEP 12: Using a marker or paint pen, make an alignment mark on the cable bracket and cable plate as show in the right image. This mark will be utilized in further steps.

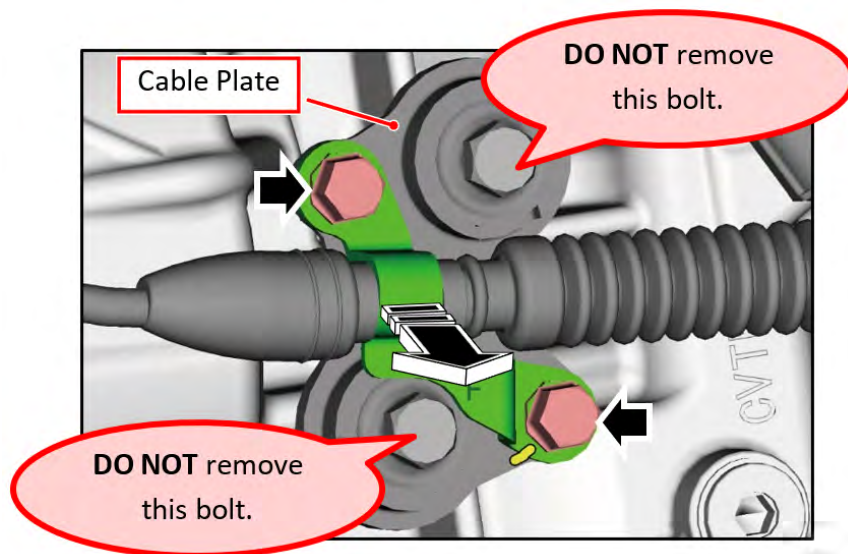
STEP 13: Remove the two retaining bolts and remove the cable bracket.

CAUTION: **DO NOT** remove the cable plate.

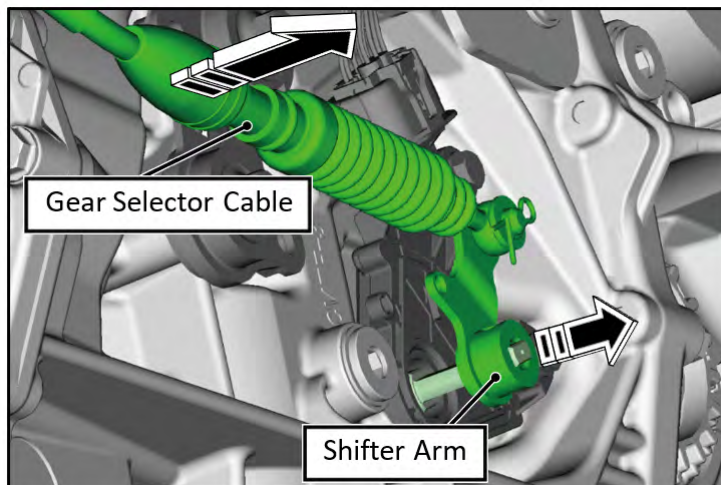
STEP 14: Remove the gear selector cable and shifter arm together from the shifter arm shaft.

CAUTION: It is possible for the shifter arm to be stuck to the shifter arm shaft. A small pry bar or screwdriver can be used to assist the release of the shifter arm. **DO NOT** apply any excessive force to the gear selector cable.

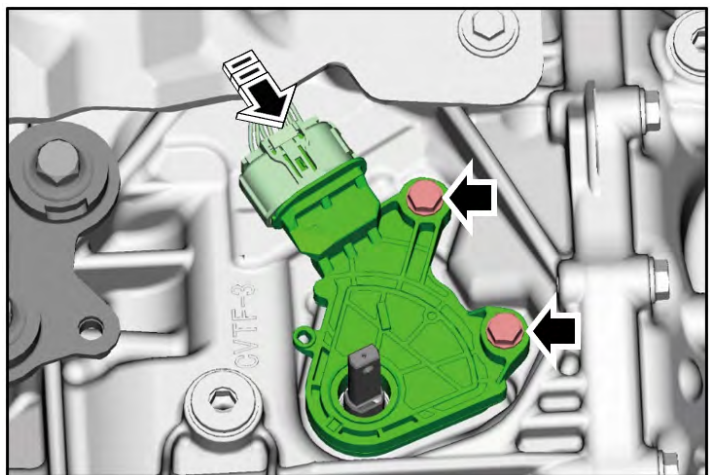
STEP 18: Connect the electrical connector. Install the two mounting bolts hand tight only. The bolts will be torqued after a final adjustment is made.

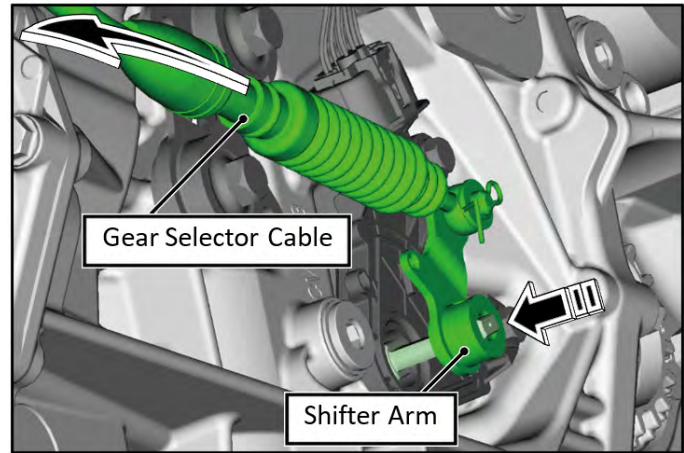
DO NOT apply an impact or a load to part (a) of the gear selector cable shown in the picture below. Doing so may damage the resin guide pipe inside the boot.

If the resin guide pipe is damaged, the inner cable can become slackened when operating the gear selector lever and the shifter arm become inoperative. As a result, the shift positions of the gear selector lever and the inhibitor switch do not match, causing malfunctions such as an engine no crank/no start condition.

STEP 19: Slightly pull the gear selector cable toward the rear of the vehicle and install the shifter arm onto the shaft.

CAUTION: DO NOT apply excessive pressure to part (a) of the gear selector cable shown below.

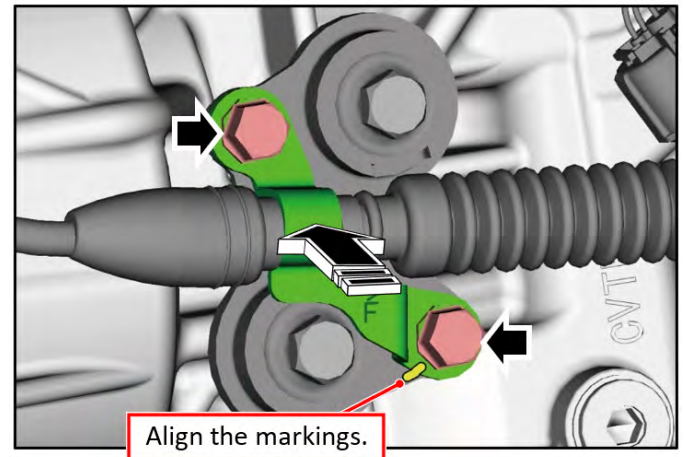
STEP 20: Install the cable bracket using the alignment marks made in Step 13. Torque the mounting bolts to 18Nm (13ft-lbs.).

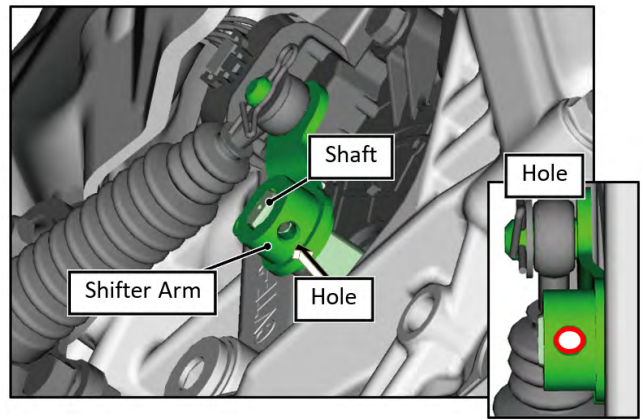
STEP 21: Align the shifter arm hole and the shaft hole.

TIP: Inserting a bolt (M5x10mm) can help prevent any misalignment of the holes. The bolt can be secured with masking tape to prevent the bolt from falling out during pin installation.

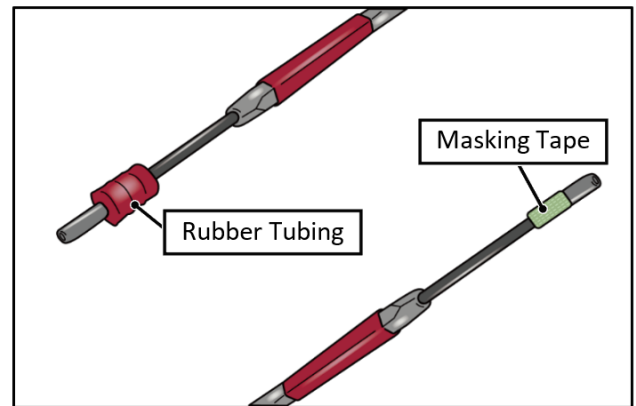
STEP 22: Prepare the new spring pin by securing it to the tip of a 5mm punch using masking tape or a piece of rubber tubing.

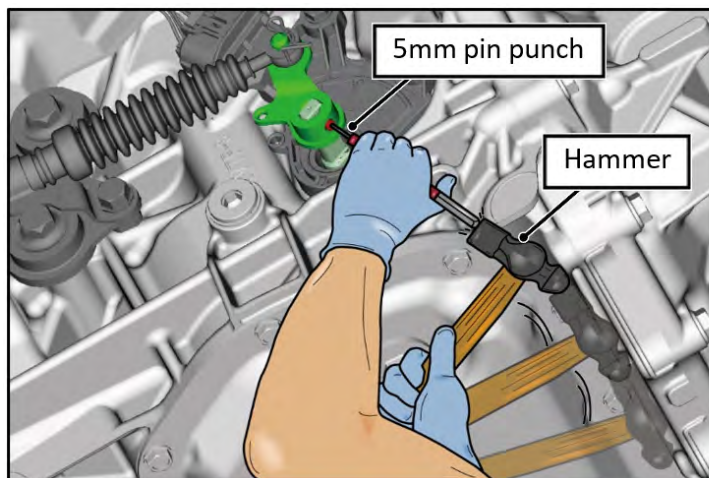
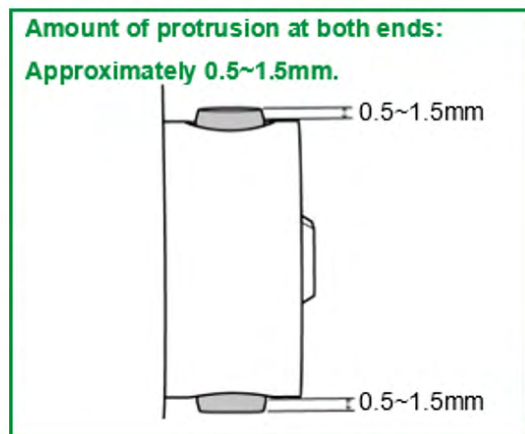
STEP 23: Install the new spring using a hammer. The spring is completely installed when the pin protrusion is equal on both sides.

CAUTION: Take particular care to not misalign the shifter arm and shaft holes during installation. **DO NOT** hit the surrounding components with the hammer.

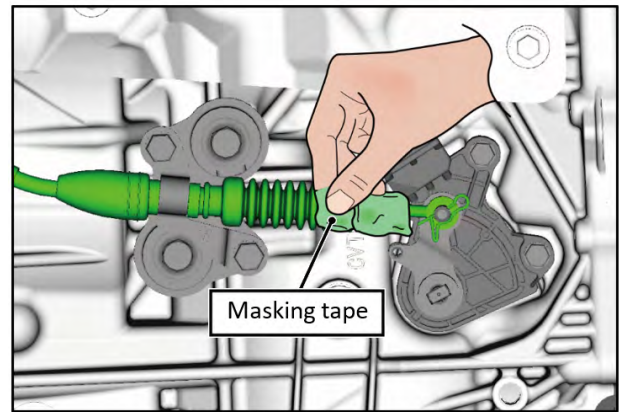
STEP 24: Remove the masking tape from the gear selector cable.
