Safety Recall – 2024 CX-90 - Steering Gear Safety Recall

A. VEHICLE INSPECTION PROCEDURE – AND PREPERATION FOR REPAIR

B. REPAIR PROCEDURE

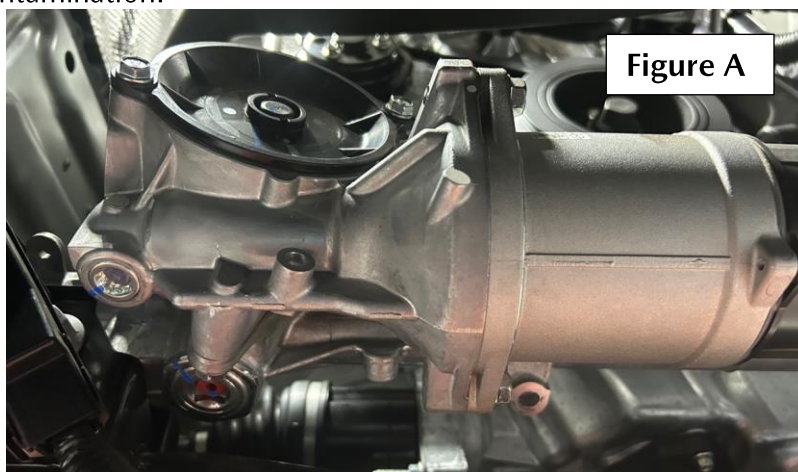
1. In order to prevent contamination later in the procedure, (step 4), wash away with water, any slush, snow, sand, mud, etc. around the steering gear and dry the entire area with an air gun (Figure A). Use Parts Cleaner if needed to completely clean the area to avoid any contamination.

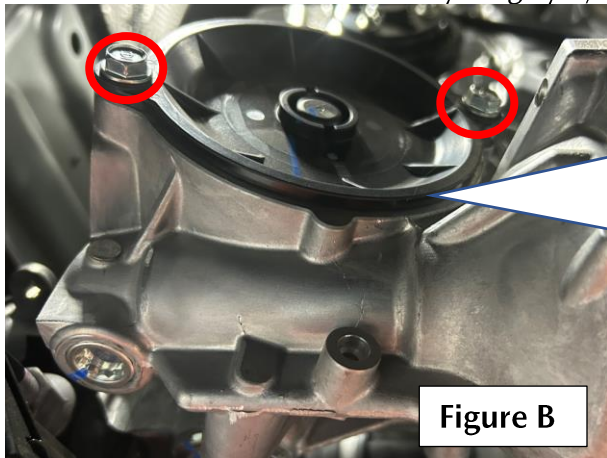
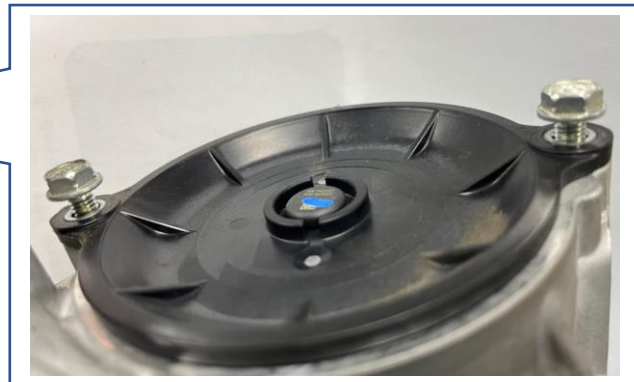
2. Loosen the two bolts for the black cover (Figure B) on the top of the steering motor to the point where the threads are visible by roughly 1/8" (3 mm).

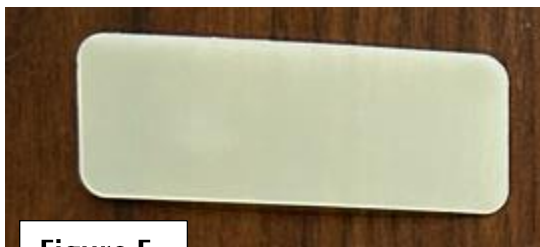
Figure E

4. Once the cover has been loosened and is against the bolts, remove both bolts and remove the cover by hand. It does not take much force with the tool to pop up the cover.
5. WASH YOUR HANDS COMPLETELY AND DRY THEM. Take out the plastic plate in the replacement parts kit and place it on a clean cloth (Figure E). Use a clean Neoprene glove.

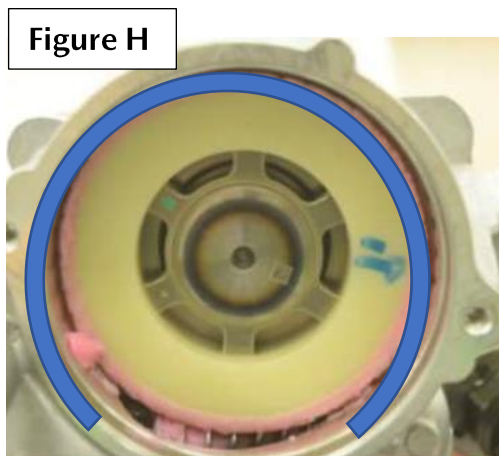
Figure H

6. Using your gloved finger, press the grease into the gap between the aluminum case and the worm gear insert around the worm gear Figure G, which adheres to the area of the blue frame in Figure H. Note G is showing a Right Hand Drive Steering Rack.

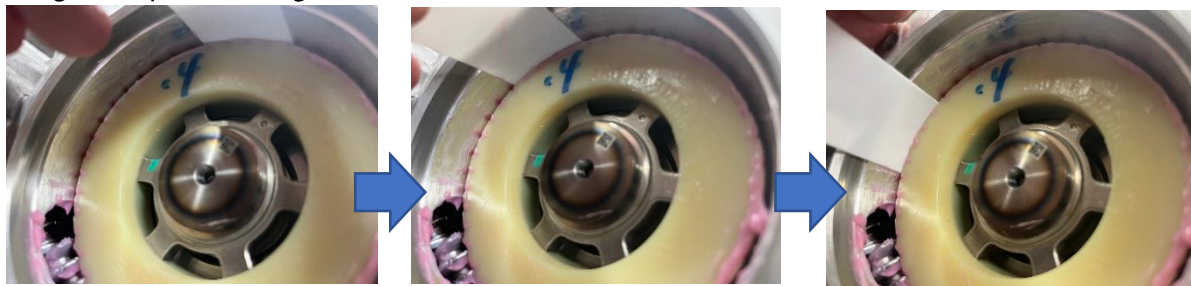
7. Place the plastic plate between the aluminum case and the worm gear, align the range of the blue frame in the figure below twice on the left and right, and press the pink grease on the groove part of the gear.

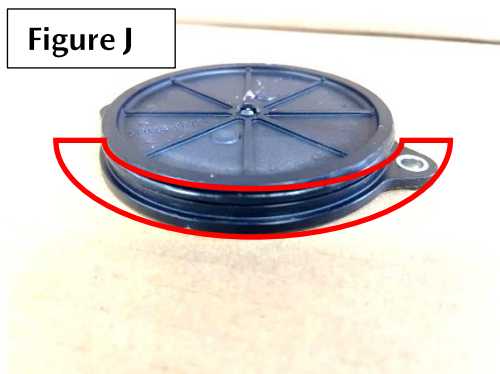
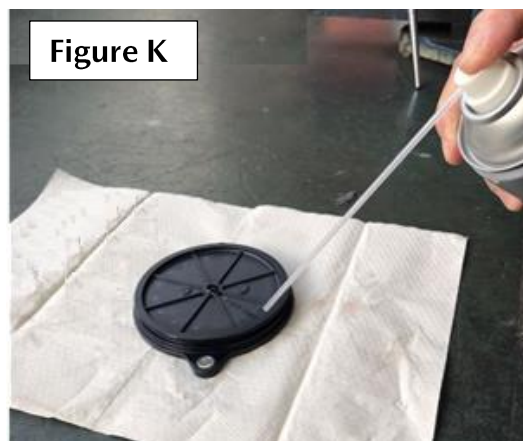
9. Discard the plastic plate used to press in the grease.
10. O-Ring removal and Cover cleaning:
 - a. Figure J. Remove the O-ring in Figure J on the outer periphery of the black cover and discard the O-ring.
 - b. Figure K. Place the black cover on a clean cloth and clean the housing contact surface of the aluminum case with a non-corrosive parts cleaner that does not degrade plastic or metal.
 - c. Figure L. Thoroughly remove dirt from the O-ring groove with a parts cleaner. Install the new O-ring in the parts kit.

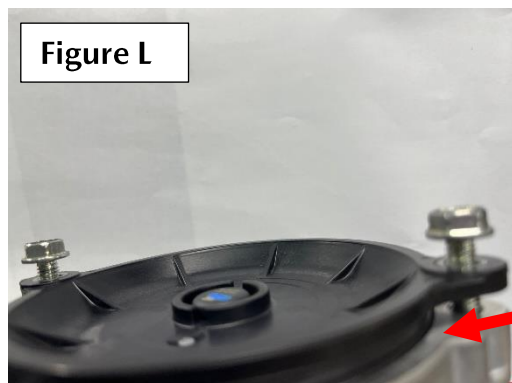
Gap in cover

11. Install the black cover, but do not push down completely. Leave a gap and insert the bolts a few turns holding the black cover in place. Refer to Figure L.

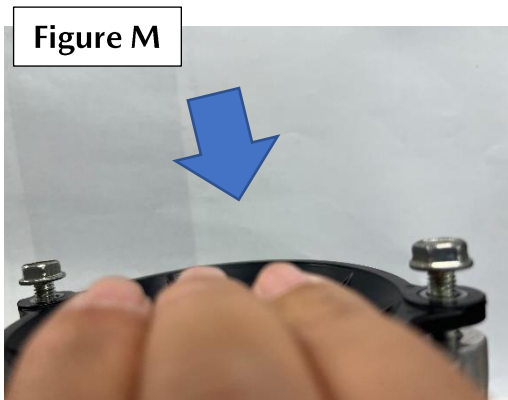
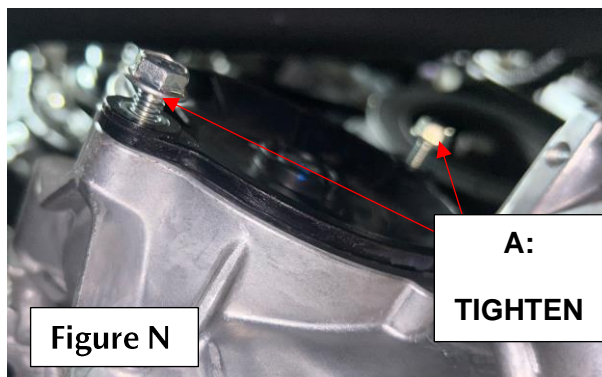
12. Gently push the black cover into the aluminum case housing surface (Figure M) and tighten the bolts with the specification below (Figure N).

Black cover bolts	Tightening torque
A	6-7lbf-ft (8 – 10) N·m

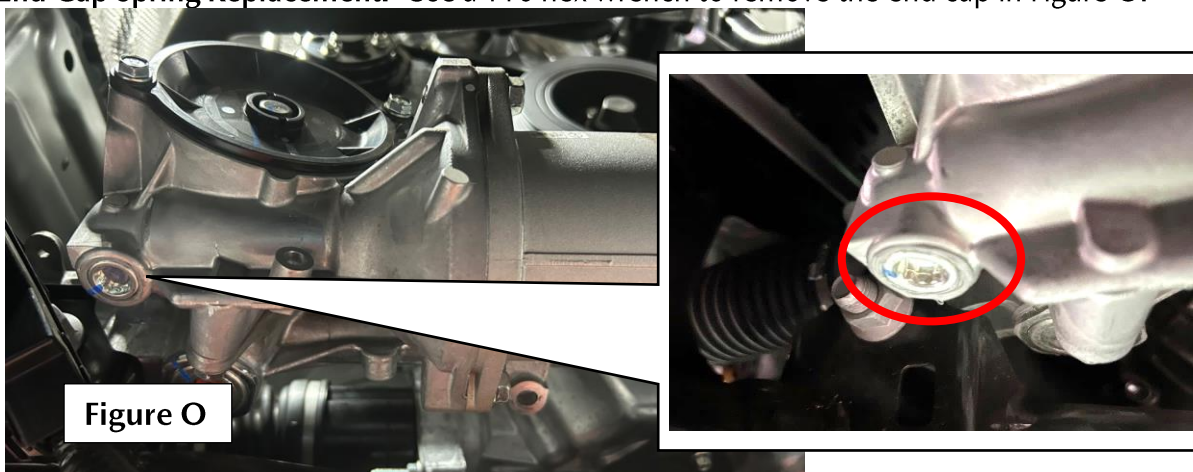
13. **End Cap Spring Replacement:** Use a T10 hex wrench to remove the end cap in Figure O.

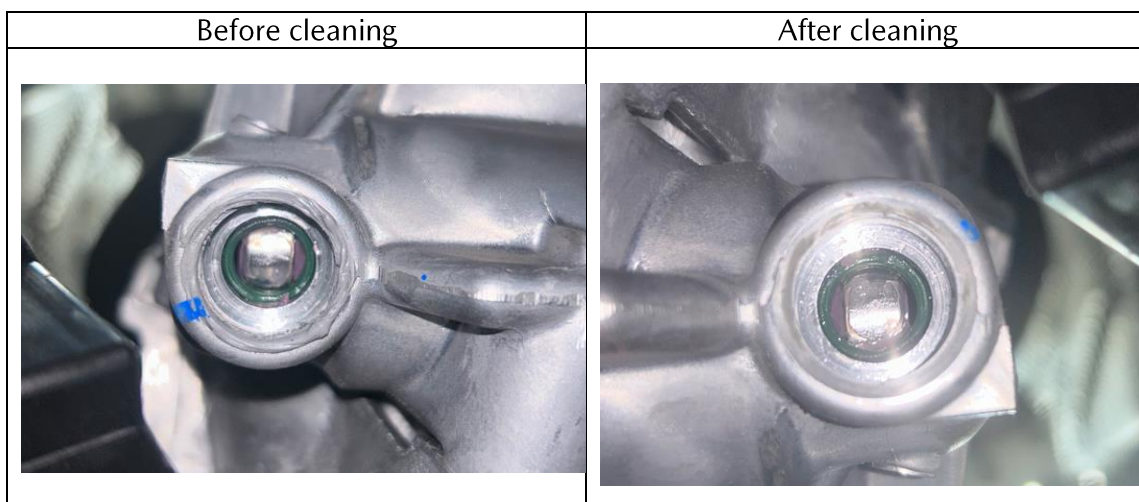
15. Remove all of the sealer on the end cap mounting surface. Use a new clean glove to remove the gray sealer applied to the threaded part of the end cap mounting surface. Remove any remaining sealer, with a clean rag and parts cleaner as necessary. by inserting it into the end cap attachment part and removing the sealant from right to left.

CAUTION: Do not rotate to the right. If you rotate it to the right, the sealer might get pushed into the housing.

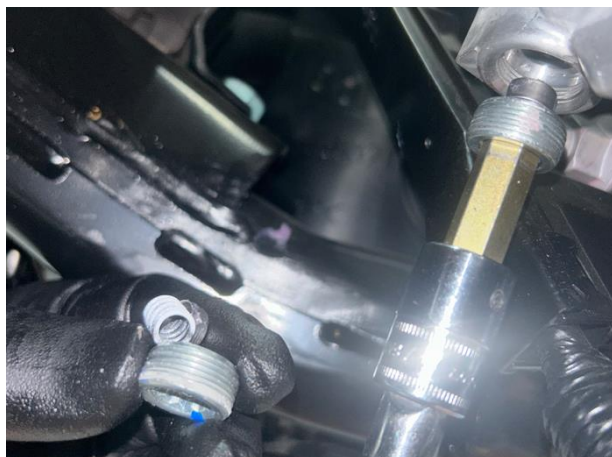
17. PHOTO REQUIREMENT #3: Take a photo for the warranty claim.

With the RO# in the photo, take a photo so that the integrated cap, spring, end cap, and old spring, which are replacement parts, are in the photo. (Note, this photo is a little low and you do not see the RO# on the rack. Make sure the RO# is present in the photo like #4

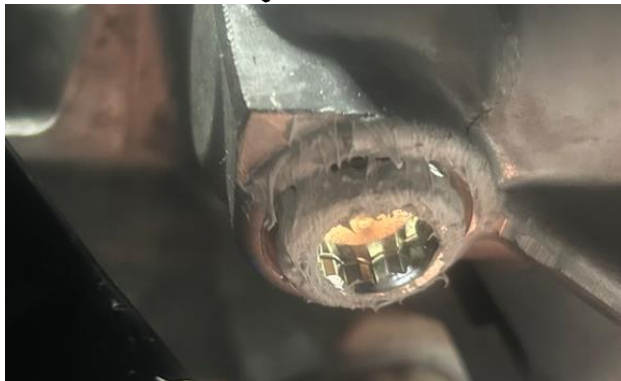
BEFORE TORQUE WITH GREASE

19. Apply a silicone liquid gasket (0000-77-1217-ES Mazda required sealant) to the thread of the end cap and tighten it. This tube will repair at least 25 vehicles. [PLEASE CLICK HERE TO WATCH THE VIDEO OF THE PROCEDURE.](#) **NOTE: THE SEALANT IS GRAY IN COLOR FROM PN# 0000-77-1217-ES)**

Tightening torque: 9-12 lbf-ft (12-16 N-m)
