SAFETY RECALL CAMPAIGN 3A01 **2024 Hayabusa ABS Hydraulic Unit Flare Nut Tightening**

- Affected Models:** Certain 2024 Hayabusa (GSX1300RR/RRZM4) motorcycles
- Affected Departments:** Management, Service, Warranty, Sales, Parts, Accessories
- Attachments:** Sales Bulletin 24-012 (Hayabusa Stop Sales) & Customer Notification Letter
- Reference:** Hayabusa GSX1300R Service Manual (99500-10L00-03E)

This notice is sent to you in accordance with the requirements of the National Traffic and Motor Vehicle Safety Act. Suzuki Motor Corporation has decided that a defect which relates to motor vehicle safety exists in certain 2024 model-year Hayabusa (GSX1300RRM4) and Hayabusa 25th Anniversary Edition (GSX1300RRZM4) motorcycles.

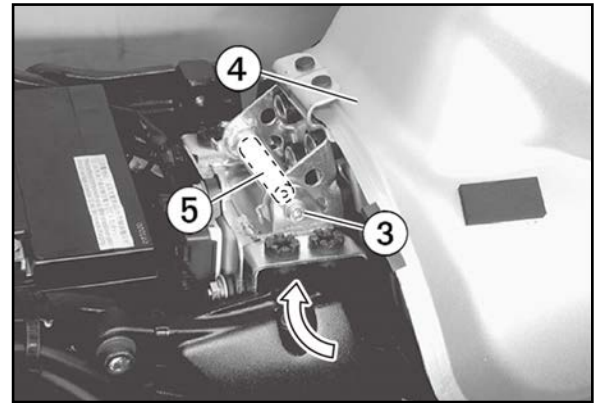
Brake Pipe Flare Nuts Tightening:

The brake fluid pipe flare nut installation torque for the brake fluid supply lines attached at the ABS unit that supply the front and rear brake calipers may have been tightened to less than the correct specification. If the motorcycle continues to be used in this condition, in the worst case, loosening of a flare nut may cause brake fluid leakage and increase braking distance, increasing the risk of a crash.

1. Tighten the brake pipe flare nuts ① to the specified torque.
