A. INTERIM VEHICLE INSPECTION PROCEDURE UNTIL PARTS ARE AVAILABLE

2009 Mazda6 (HP) and 2010 Mazda6 (HZ) vehicles, which were originally sold in, or currently or previously registered in Salt Belt States listed below.

B. CROSS MEMBER INSPECTION PROCEDURE 2009-2010 MAZDA6

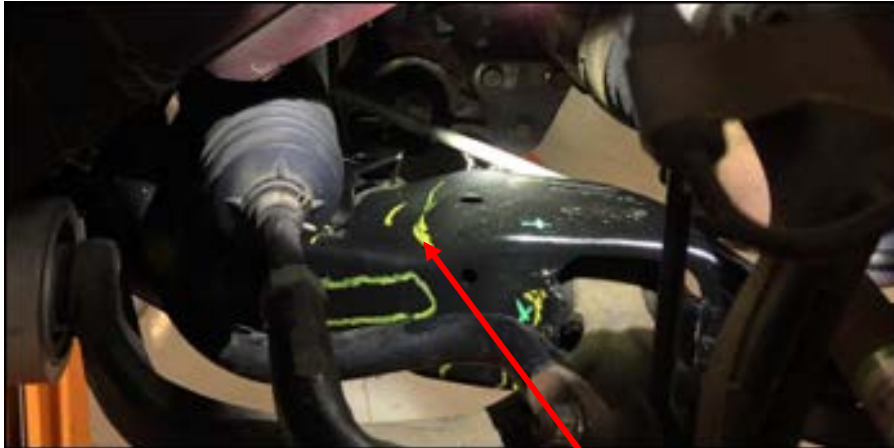
Top Side View: Non-Damaged Cross Member

Zone 1 Inspection – Upper Surface/Top side

Zone 1 inspection Area: Top Surface

Look for holes or cracks along the top surface in these areas. If a hole or crack is present, the cross member needs to be replaced. This cross member fails inspection as there is perforation

If the cross member fails inspection in this Zone, take a clear photo showing the failure. You will need it for later.

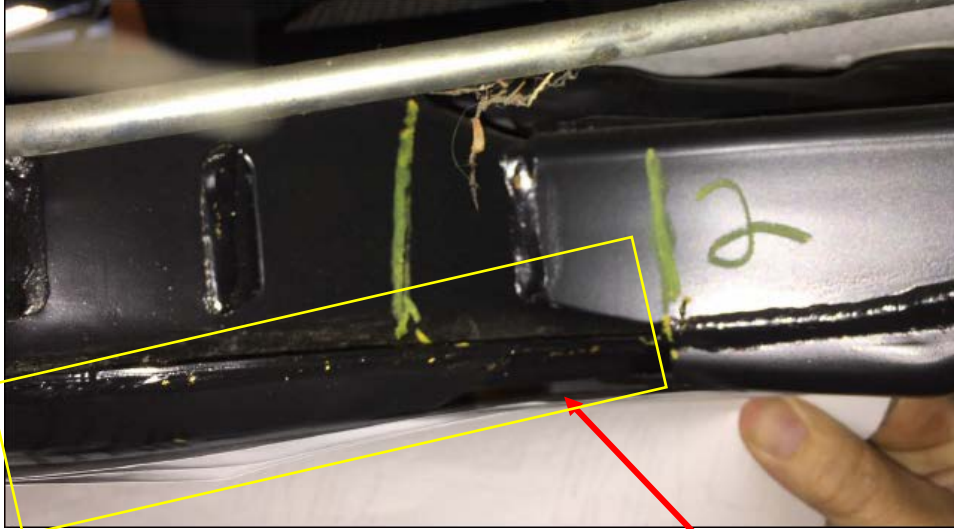
Inside View: Non-Damaged Cross member

Zone 2 Inspection - Inside Corner/Flange Weld

Zone 2 inspection Area:

Look for perforation or crack along the flange in this area. If a crack or perforation is present, replace the cross member.

If the cross member fails inspection in this Zone, take a clear photo showing the failure. You will need it for later.

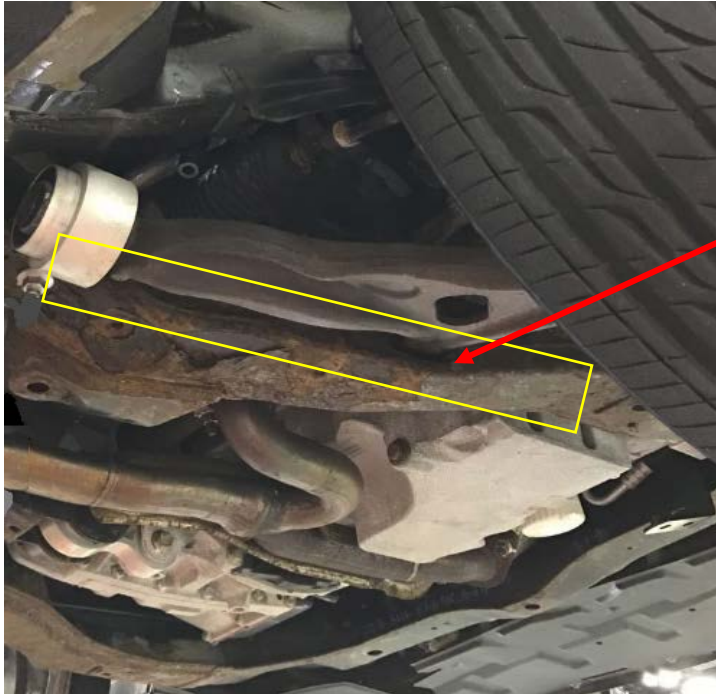
Side View: Non-Damaged Cross member

Zone 3 Inspection - Outer Area

Zone 3 inspection Area:
Look for perforation especially along the bottom corner ridge line (this area). If perforation or a crack is present the cross member needs to be replaced.

This cross member passes inspection even with the perforation as the bracket supports and covers the hole. If perforation is visible beyond what the bracket covers, the cross member must be replaced as it will fail a state safety inspection for perforation.

If the cross member fails inspection in this Zone, take a clear photo showing the failure. You will need it for later.
