TECHNICAL INSTRUCTIONS

SAFETY RECALL JOY

REAR AXLE HUB BEARING BOLT INSPECTION

CERTAIN 2019 C-HR

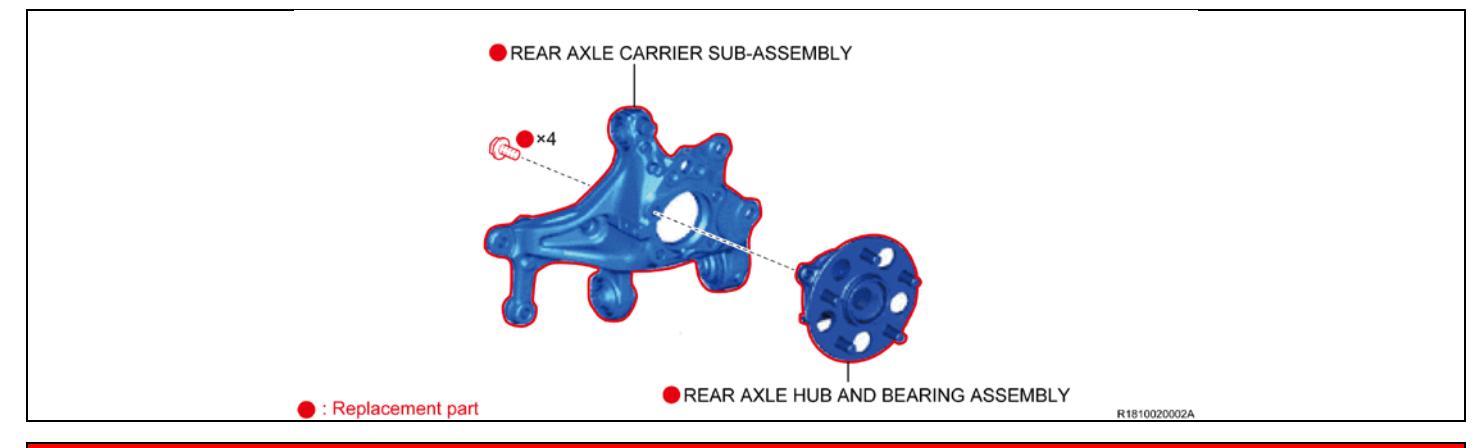
VI. REPLACE THE REAR AXLE CARRIER SUB-ASSEMBLY & REAR AXLE HUB AND BEARING ASSEMBLY (ONLY PERFORM IF YOU FOUND ONE OF THE BOLTS TO BE <u>NG</u> IN THE PREVIOUS STEP)

a. Replace the rear axle carrier sub-assembly, the rear axle hub and bearing assembly, and the rear bearing case bolts with *NEW* ones.

Click here to access TIS for instructions on REAR AXLE CARRIER / REMOVAL & INSTALLATION
