Michael A. Berardi  
 Director  
 Service Engineering Operations  
 Ford Customer Service Division

September 13, 2017

**SUBJECT:** **NEW VEHICLE DEMONSTRATION / DELIVERY HOLD –  
 Customer Satisfaction Program 17B25**  
 Certain 2013-2017 Model Year Police Interceptor Utility Vehicles  
 Exhaust Odor and Carbon Monoxide Complaints

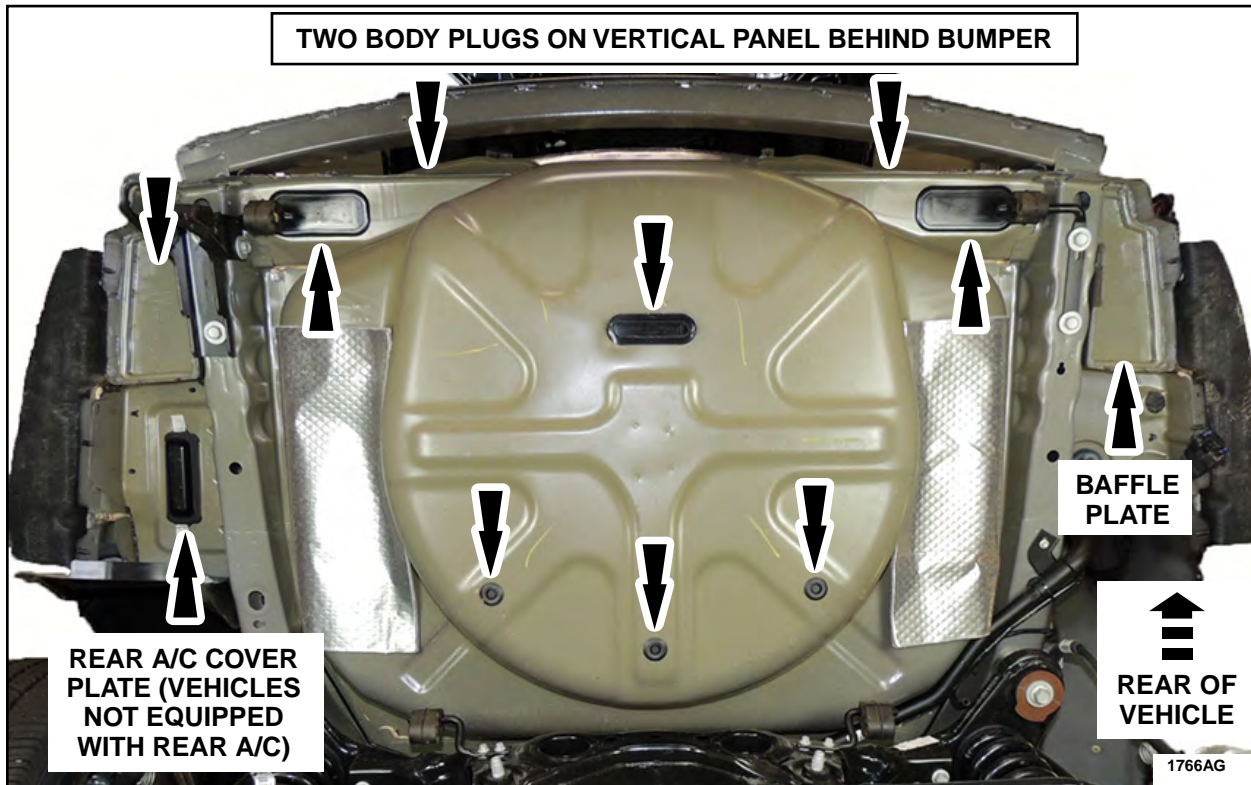
FIGURE 1

1. With the vehicle in NEUTRAL, position it on a hoist. Please follow the Workshop Manual (WSM) procedures in Section 100-02.
2. Inspect the rear underbody for damaged or missing body plugs, punctured/damaged floor pan sheet metal and baffle plates, damaged wiring harness grommets, aftermarket fasteners, and pass throughs (holes) created for aftermarket wiring/equipment. See Figures 1, 2a and 2b.
  - Seal all aftermarket wiring and equipment pass throughs using Motorcraft® TA-2 seam sealer or equivalent, and Foil-Backed Mastic Patch as needed.

**NOTE:** Do not use silicones, RTVs or caulks during this repair.

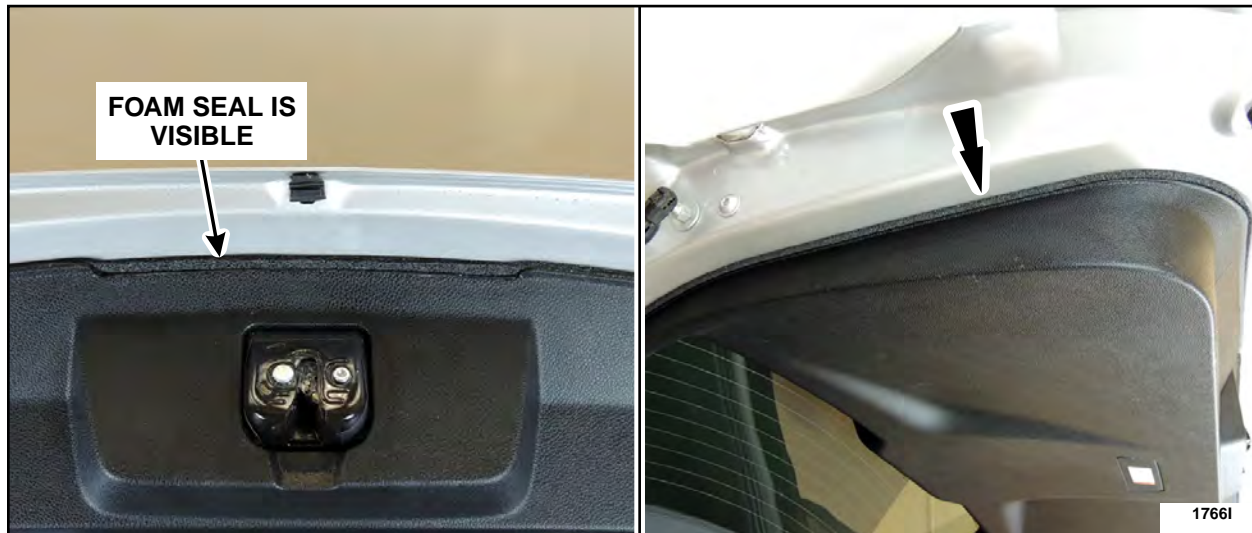
**NOTE:** The clips where the upper and lower liftgate trim panels are joined are easily damaged on installation. Use care when installing the upper liftgate trim panel.

13. Install the liftgate trim panel. Please follow the WSM procedures in Section 501-05. See Figures 25a and 25b.
