**NEW VEHICLE DEMONSTRATION / DELIVERY HOLD –
Customer Satisfaction Program 17B25 – Supplement #3**
Certain 2013-2017 Model Year Police Interceptor Utility Vehicles
Exhaust Odor and Carbon Monoxide Complaints

17B25 – Customer Information Form

Liftgate Spoiler – Aftermarket Lighting and/or Equipment

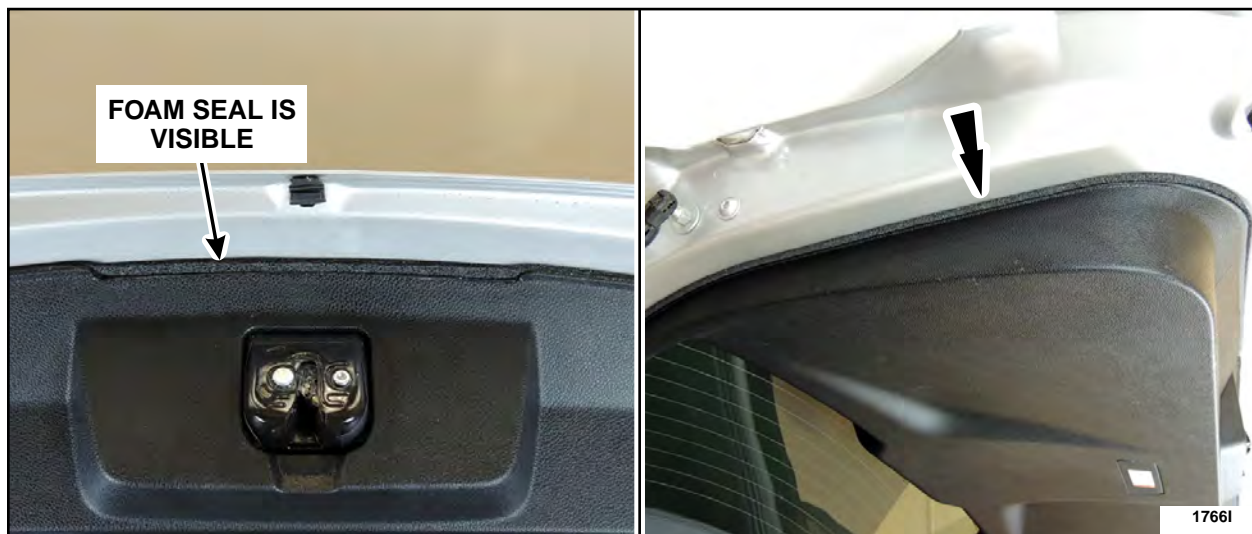
NOTE: The clips where the upper and lower liftgate trim panels are joined are easily damaged on installation. Use care when installing the upper liftgate trim panel.

13. Install the liftgate trim panel. Please follow the WSM procedures in Section 501-05. See Figures 25a and 25b.
