David J. Johnson
 Director
 Service Engineering Operations
 Ford Customer Service Division

Ford Motor Company
 P. O. Box 1904
 Dearborn, Michigan 48121

SUBJECT: **NEW VEHICLE DEMONSTRATION / DELIVERY HOLD – Customer Satisfaction Program 17B25 – *Supplement #5***
 Certain 2013-2017 Model Year Police Interceptor Utility Vehicles
 Exhaust Odor and Carbon Monoxide Complaints

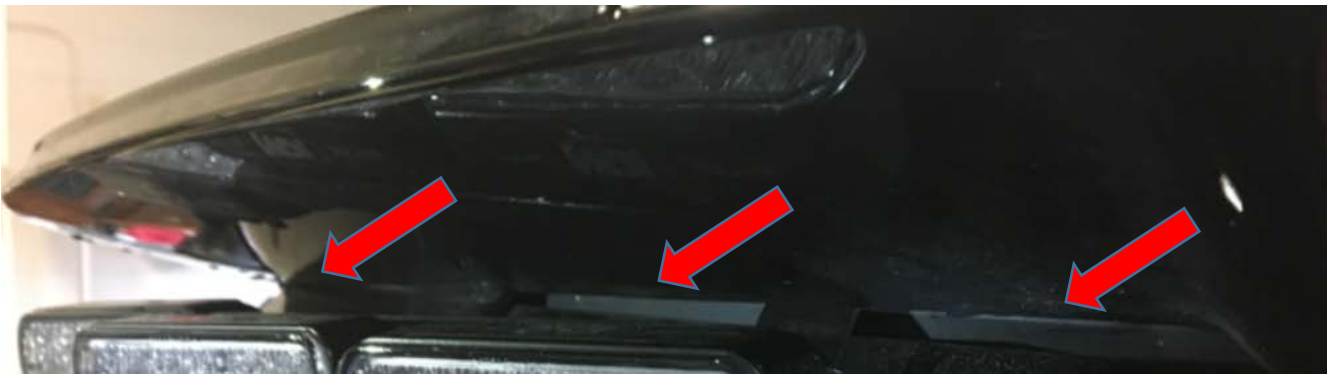
Figure 2

- Brackets positioned between the spoiler and the liftgate (See Figure 1)
- Lighting and/or equipment that forces the spoiler out of position creates a gap between the spoiler and the liftgate (See Figure 2)
- Unsealed holes drilled in the spoiler or liftgate (See Figures 3 and 4)
- Wiring for lighting and/or equipment routed from the spoiler to the vehicle in a manner that damages the seals between the spoiler and the vehicle (See Figures 5 and 6)
- When the spoiler is removed to install aftermarket lights and/or equipment, the spoiler attachment clips and seals may be damaged. If the spoiler was removed from the vehicle, the spoiler attachment clips and seals should be replaced. Use part number HB5Z-78442K03-A

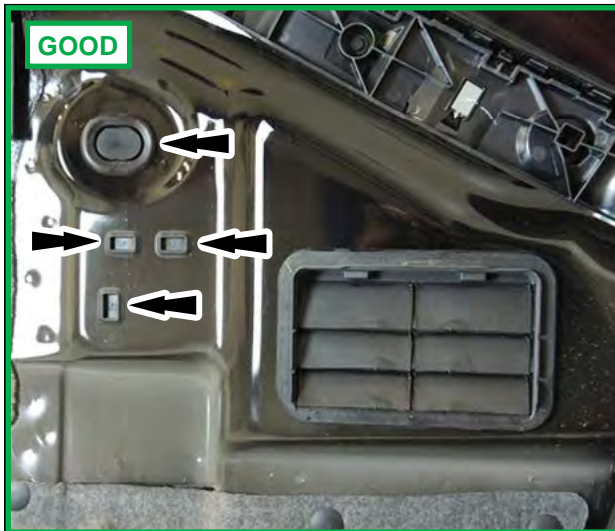
FIGURE 4a

4. Using a telescoping mirror and flashlight, inspect the 4 body plugs and air extractor through the wheelhouse openings on each side of the vehicle to determine if aftermarket wiring has been routed through these components. Reroute aftermarket wiring as needed. See Figures 4a and 4b.

- Replace body plugs or air extractors if any damage is present. Rear bumper cover removal is required to replace the air extractor. Please follow the WSM procedures in Section 501-19.
