**PRODUCT CAMPAIGN BULLETIN**

**APPLICABILITY:** 2017MY Impreza

**NUMBER:** WTN-74R

**SUBJECT:** Reprogramming File Availability to Optimize Rear View Camera Operation on Harman Gen 3 Audio and Navigation Head Units

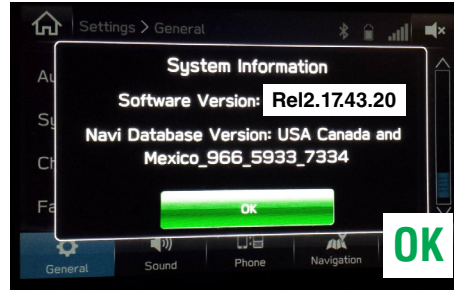
**NG-** Head Unit Must Be Updated, Proceed To Step 2.
