PRODUCT CAMPAIGN BULLETIN

APPLICABILITY: 2017-18MY Impreza

2018MY Crosstrek

SUBJECT: PCV Valve- Design Change **NUMBER:** WUP-01

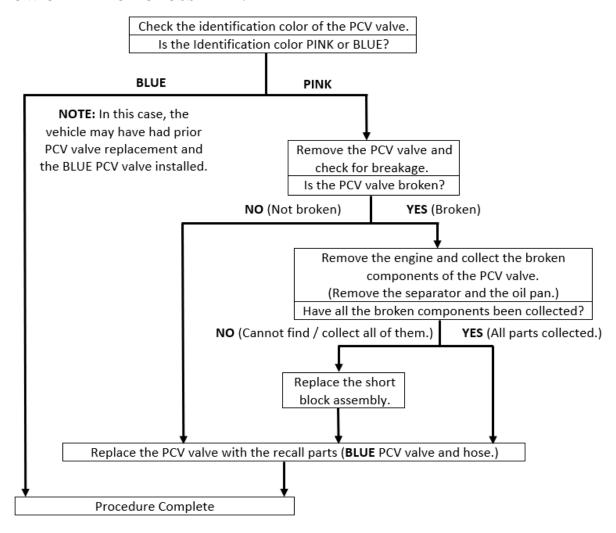
FLOW CHART FOR CROSSTREK:

IMPORTANT: The two flow charts below provide an overview for the service procedures. The first is for Crosstrek and the second for Impreza. Detailed service procedures to be followed are also provided and must reviewed completely before proceeding.

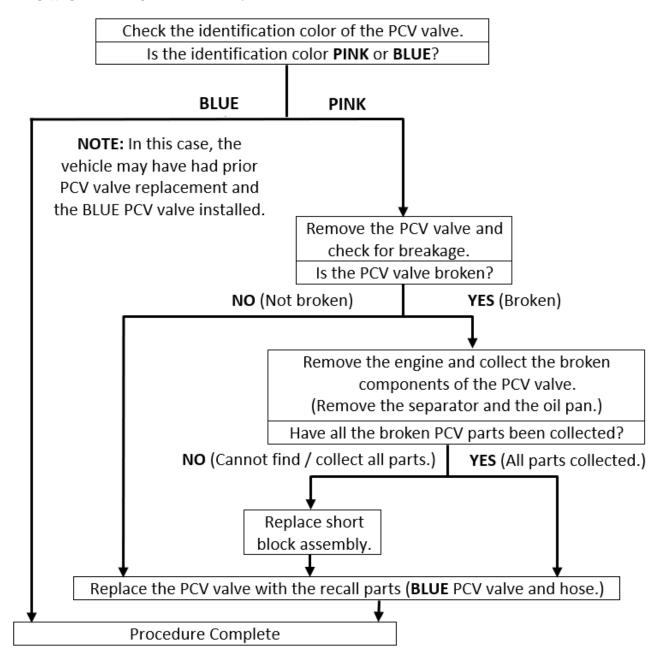
FLOW CHART FOR IMPREZA:

STEP 1: Locate the PCV valve and check the identification color. If for some reason the color cannot be identified, remove the PCV valve and confirm the condition (failed / come apart). If the (unidentifiable) PCV valve is not broken, replace it with a new (**BLUE**) valve and PCV hose. If the valve is broken, proceed as if it were a **PINK** valve using the flow chart(s) above as a guide.
