SERVICE PROGRAM BULLETIN

APPLICABILITY: 2019MY Crosstrek
SUBJECT: Rear Seat Belt Webbing Locking

NUMBER: WRA-20R
DATE: 02/25/20
REVISED: 04/01/20

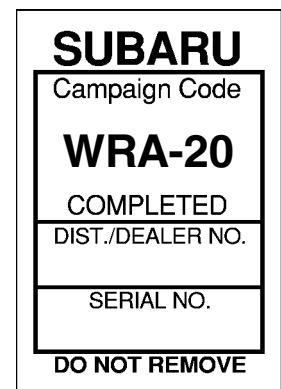
Type or print the necessary information on a Campaign Identification Label. The completed label should be attached to the vehicle’s upper radiator support. Additional labels are available through normal parts ordering channels. The part number is **MSA6P1302**, which comes as one sheet of 20 labels.
