SUBJECT: **Customer Satisfaction Program 20N11 - Supplement #2**
Certain 2016 - 2019 Model Year Explorer Vehicles equipped with a Roof Rail
Roof Rail Cover Detachment

REF: **Technical Service Bulletins 19-2364 and 20-2154**
2016-2019 Explorer – Roof Rail Covers Loose

CERTAIN 2016-2019 MODEL YEAR EXPLORER VEHICLES — ROOF RACK REPAIR

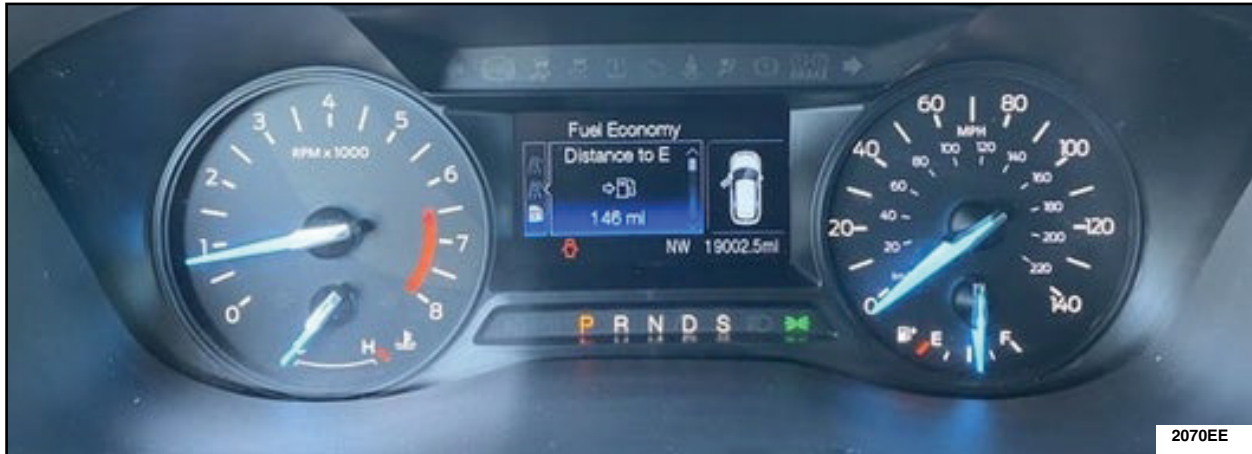
FIGURE 10

ii. Take photo showing vehicle mileage. See Figure 10.

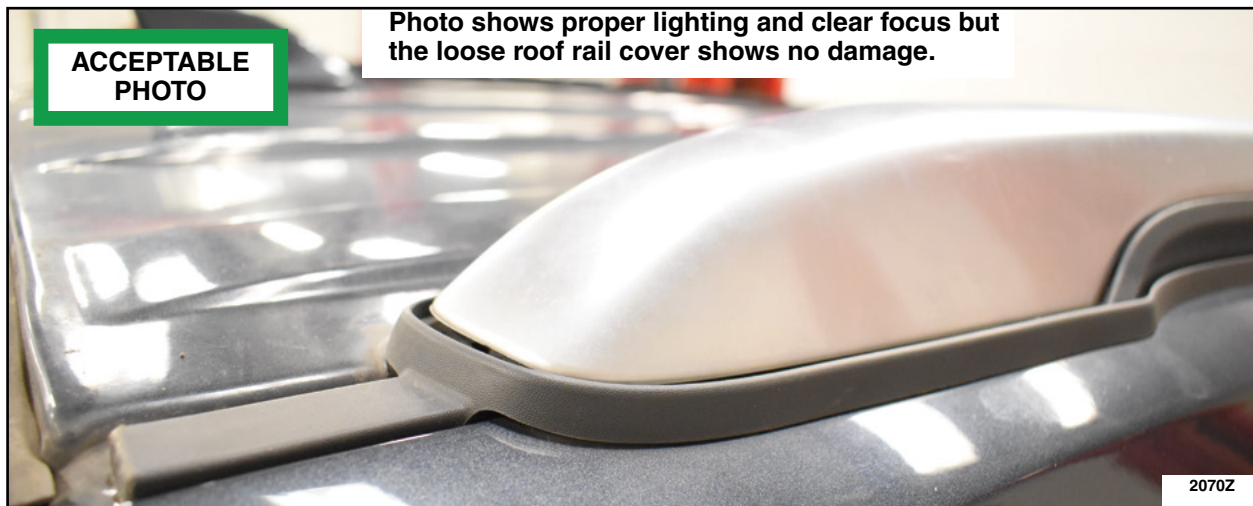
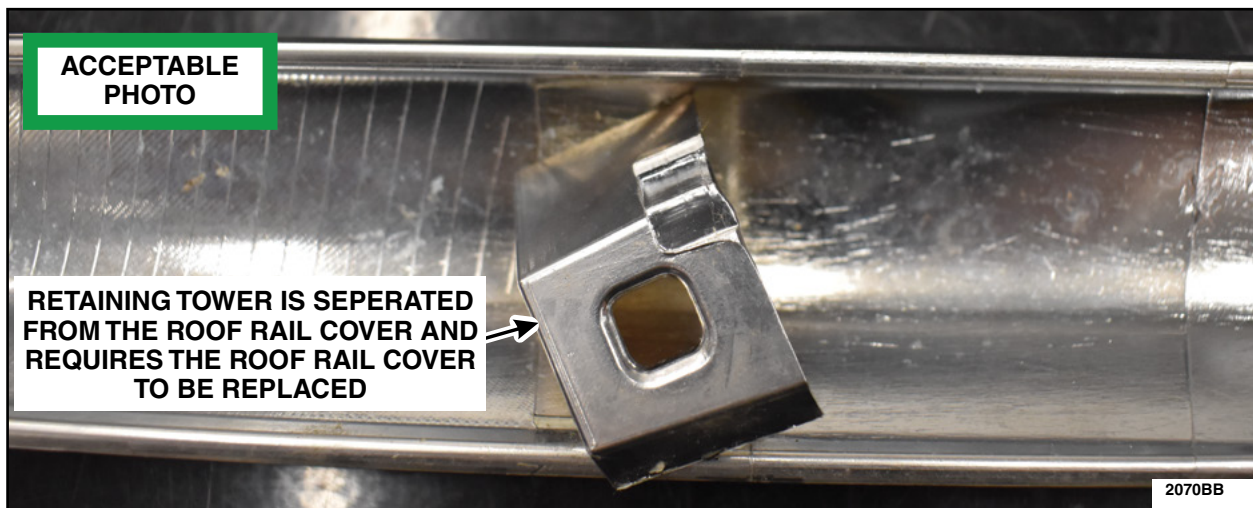
1. Digital images are now required to be attached to each roof rail cover part order. Before submitting VIN-specific part order to SSSC, review new digital image submission requirements on page 2 of Attachment II in the Dealer Bulletin. See Figures 22 through 25 for examples.
