David J. Johnson  
 Director  
 Service Engineering Operations  
 Ford Customer Service Division

**SUBJECT: NEW VEHICLE DEMONSTRATION / DELIVERY HOLD  
 Customer Satisfaction Program 21B03 - Supplement #3**  
 Certain 2020 Model Year Super Duty F250-F600 Vehicles Equipped with a 10R140  
 Transmission - Number One Planetary and Ring Gear Assembly

## CERTAIN 2020 MODEL YEAR SUPER DUTY F250-F600 VEHICLES EQUIPPED WITH A 10R140 TRANSMISSION — NUMBER ONE PLANETARY AND RING GEAR ASSEMBLY

### **NEW!** SERVICE PROCEDURE

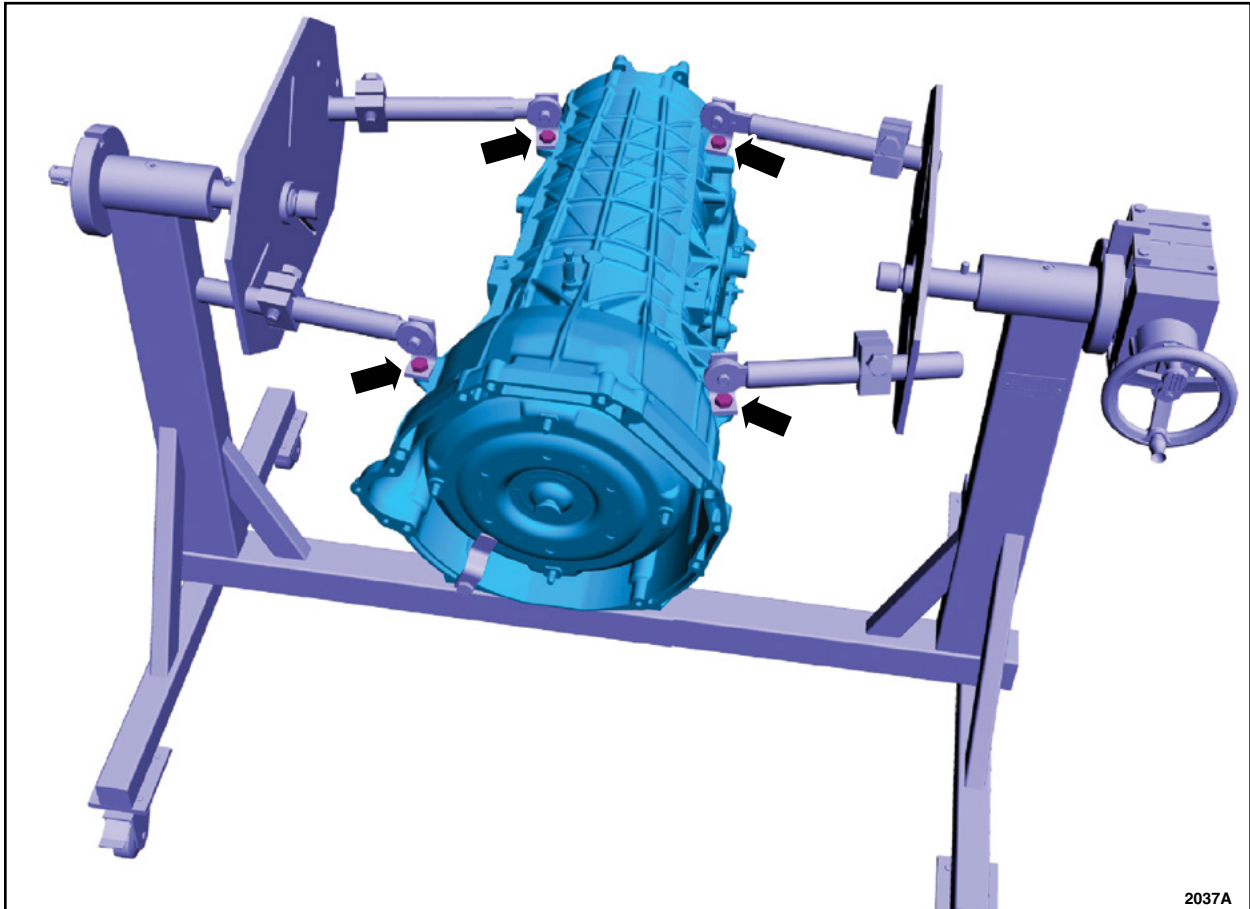
FIGURE 1

2. Place the transmission on a mounting stand. See Figure 1.

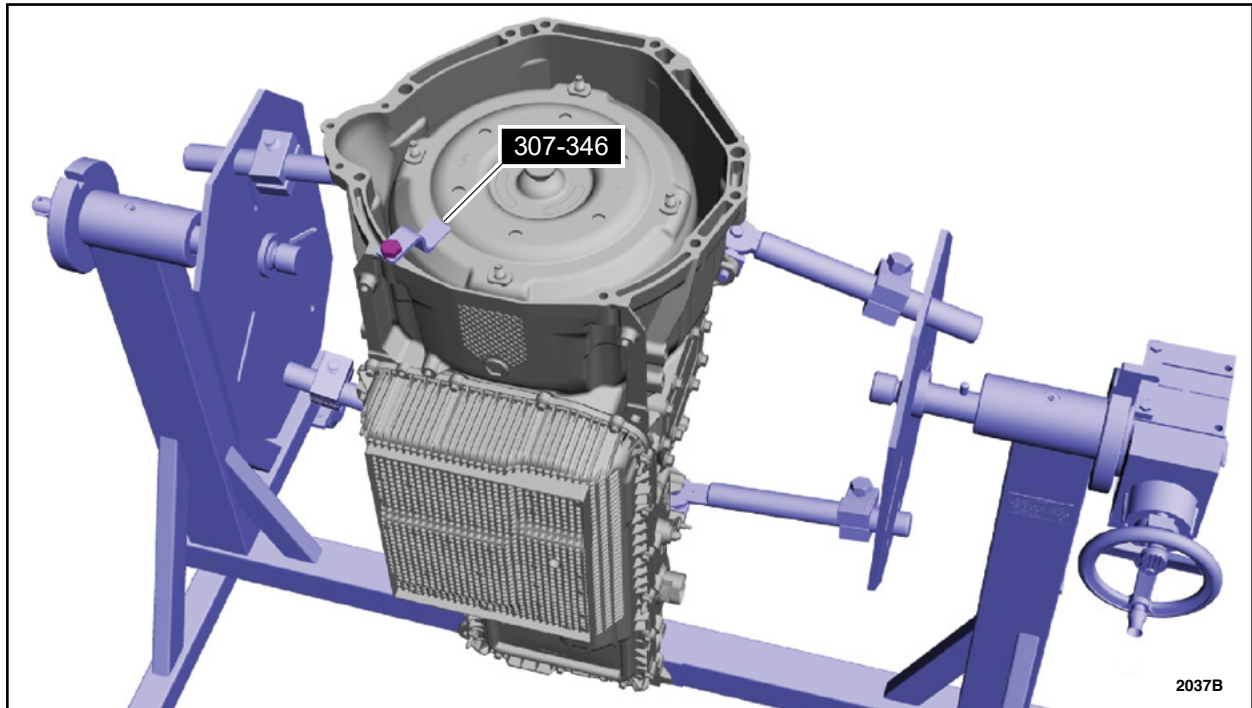
**FIGURE 2**

3. Rotate the transmission in a vertical position, then remove the special service tool 307-346.  
See Figure 2.

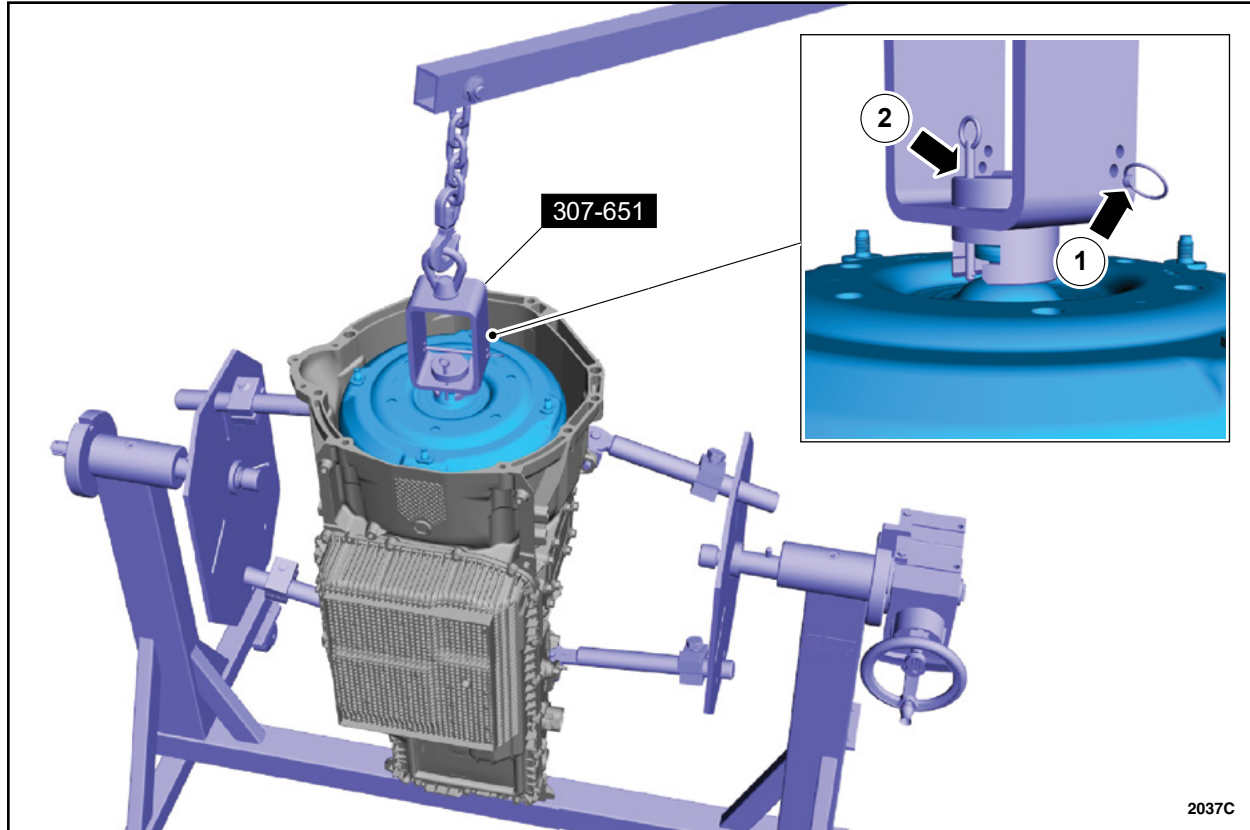
FIGURE 3

4. Using special service tool 307-651 and a floor crane, remove the torque converter. See Figure 3.

1. Horizontal pin is in the bottom hole.
2. Vertical pin prevents part movement.

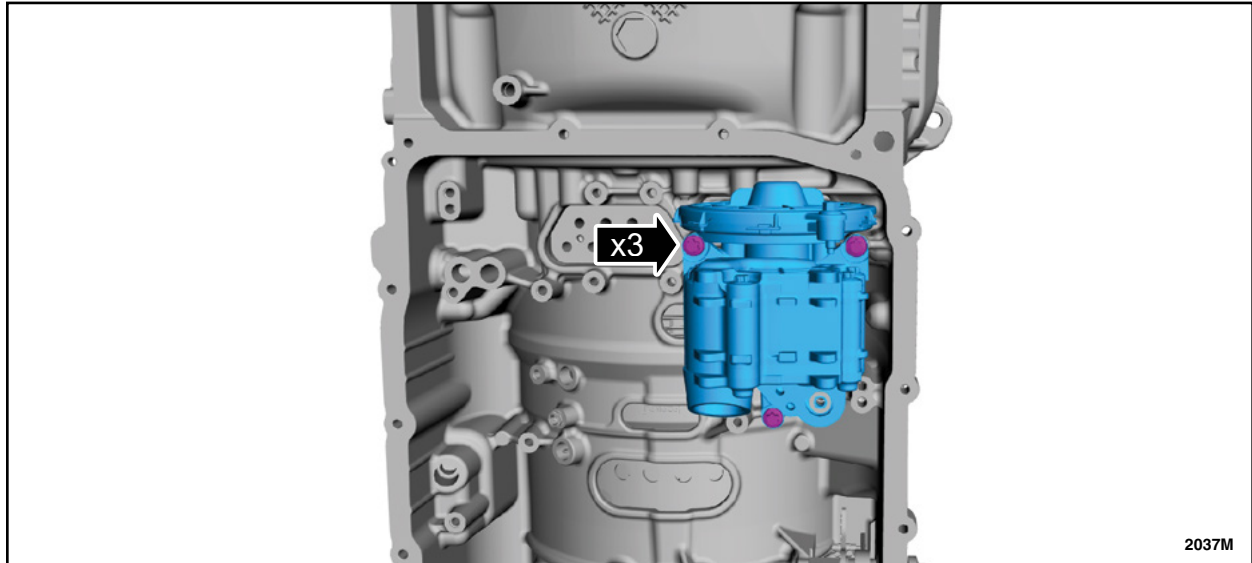
**FIGURE 5**

8. Remove the bolts and the transmission fluid pump. See Figure 5.

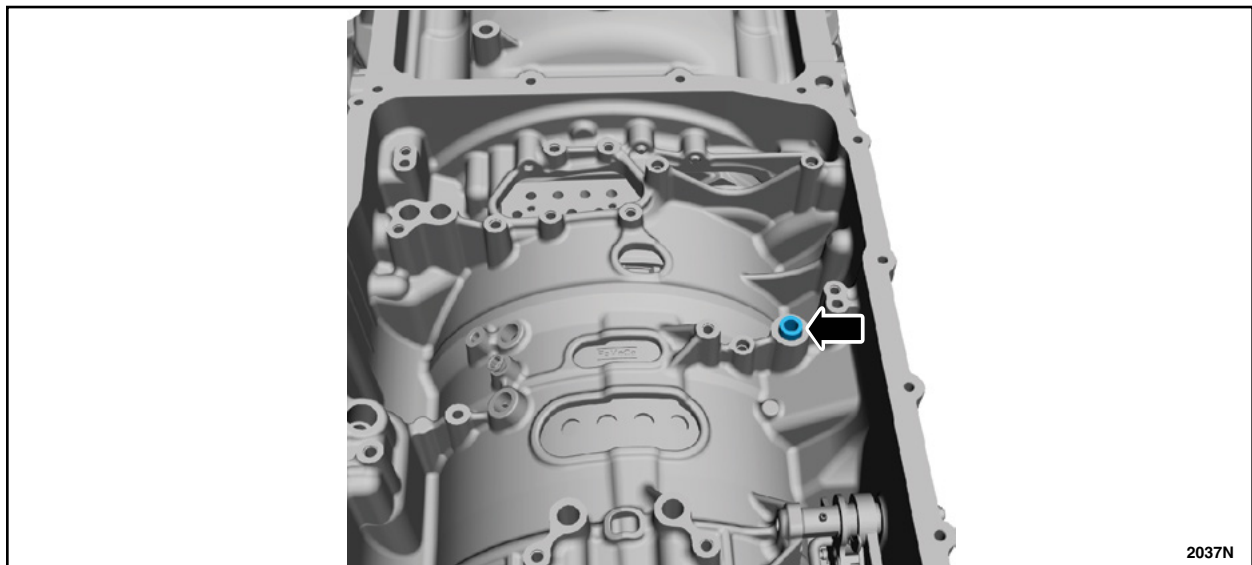
**FIGURE 6**

9. Remove the transmission fluid pump seal. See Figure 6.

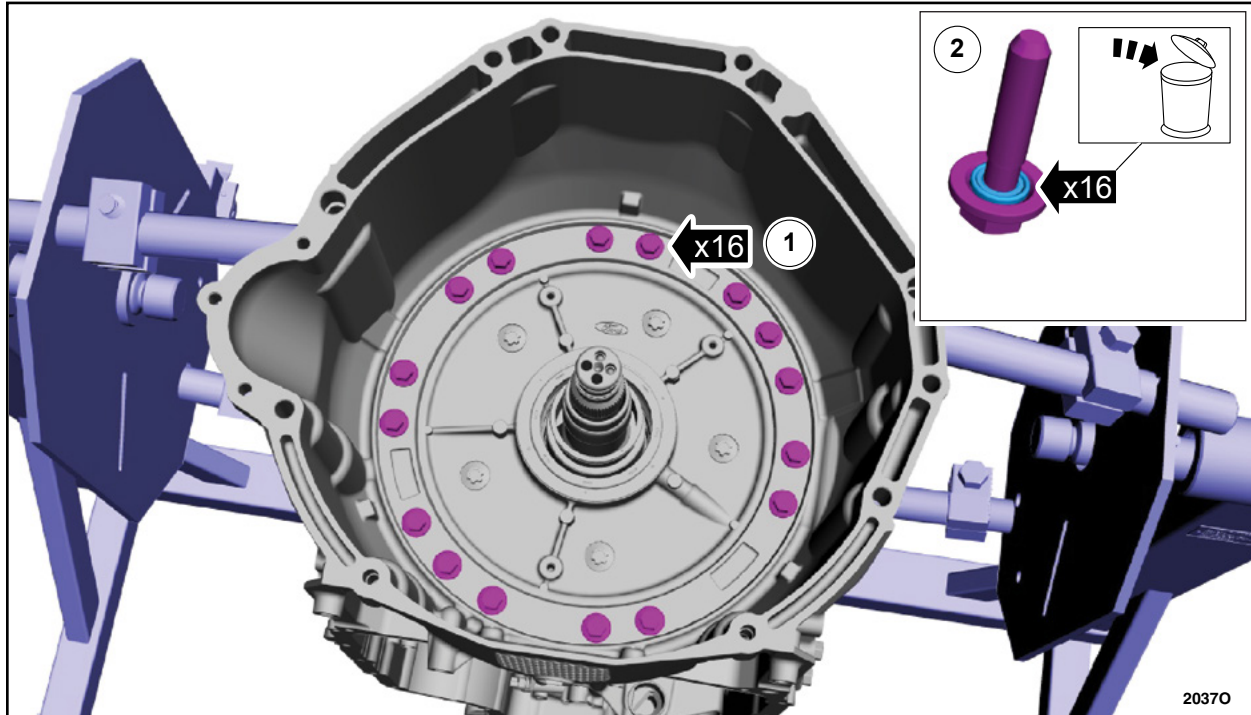
FIGURE 7

10. Remove the front support assembly bolts. See Figure 7.

- Discard the front support assembly bolt washers.

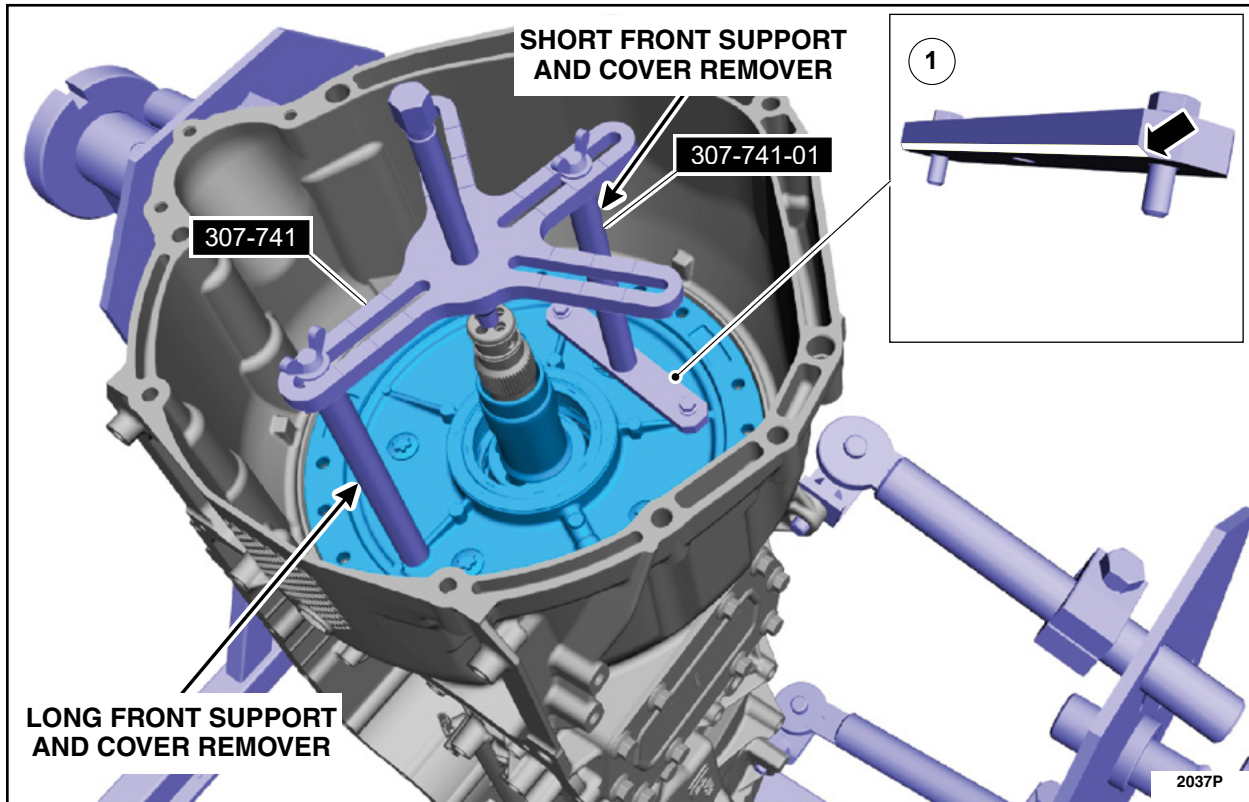
FIGURE 8

11. Using special tool 307-741 and 307-741-01, separate the front support assembly from the transmission case and remove the final support assembly. Remove special tools 307-741 and 307-741-01. See Figure 8.

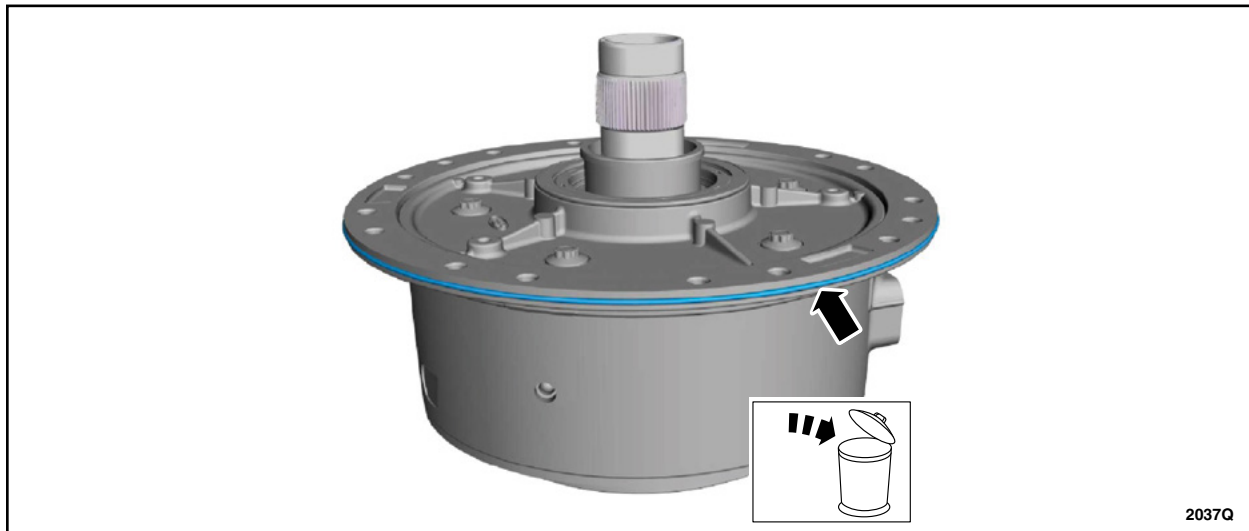
FIGURE 9

12. Remove and discard the front support-to-case seal. See Figure 9.

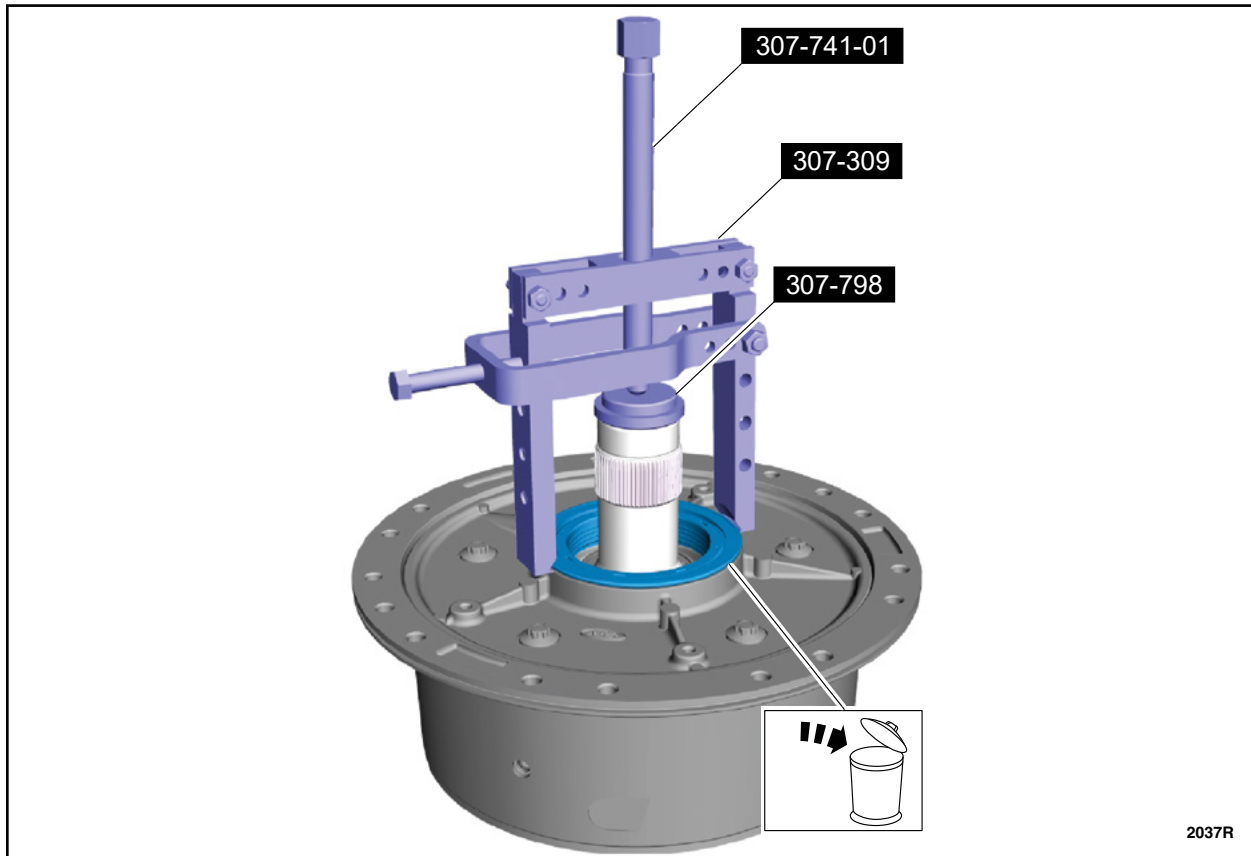
FIGURE 10

13. Using special tools 307-309, 307-741-01 and 307-798, remove and discard the converter hub seal.  
See Figure 10.

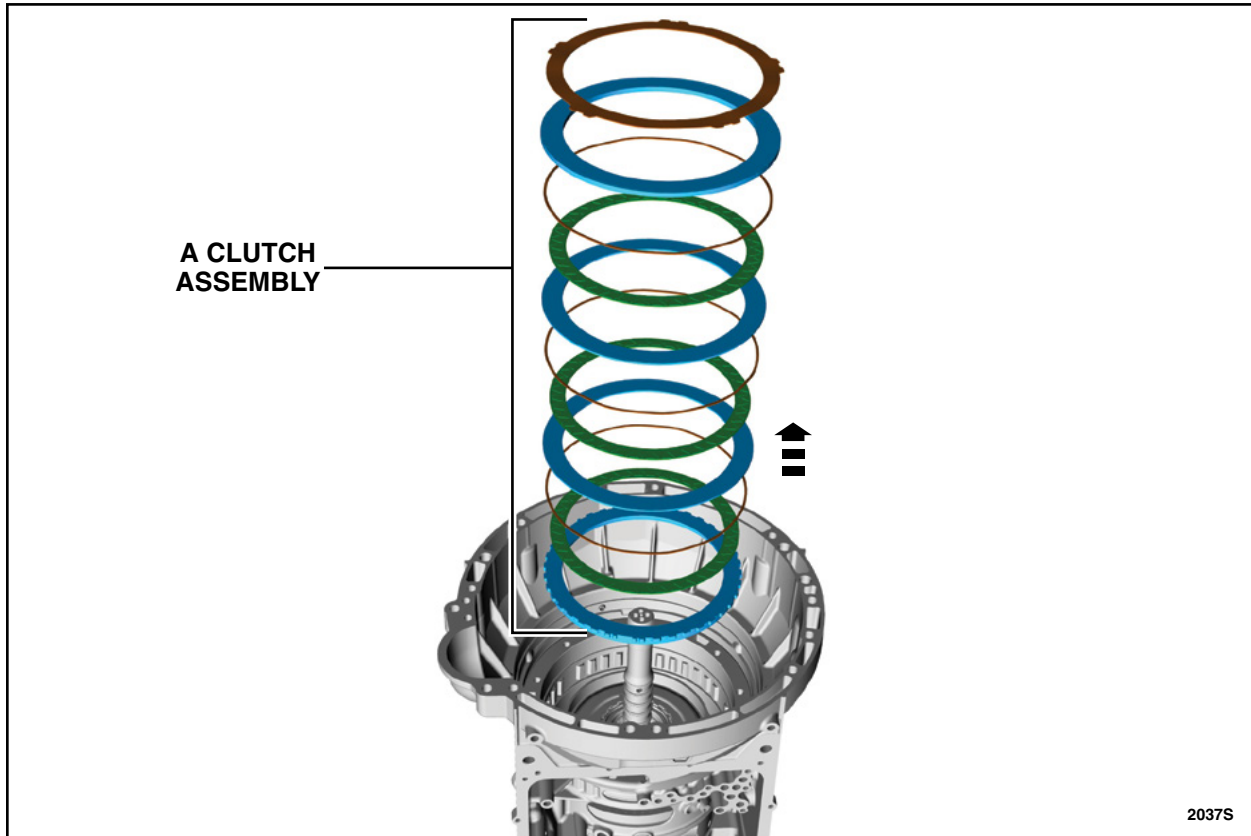
FIGURE 11

14. Using a magnet, remove the A clutch assembly. See Figure 11.

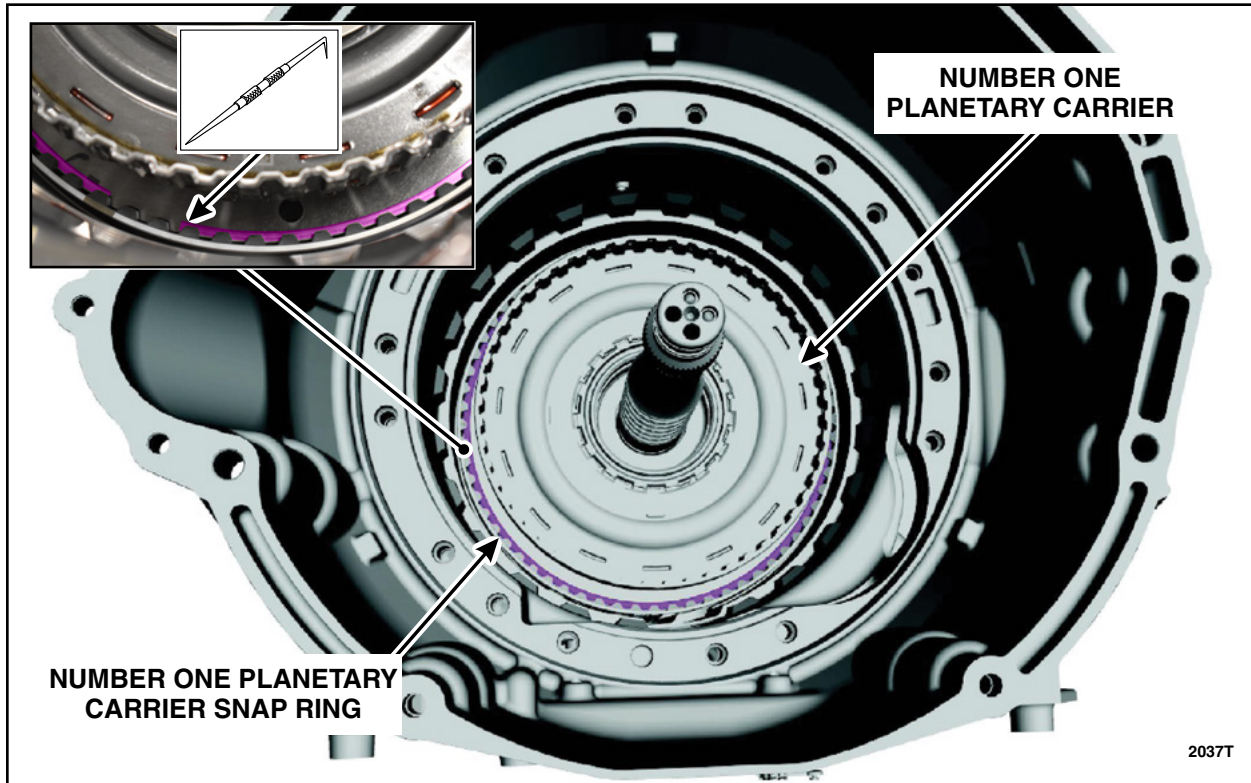
FIGURE 12

15. Using a pick, remove the number one planetary carrier snap ring. See Figure 12.

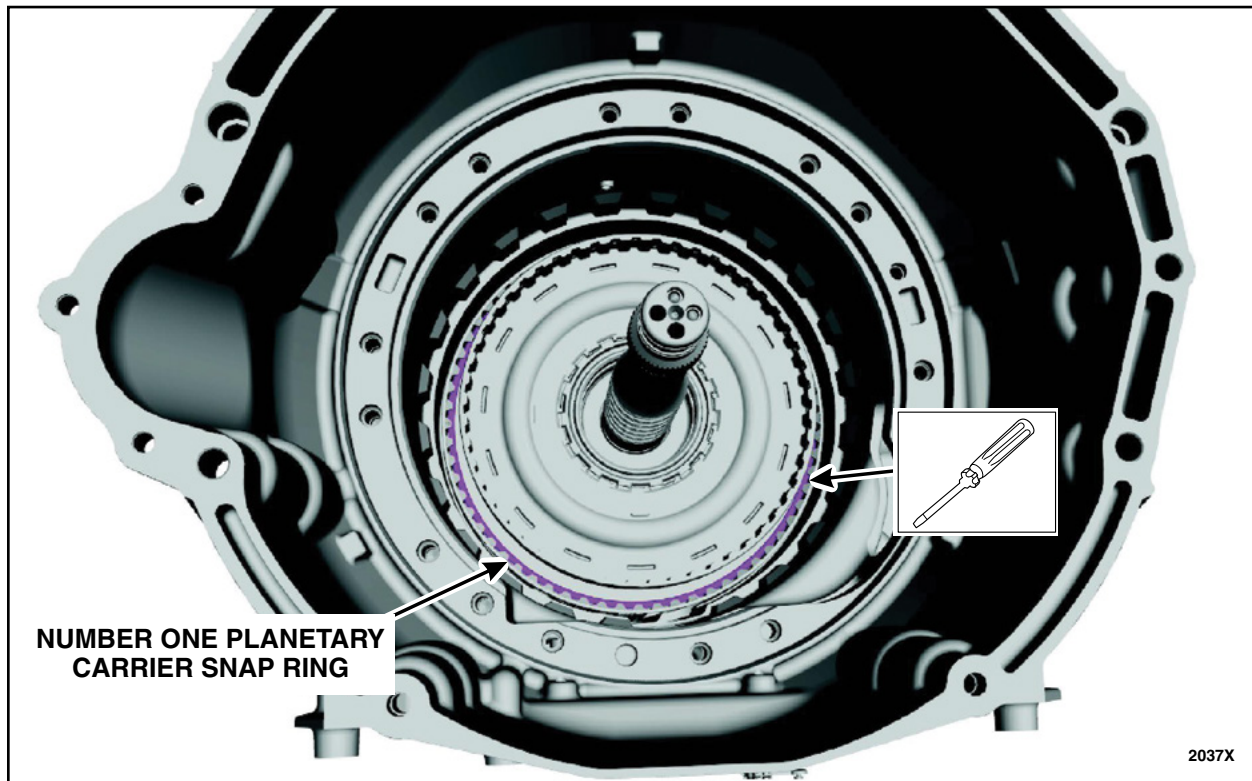
FIGURE 15

18. Using a long flat head screwdriver, install the number one planetary carrier snap ring. Be sure that the snap ring is fully seated. See Figure 15.

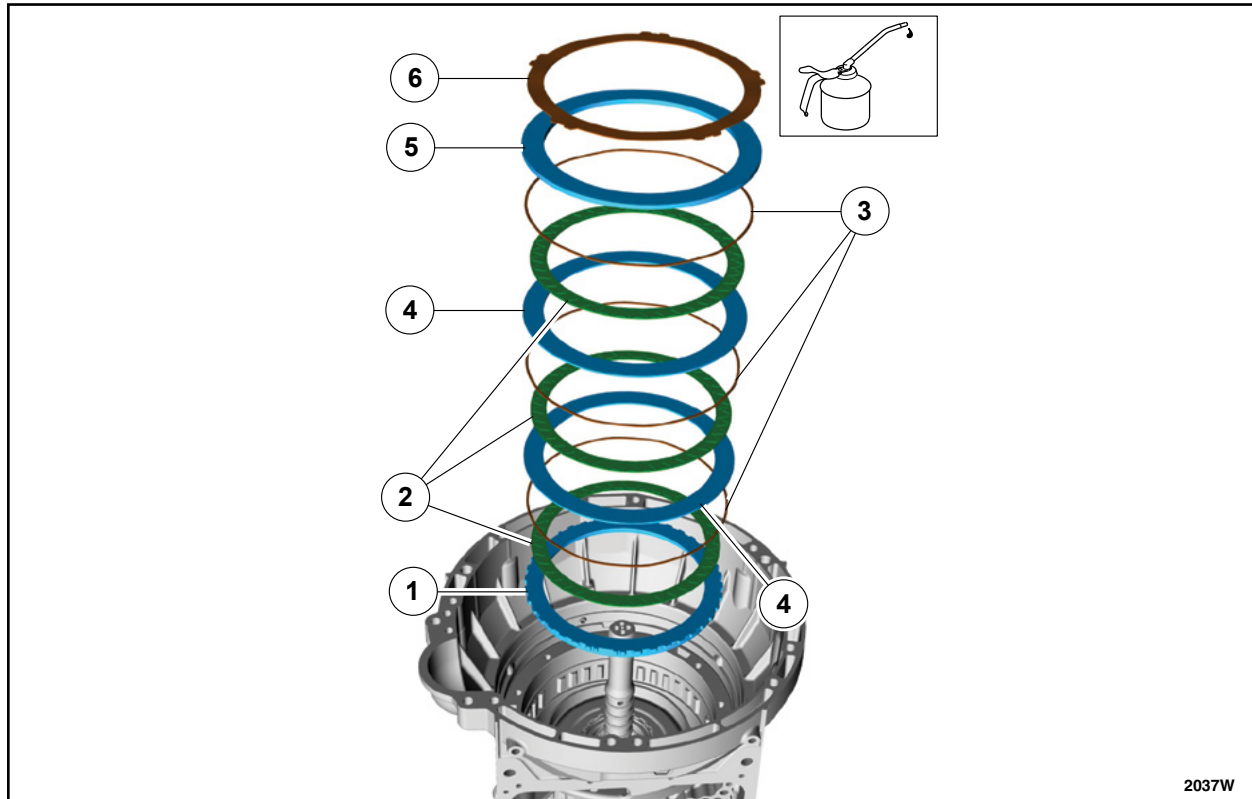
FIGURE 16

19. Soak the A clutch plates in clean transmission fluid and then install the A clutch assembly.  
See Figure 16.

1. Pressure Plate.
2. Friction Plates.
3. Separator Springs.
4. Steel Plates.
5. Apply Plate (select fit).
6. Wave Spring.

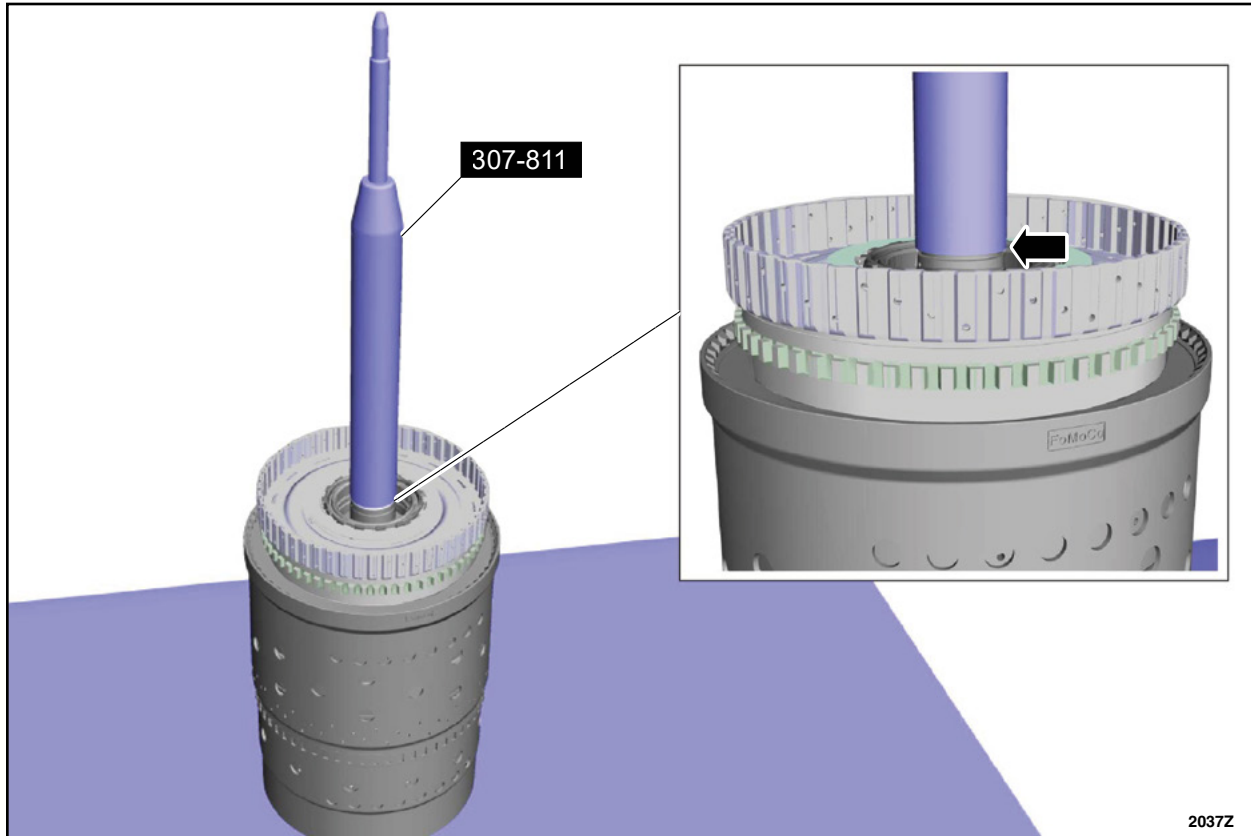
**FIGURE 18**

21. Install special tool 307-811 and adjust it to align the bottom edge of the tool with the top end of the groove of the Teflon® seal being replaced. See Figure 18.

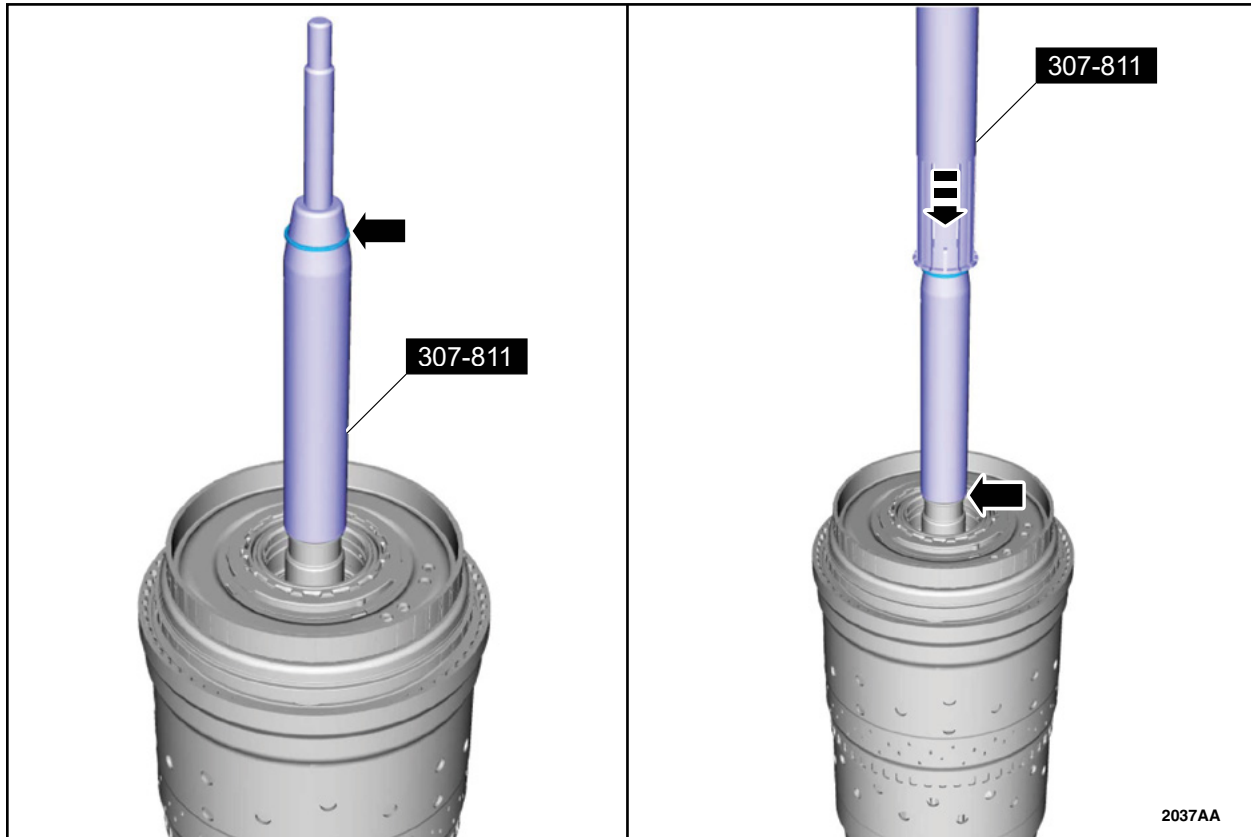
FIGURE 19

22. Install a new Teflon® seal on special tool 307-811. Using the top half of special tool 307-811, slide the Teflon® seal into the groove. Remove special tool 307-811 and repeat the steps for the other damaged front support assembly seal. See Figure 19.

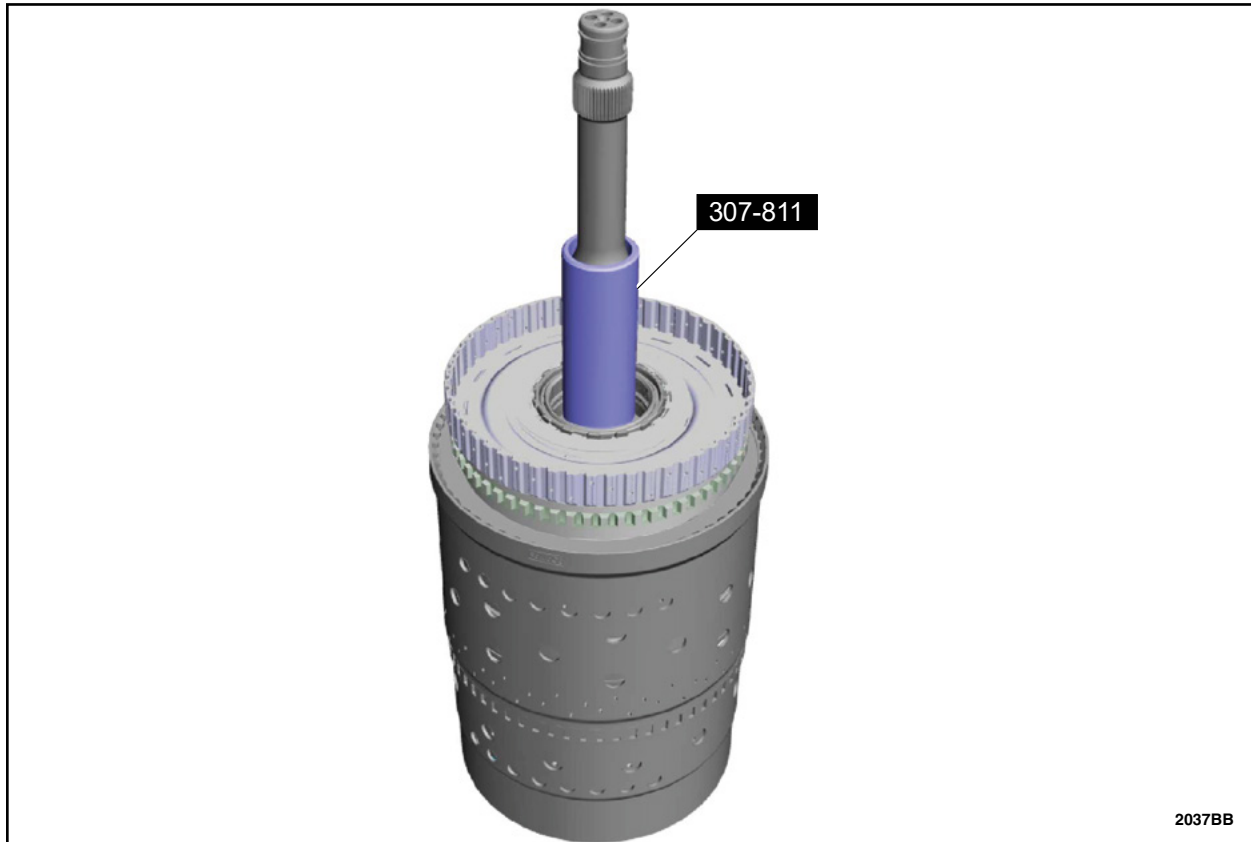
**FIGURE 20**

23. Install special tool 307-811 to size the 7 Teflon® seals to the input shaft. See Figure 20.

- Allow the special tool to stay on the input shaft until final assembly.

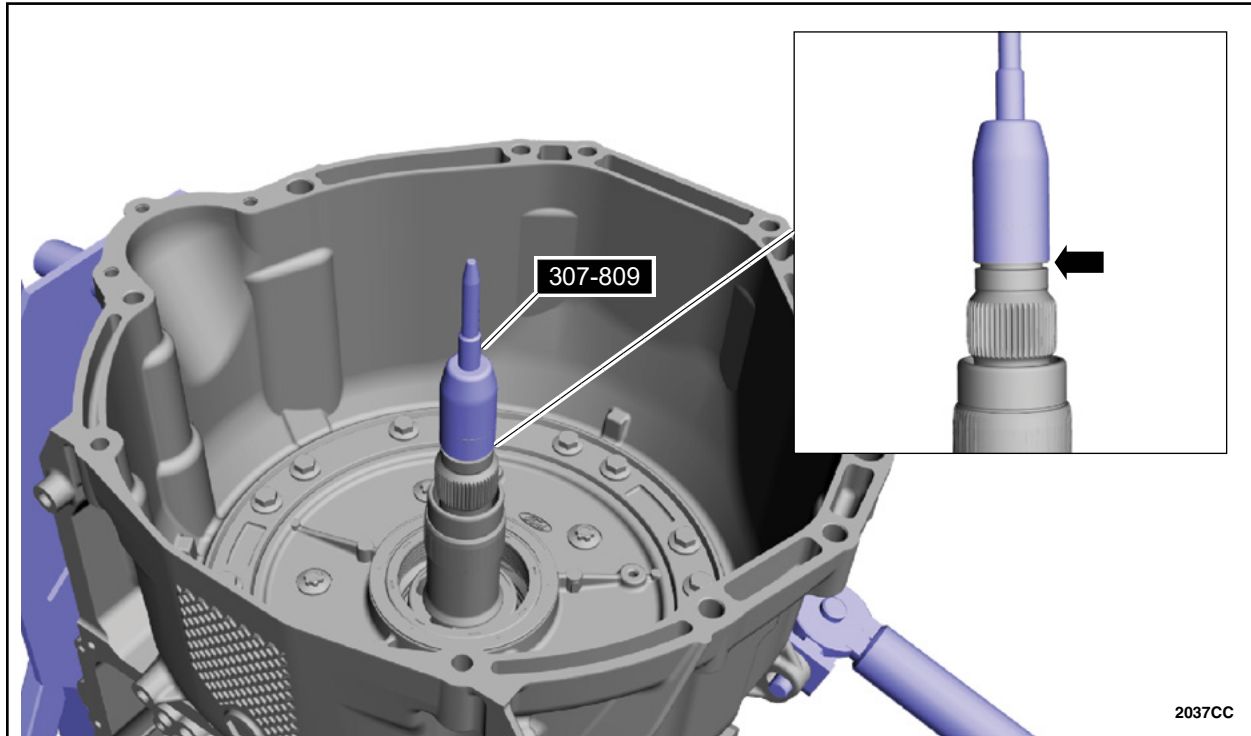
**FIGURE 21**

24. Install special tool 307-809 and adjust it to align the bottom edge of the tool with the top end of the groove of the Teflon® seal being replaced. See Figure 21.

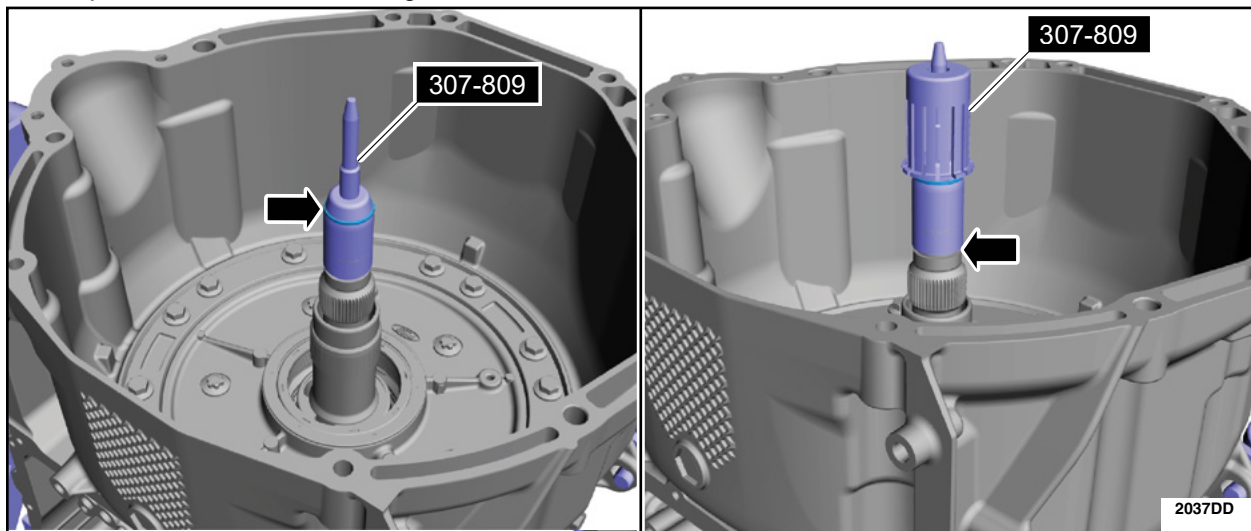
**FIGURE 22**

25. Install a new Teflon® seal on special tool 307-809. Using the top half of the special tool, slide the Teflon® seal into the groove. Remove the special tools and repeat the steps for the other damaged torque converter seals. See Figure 22.

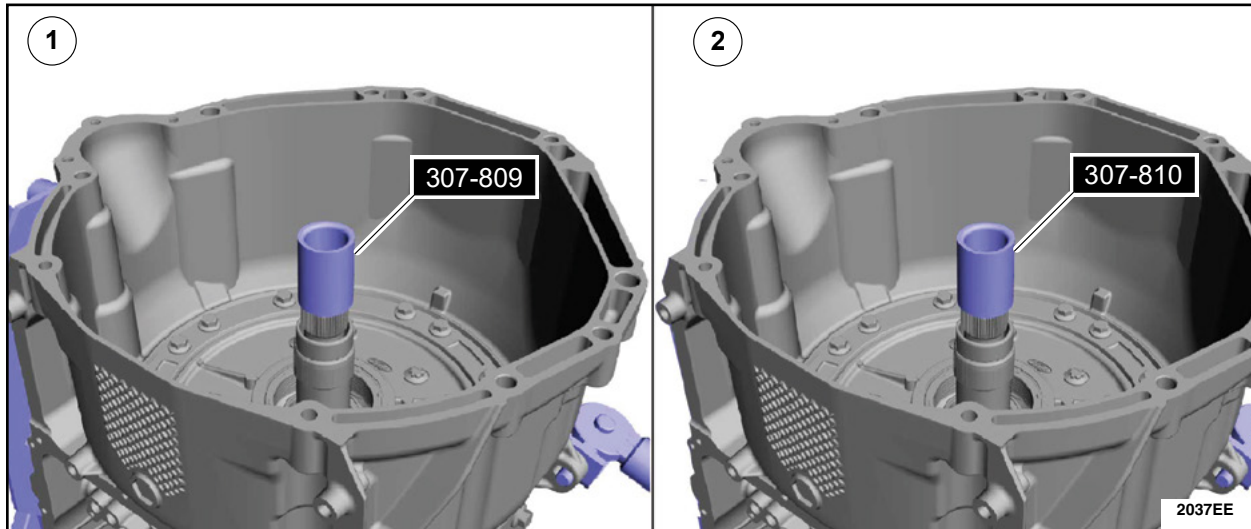
FIGURE 23

26. Using the special tool 307-809 and 307-810, size the input shaft torque converter Teflon® seals with a two step process. See Figure 23.

1. Using special tool 307-809, pre-size the input shaft torque converter Teflon® seals.
2. Using special tool 307-810, final size the input shaft torque converter Teflon® seals.

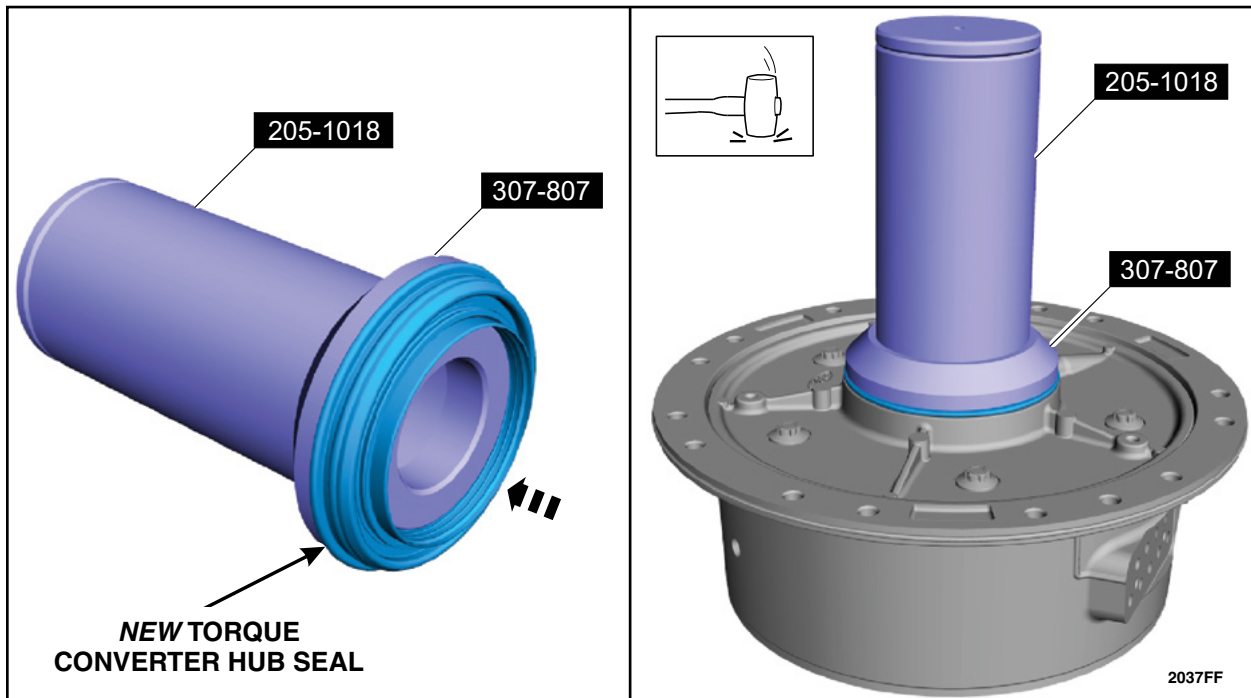
FIGURE 24

27. Install the *new* torque converter hub seal on special tools 205-1018 and 307-807. Using the special tools and a rubber mallet, install the *new* torque converter hub seal. See Figure 24.

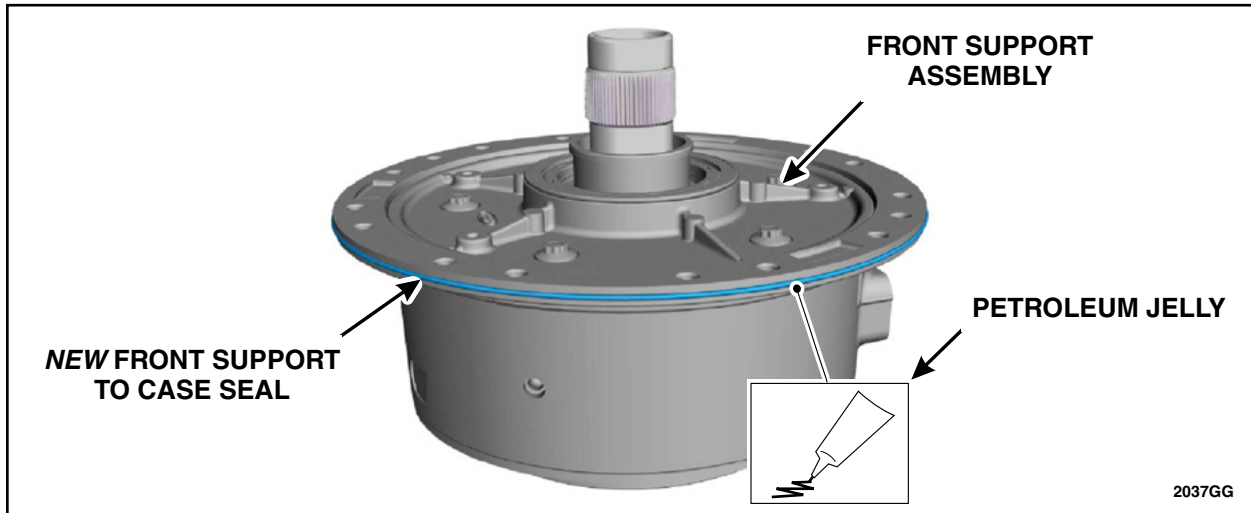
FIGURE 25

28. Install the *new* front support-to-case seal. Lubricate the seal with petroleum jelly. See Figure 25.

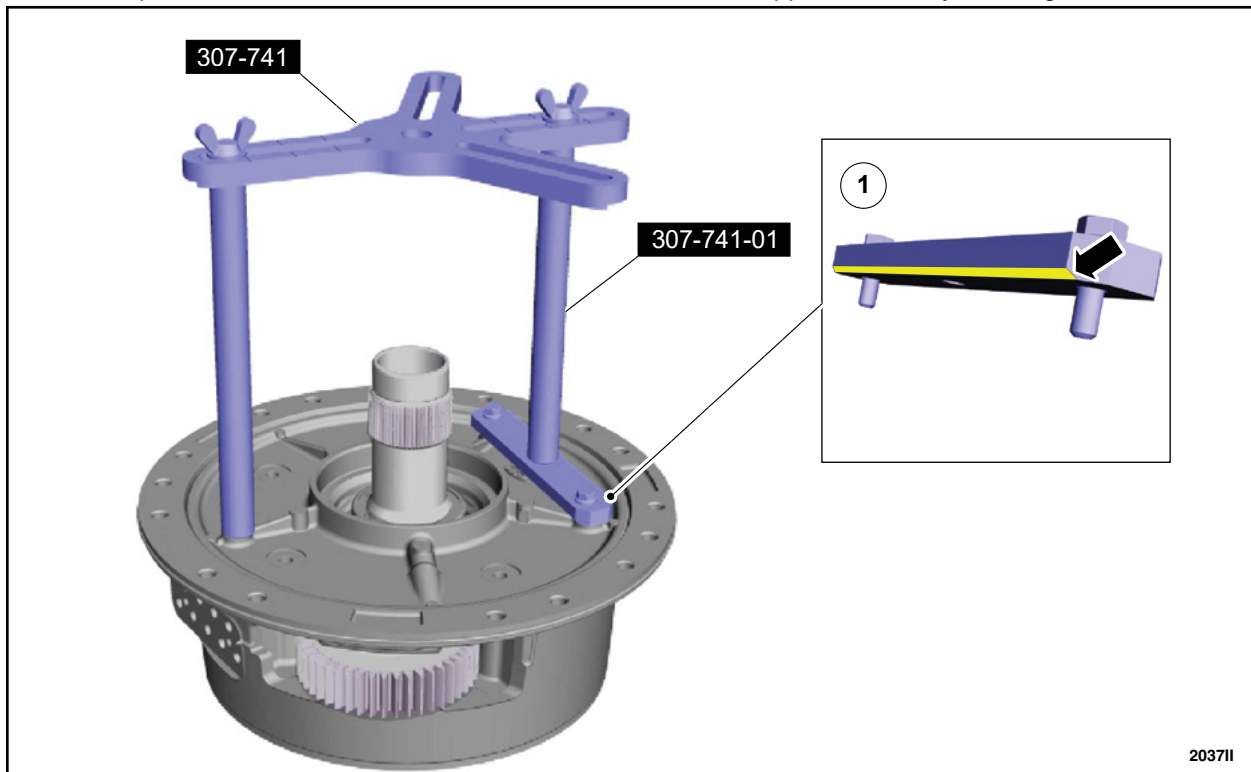
FIGURE 26

29. Install special tools 307-741 and 307-741-01 onto the front support assembly. See Figure 26.

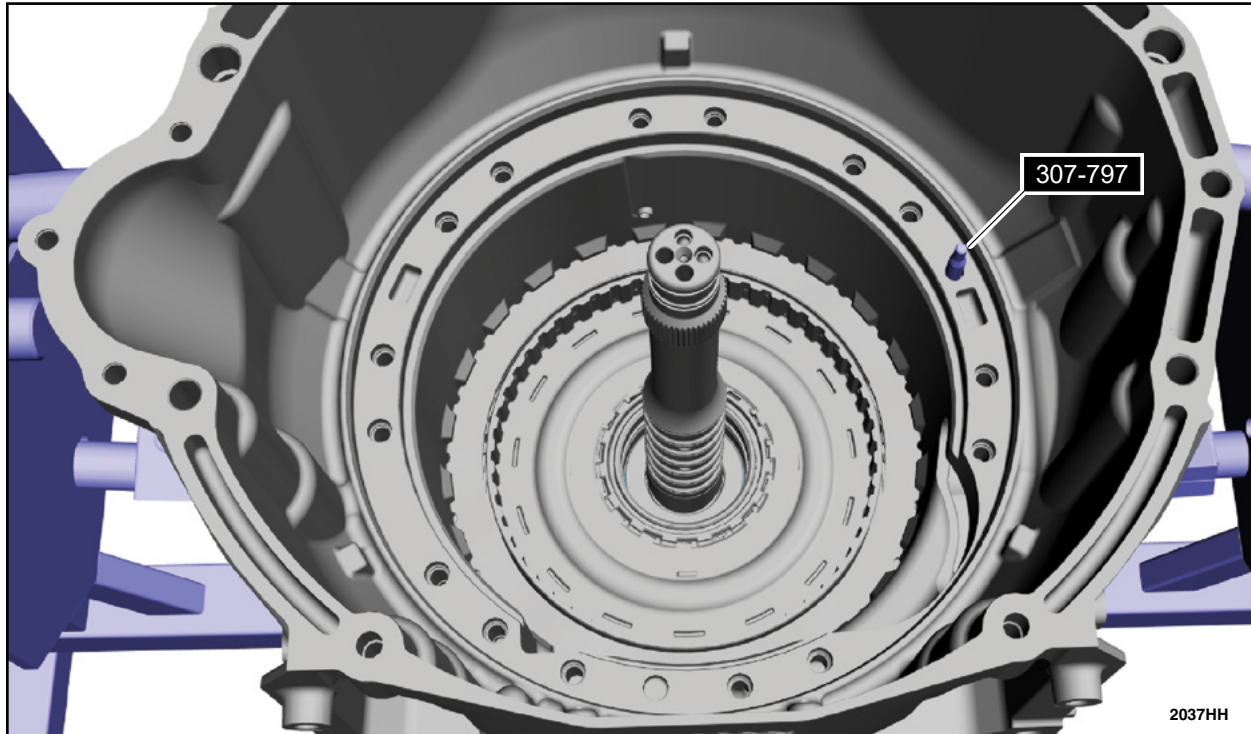
**FIGURE 27**

30. Install special tool 307-797 in the location shown. See Figure 27.

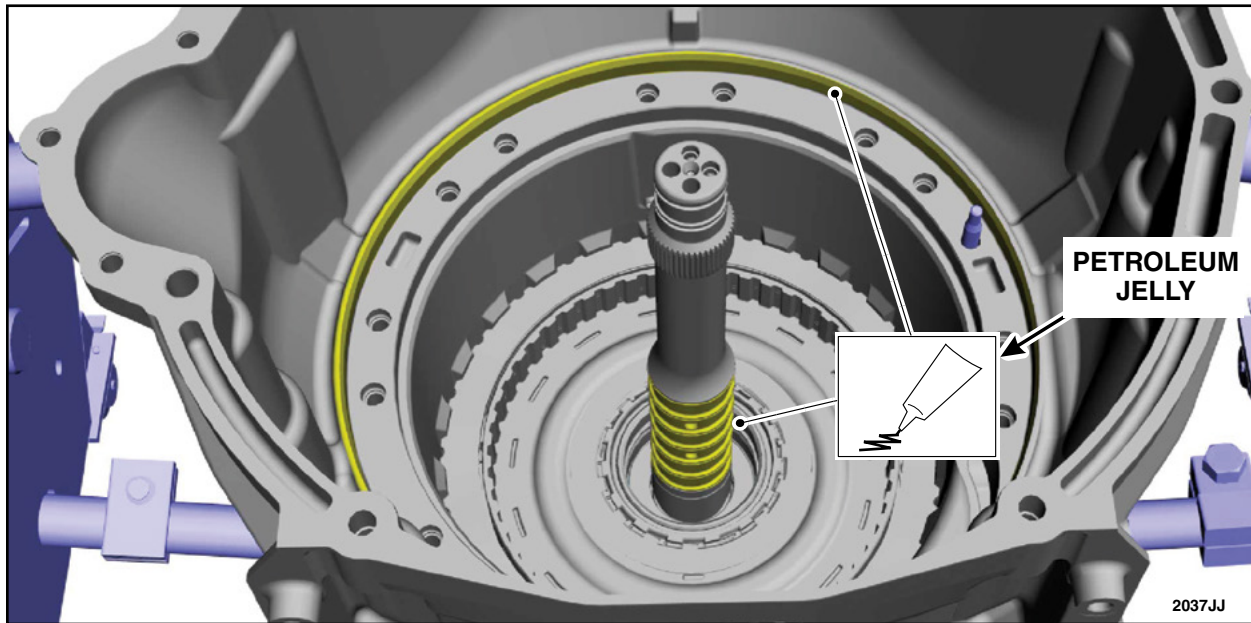
**FIGURE 28**

31. Lubricate the transmission case-to-front support sealing surface, and the Teflon® seals with petroleum jelly. See Figure 28.
