David J. Johnson  
 Director  
 Service Engineering Operations  
 Ford Customer Service Division

**SUBJECT: NEW VEHICLE DEMONSTRATION / DELIVERY HOLD  
 Customer Satisfaction Program 21B03 - Supplement #3**  
 Certain 2020 Model Year Super Duty F250-F600 Vehicles Equipped with a 10R140  
 Transmission - Number One Planetary and Ring Gear Assembly

## CERTAIN 2020 MODEL YEAR SUPER DUTY F250-F600 VEHICLES EQUIPPED WITH A 10R140 TRANSMISSION — NUMBER ONE PLANETARY AND RING GEAR ASSEMBLY

### **NEW!** SERVICE PROCEDURE

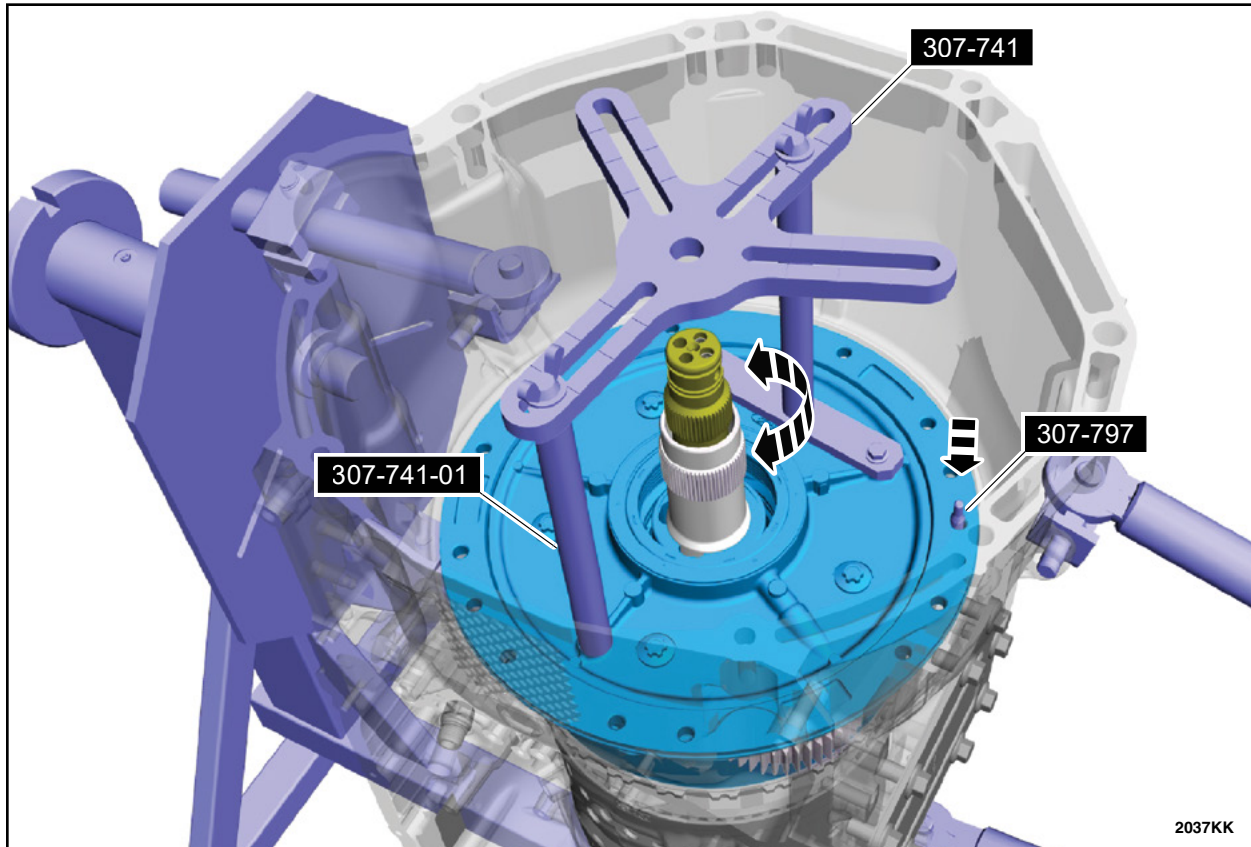
FIGURE 29

32. Using the special tools 307-741 and 307-741-01, install the front support into the transmission case. Rotate the input shaft while aligning the front support to the special tool guide pin 307-797. See Figure 29.

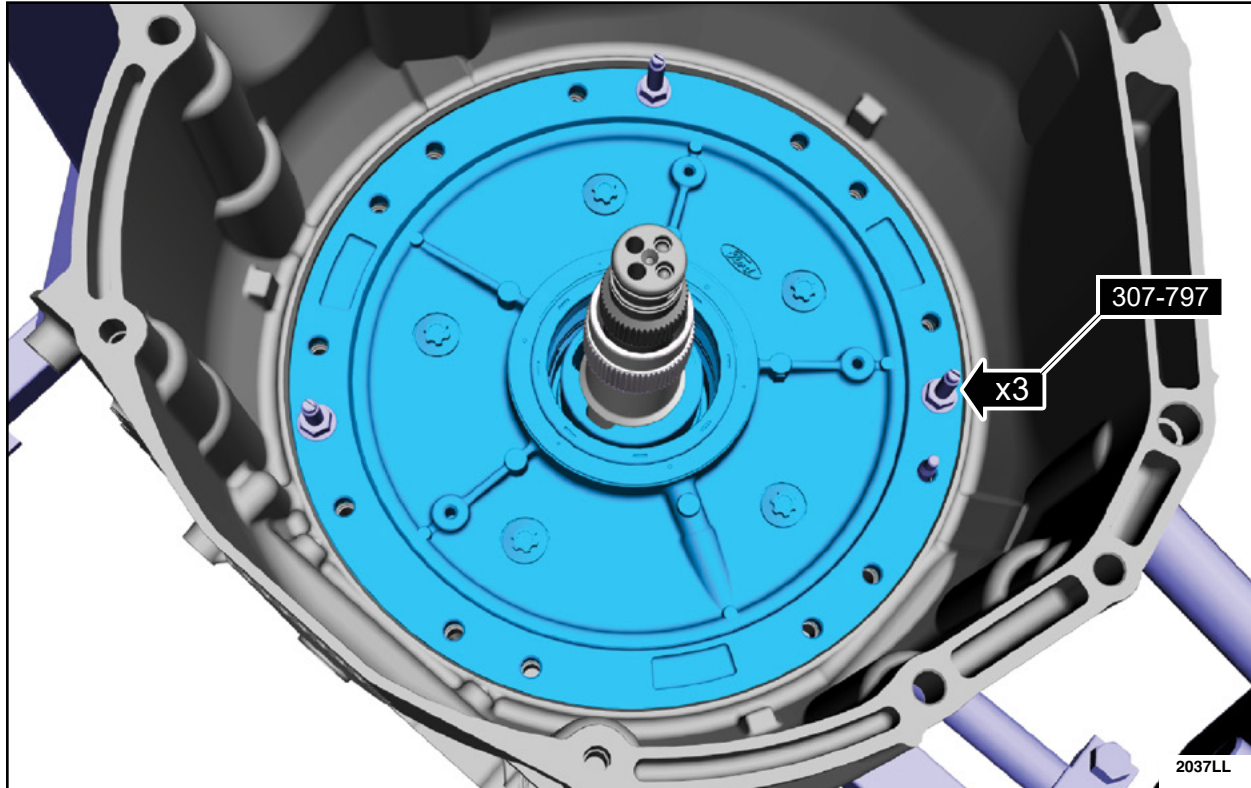
FIGURE 30

33. Install special tool 307-797 studs, washers and nuts in the location shown. See Figure 30.

- Tighten the special tool 307-797 nuts evenly to seat the front support assembly to the transmission case.

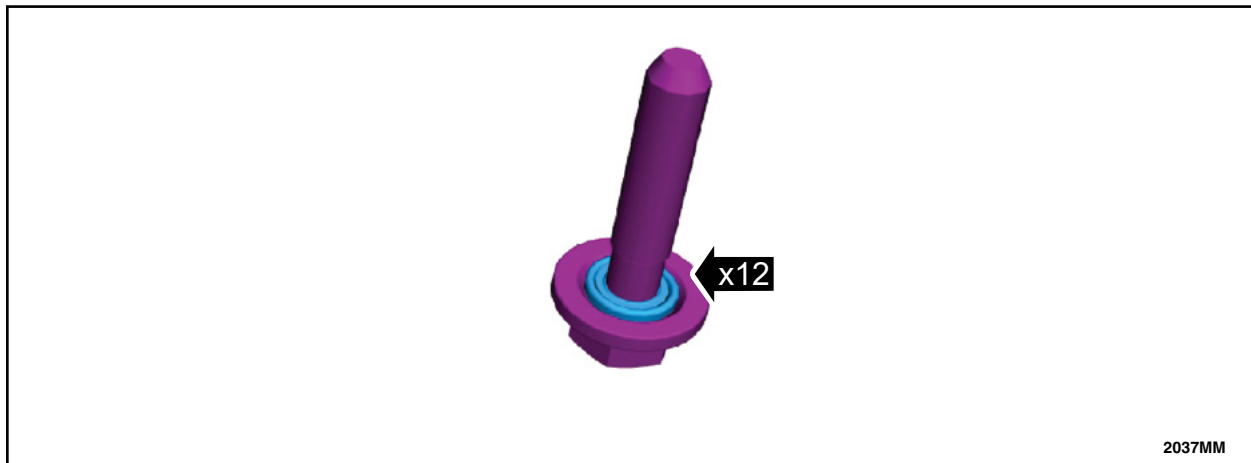
FIGURE 31

34. Install the new front support assembly bolt washers. See Figure 31.

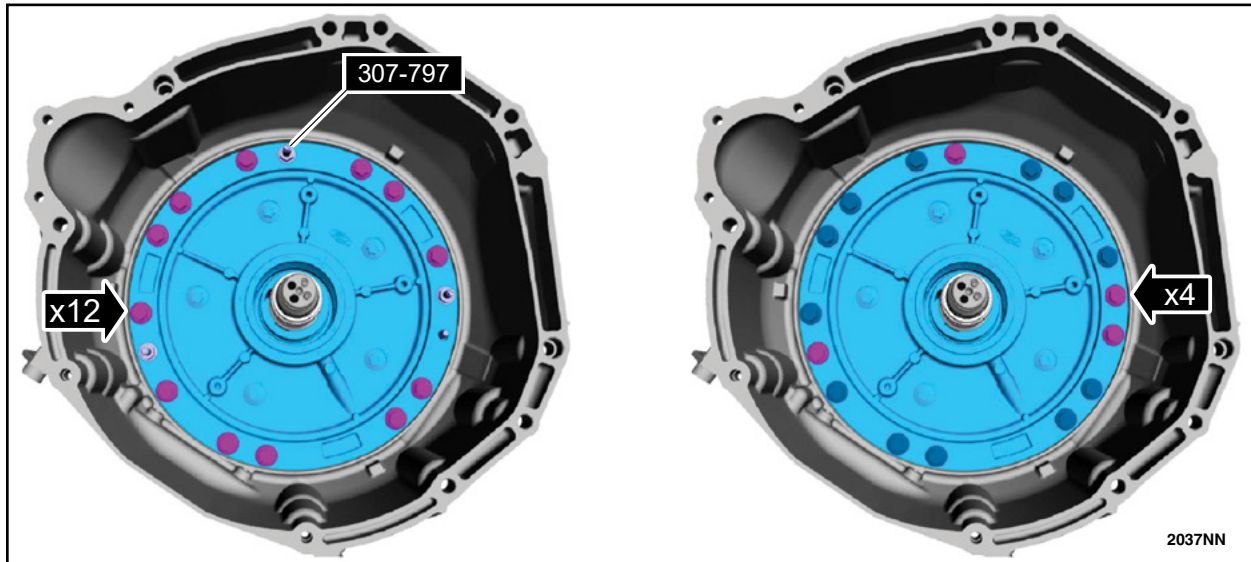
FIGURE 32

35. With the special tools 307-797 installed, hand tighten the front support bolts in a crisscross pattern.

- Remove the special tools 307-797 and install the front support bolts hand tight. See Figure 32.

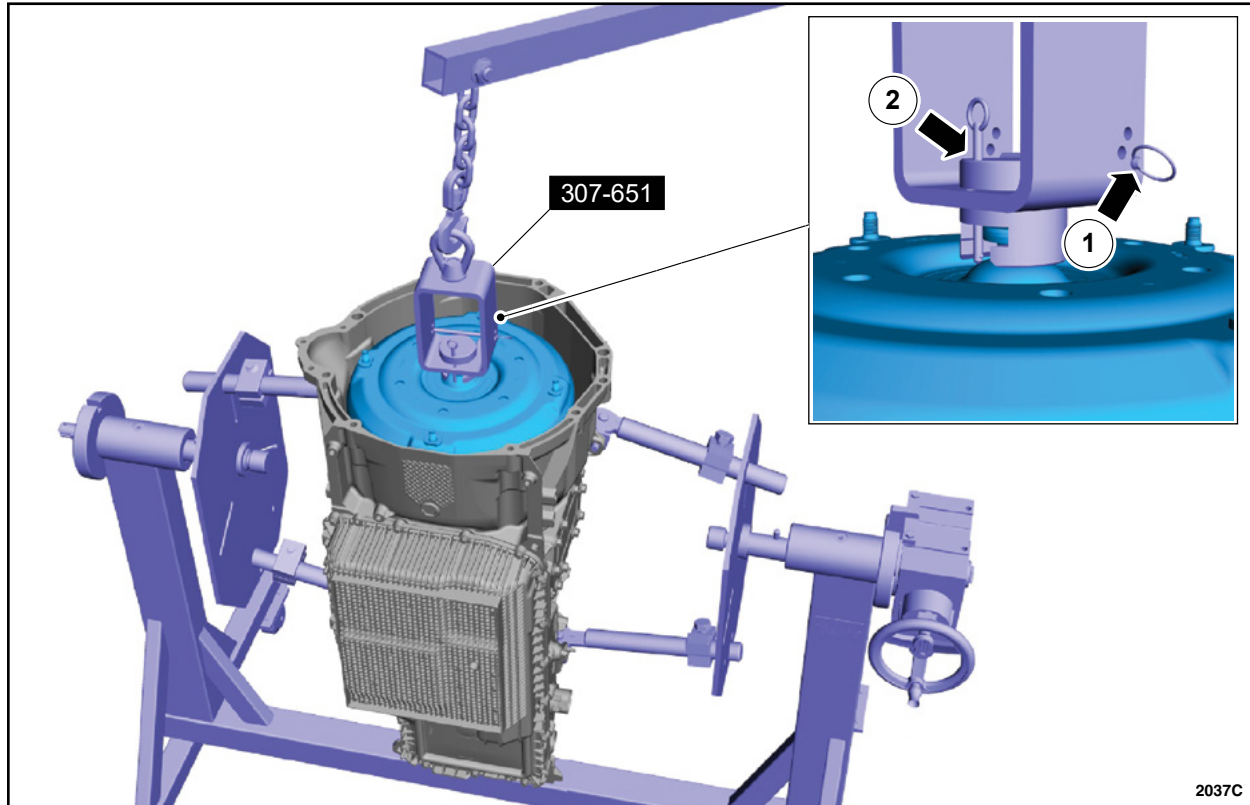
FIGURE 34

37. Using special tool 307-651 and a floor crane, install the torque converter. See Figure 34.

1. Horizontal pin is in the bottom hole.
2. Vertical pin prevents part movement.

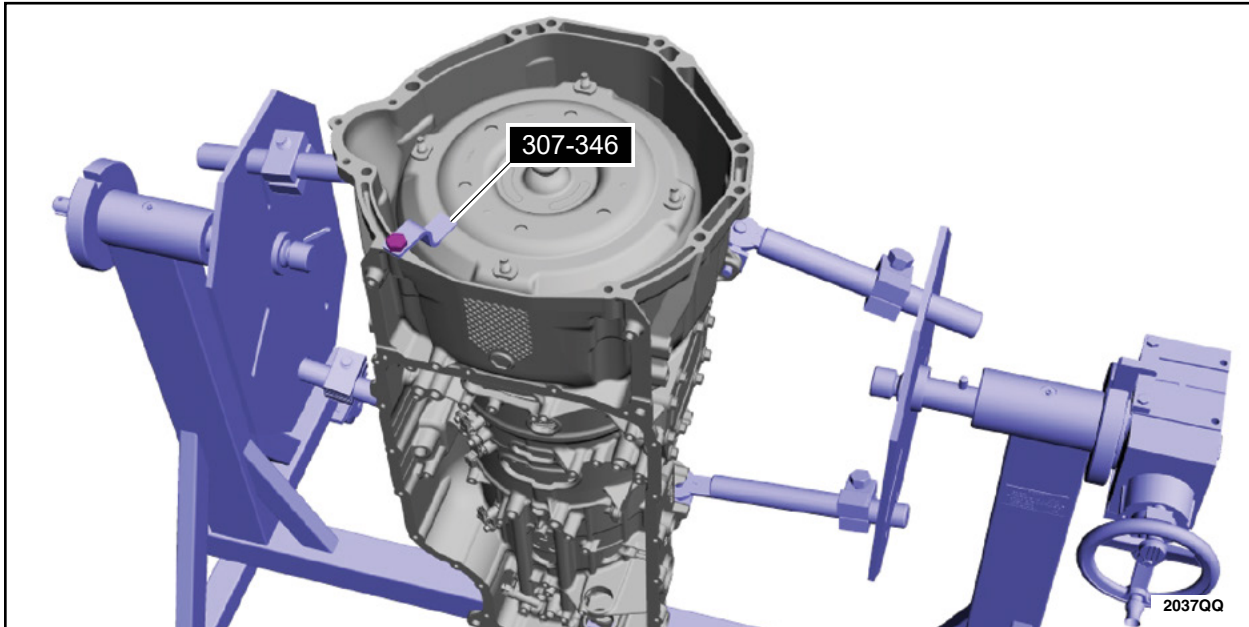
**FIGURE 35**

38. Install special tool 307-346 to hold the torque converter. See Figure 35.

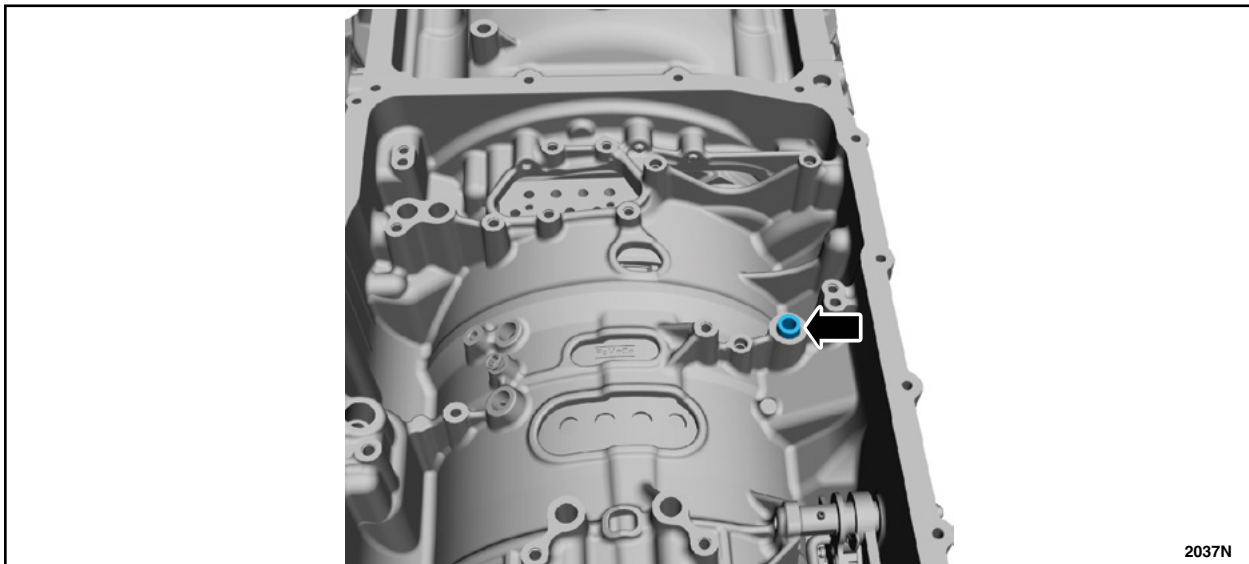
**FIGURE 36**

39. Install the transmission fluid pump seal. See Figure 36.

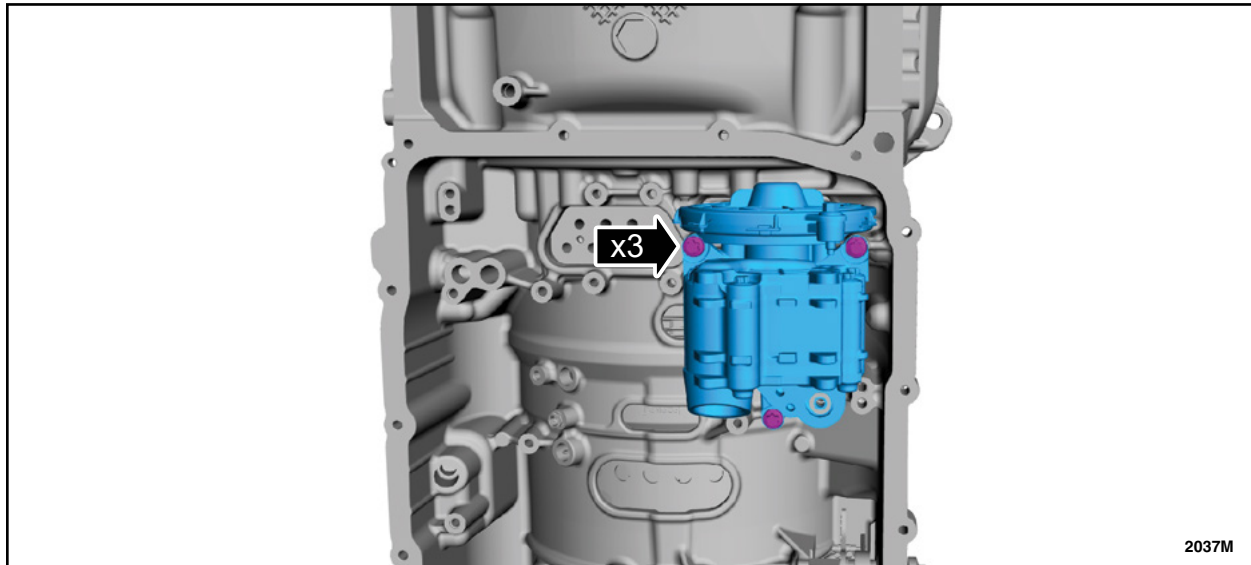
**FIGURE 37**

40. Install the transmission fluid pump and the bolts. See Figure 37.

- Torque: 97 lb.in (11 Nm).
