June 17, 2021

**SUBJECT: NEW VEHICLE DEMONSTRATION / DELIVERY HOLD  
 Customer Satisfaction Program 21B03 - *Supplement #4***  
 Certain 2020 Model Year Super Duty F250-F600 Vehicles Equipped with a 10R140  
 Transmission - Number One Planetary and Ring Gear Assembly

**NEW VEHICLE DEMONSTRATION / DELIVERY HOLD  
Customer Satisfaction Program 21B03 - *Supplement #4***

Certain 2020 Model Year Super Duty F250-F600 Vehicles Equipped with a 10R140 Transmission  
Number One Planetary and Ring Gear Assembly

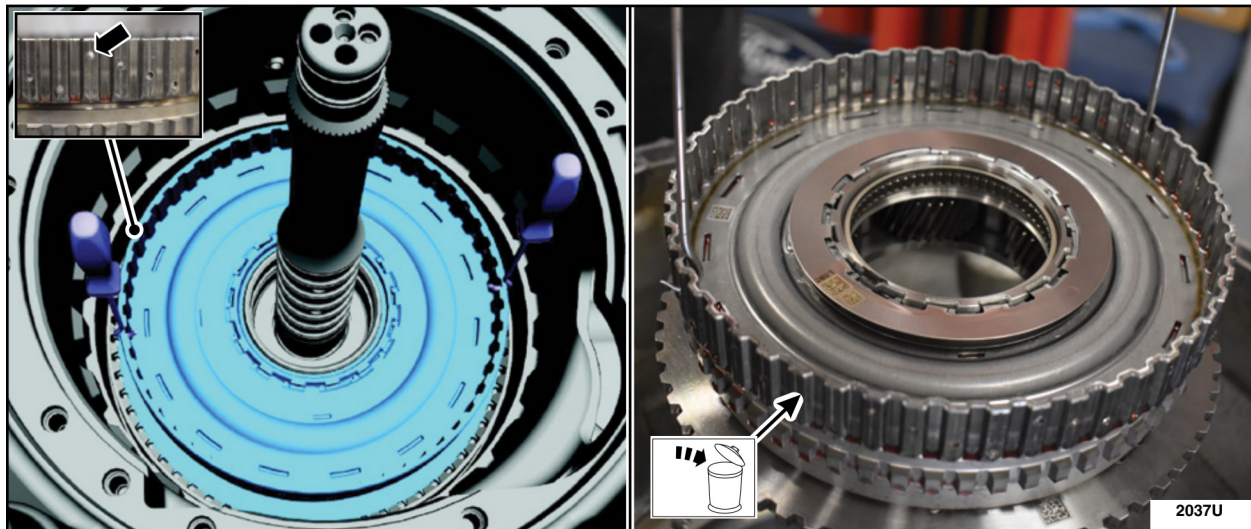
FIGURE 13

**Why are you receiving this notice?** On your vehicle, a bearing within the transmission could wear prematurely, resulting in rough shifts.

16. Using two pick hooks inserted into holes on the outside gear, remove and discard the number one planetary carrier. See Figure 13.
