SERVICE PROGRAM BULLETIN

APPLICABILITY:	2015-2016MY Legacy 2.5L	NUMBER:	WUJ-95R
	2015-2016MY Outback 2.5L	DATE:	02/11/20
SUBJECT:	Exhaust Pipe Front (EPF) Bellows Cracking	REVISED:	07/30/21

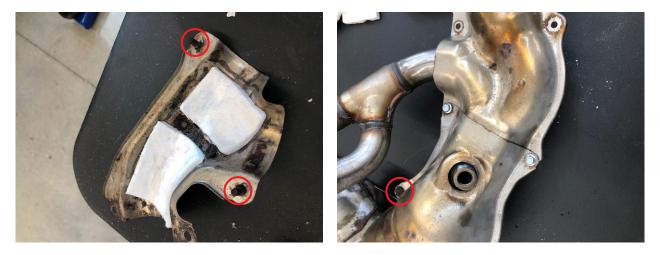
- ✓ ALWAYS wear eye protection!
- ✓ The EPF heat shields are stamped stainless steel and have MANY sharp edges. Always use CAU-TION to avoid nicks, cuts and scrapes.
 - When disassembling the heat shields from the original EPF, pay close attention to the two shields with retaining studs made onto them instead of nuts / bolt fasteners. TAKE YOUR TIME with these to avoid having to replace the shield(s) due to a broken stud. Use a wire brush to clean the stud threads along with a touch of lubricant before reassembly is recommended.
