## SERVICE PROGRAM BULLETIN

**APPLICABILITY:** 2022MY Outback Wilderness

**NUMBER:** WRJ-21R

**SUBJECT:** Left Front B-Pillar / Inspection for Splitting Condition

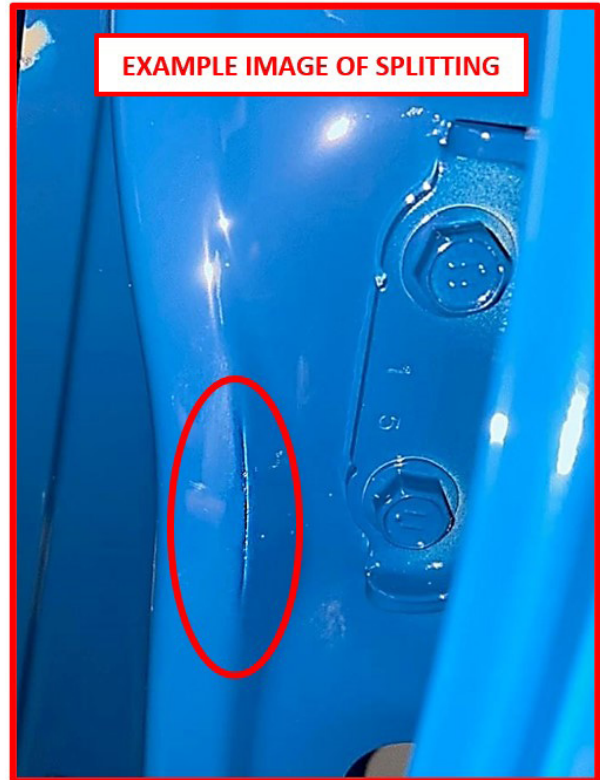
**CRITICAL:** Paint pattern inconsistencies such as surface variations and/or blemishing are considered to be acceptable within this area. The splitting condition can ONLY be confirmed when light is found shining through the inspection area.

- Clear photos of the split condition showing the inspection light emitting through the B-pillar
- The current vehicle mileage
- Clear photo of the B-pillar VIN label
- Body Repair Facility Estimate for the splitting condition repair outlining a planned welding repair of the condition with the related paint procedure information.

Once the QMR is complete, contact Techline to report the inspection results and receive further direction.
