SERVICE PROGRAM BULLETIN

APPLICABILITY: 2022 MY WRX

NUMBER: WRA-22

SUBJECT: WRX EyeSight® Reprogramming

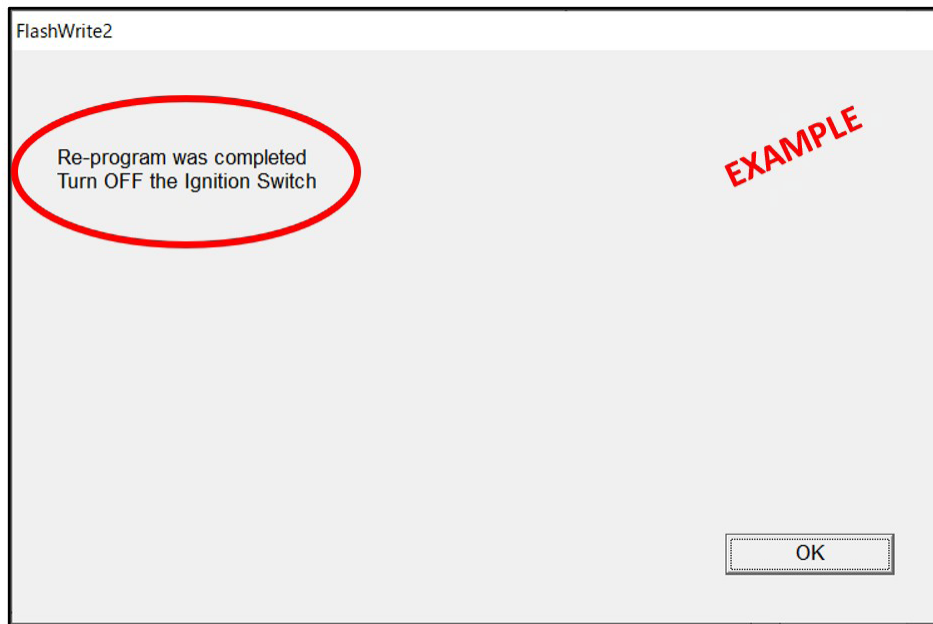
REMINDER: When the reprogramming procedure is completed correctly, Flashwrite will prompt a message displaying “Turn OFF the Ignition Switch.” The gear selector **MUST** be placed in the Park (P) position prior to switching the ignition switch to the “Off” position.

- A. Reprogram the EyeSight® Stereo Camera Assembly following the normal FlashWrite procedure.
