PRODUCT CAMPAIGN BULLETIN

APPLICABILITY: 2019-20MY Ascent
 2020-21MY Legacy 2.4L (turbo models)
 2020-21MY Outback 2.4L (turbo models)

NUMBER: WRK-21/22R
DATE: 07/05/22
REVISED: 09/30/22

SUBJECT: CVT Chain Guide Breakage

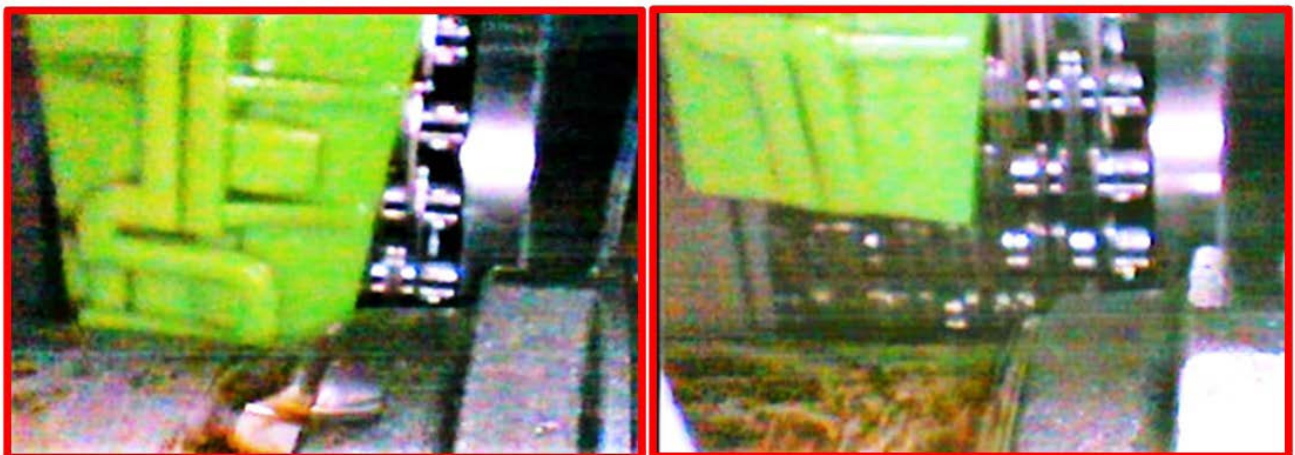
ONLY in a situation when no CVT chain slip is detected with SSM and the chain guide is found to be in the incorrect position during inspection, a clear photo or screenshot of the scope image is required to be stored and noted along with the previously mentioned items 1 through 3.

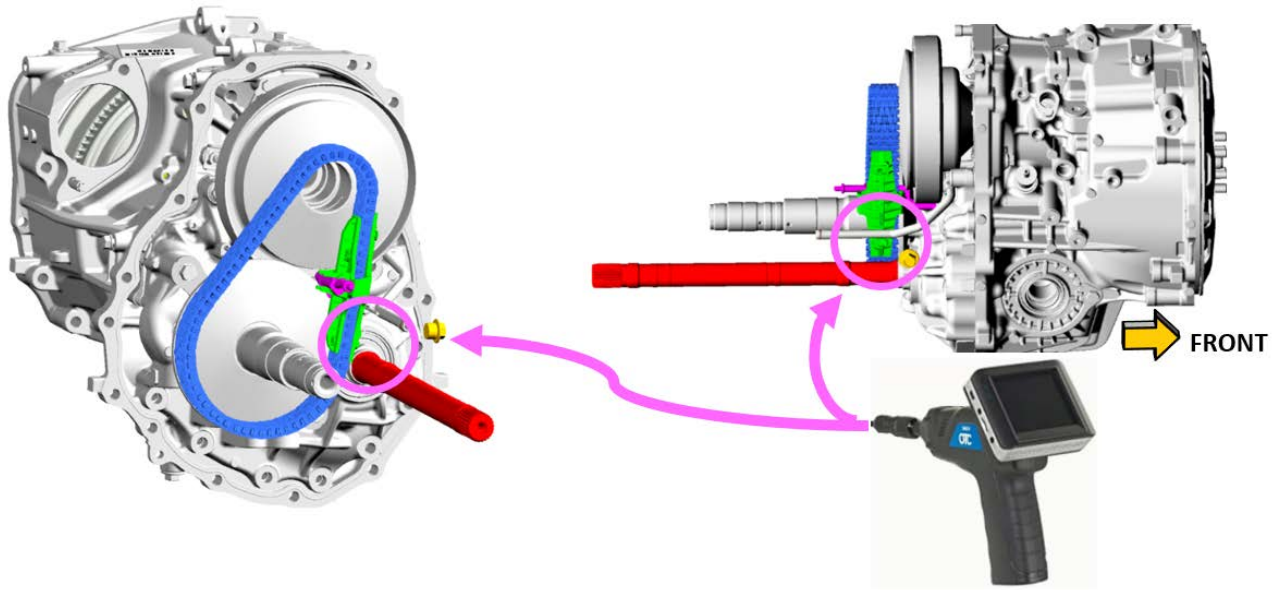
STEP 3E: Inspect the position of the lower end of the chain guide rail and the drive pinion shaft.

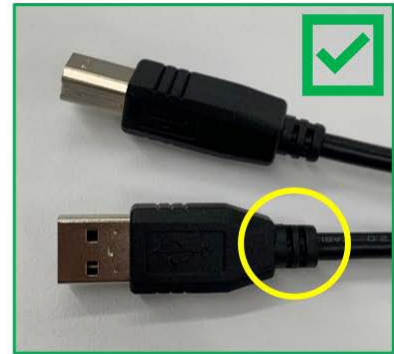
**Exposed Wiring &
Incorrect Cable**

Confirm the PC being use for reprogramming is connected to a known good power source. Turn off any screen saver settings. Make sure the PC is not in power saving mode and is set to the normal power mode. Always inspect the DST-I/DST-010 and PC cables prior to programing. Confirm the cables are CORRECT and there is no exposed wiring, corroded connections, or loose fitment. See the example images below.
