Stacy L. Balzer Operating Director Service Engineering Operations Ford Customer Service Division Ford Motor Company P. O. Box 1904 Dearborn, Michigan 48121

November 22, 2022

SUBJECT: Customer Satisfaction Program 21M05 - Supplement # 3 Certain 2017-2022 Model Year Super Duty Vehicles Equipped with a Power Release Tailgate - Unintended Tailgate Opening

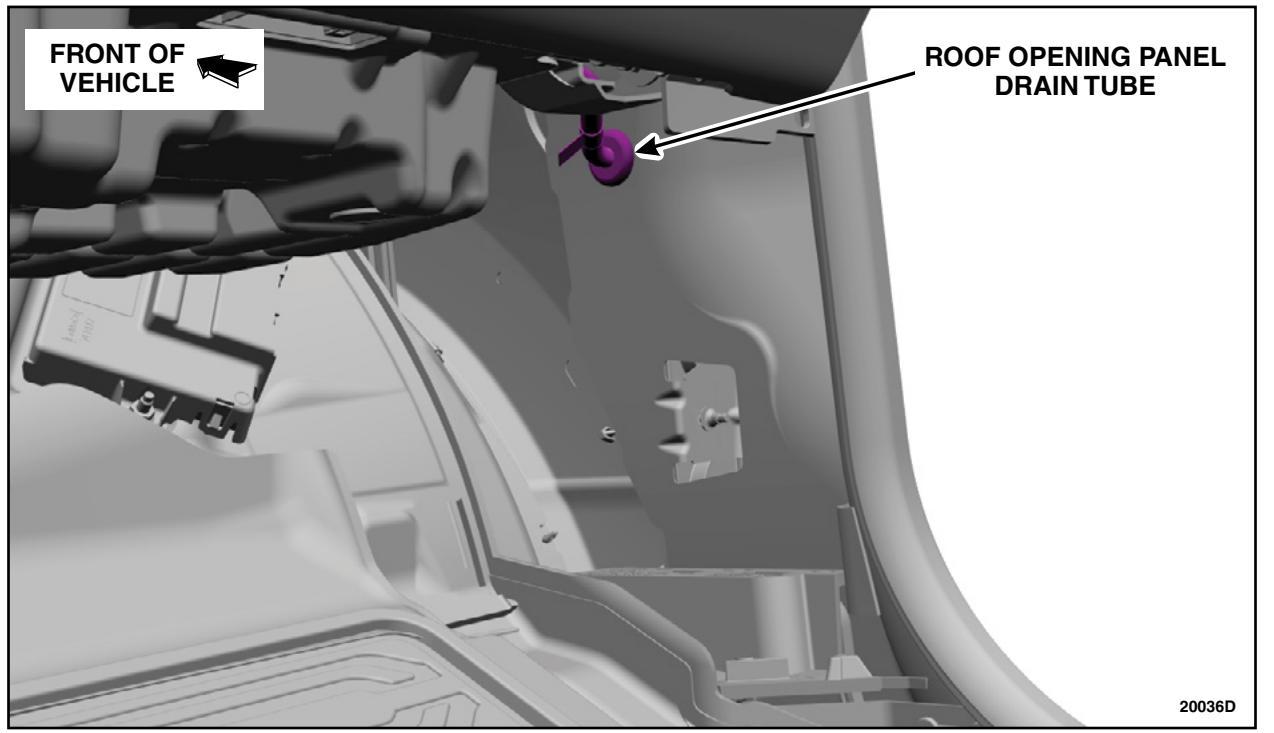
FIGURE 4

9. Locate the roof opening panel drain tube on the Right Hand (RH) side of the vehicle behind the BCM. See Figure 4.

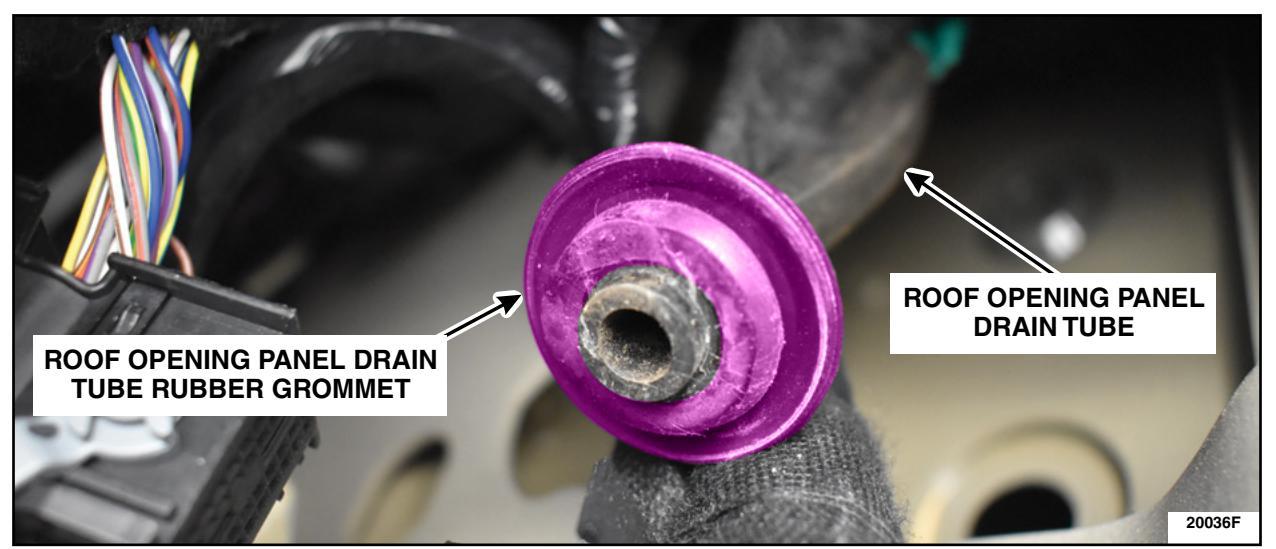
FIGURE 6

11. Is the grommet attached to the roof opening panel drain tube as seen in Figure 6?

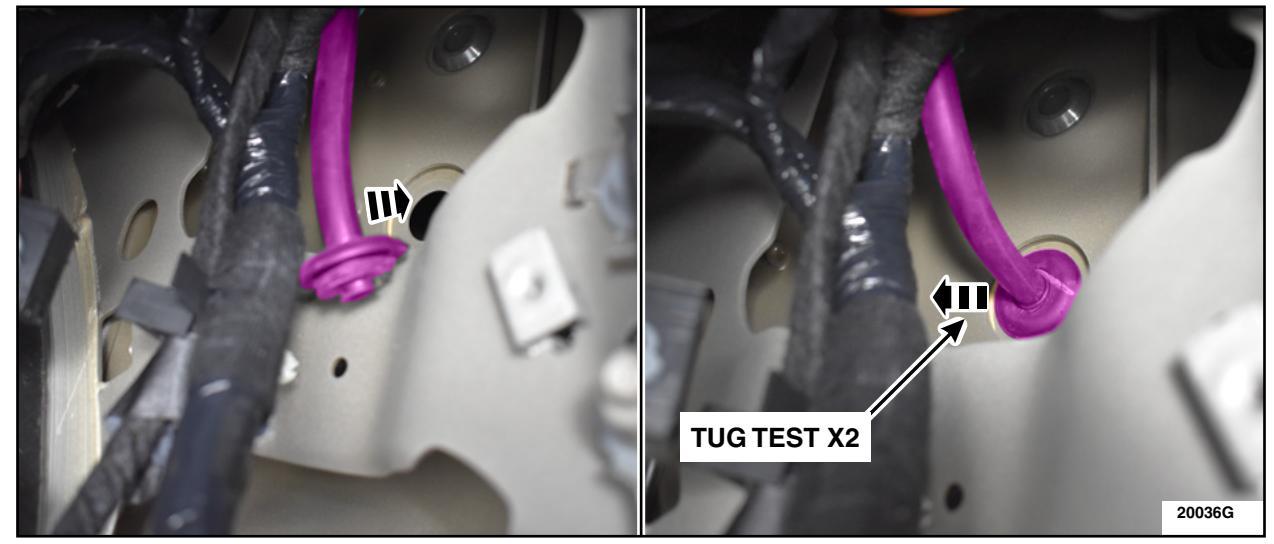
FIGURE 7

- 12. Install the roof opening panel drain tube into the body panel making sure that the grommet is fully seated. Perform a 2-tug test on the roof opening panel drain tube.
 - Did the drain tube and grommet remain in place? See Figure 7.

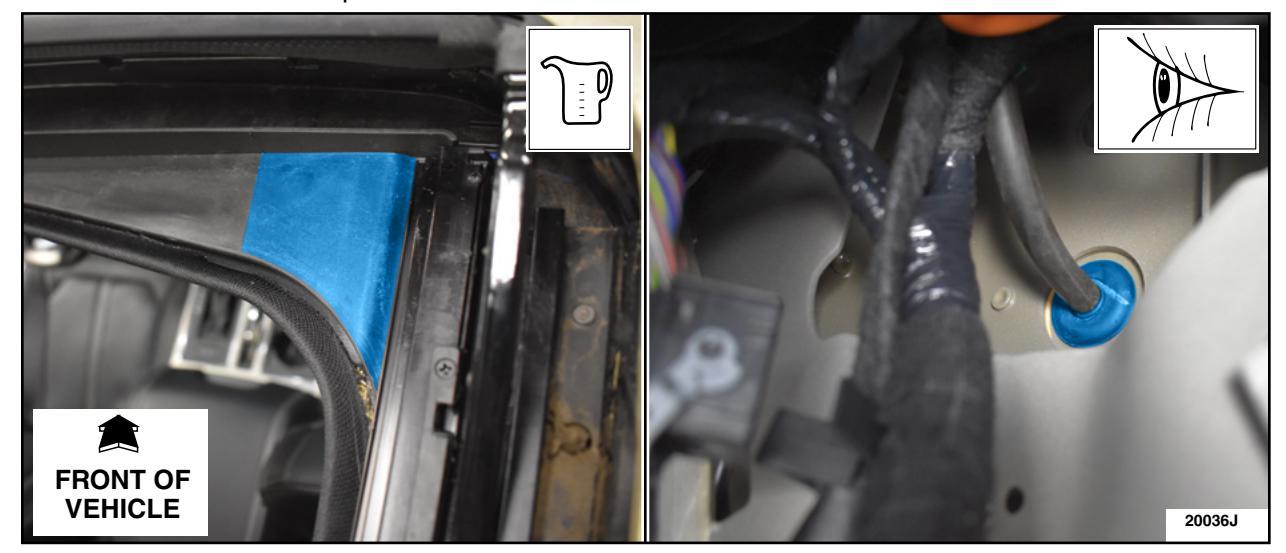
FIGURE 10

- 17. Pour a glass of water into the roof opening panel drain tube channel and immediately inspect the roof opening panel drain tube grommet for water leakage. See Figure 10.Is there water leakage inside the vehicle at the grommet?
 - Yes Proceed to Step 18. No - Proceed to Step 19.

18. Check that the roof opening panel drain tube rubber grommet is fully seated, then repeat Step 17.

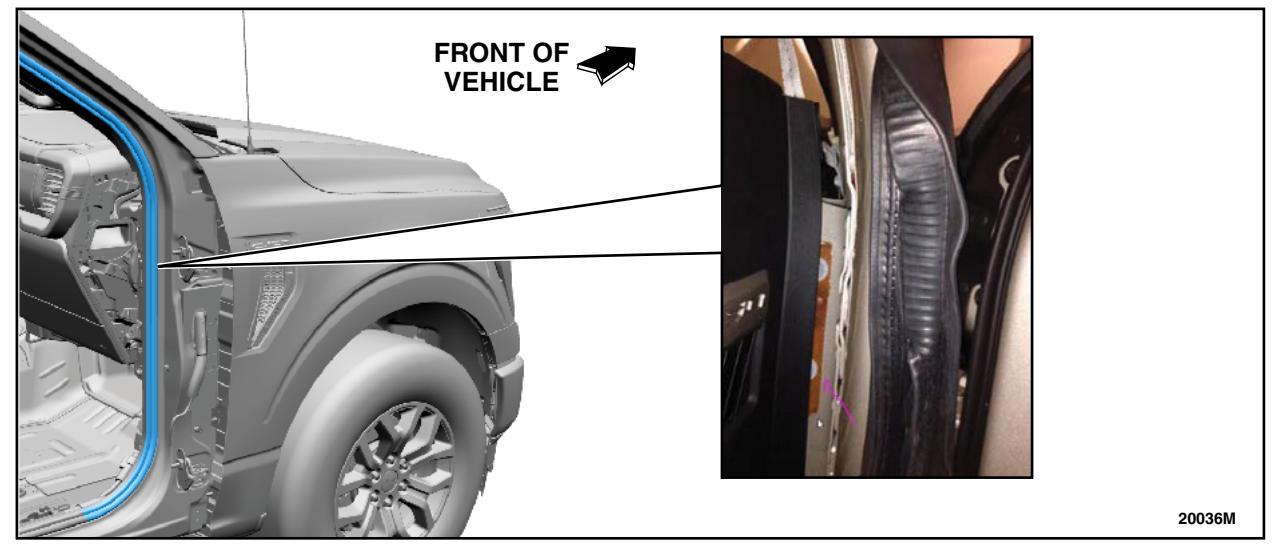
FIGURE 13

25. Inspect the front RH side door weatherstrip for any rips or deformity. See Figure 13. - Were any rips or deformity present?

Yes - Install a *new* Front Passenger Door Weatherstrip. Proceed to Step 26. No - Proceed to Step 26.

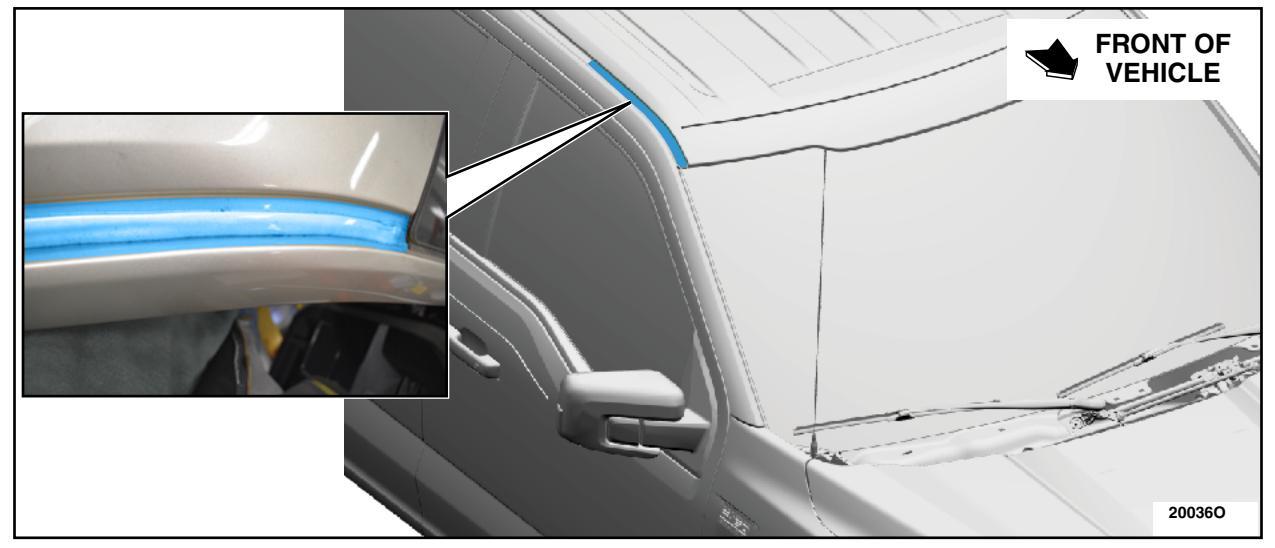
FIGURE 15

27. Using a garden hose, run water over the front RH roof ditch, immediately inspect the A-pillar inside the vehicle for signs of moisture and/or leakage. See Figure 15.

28. Apply some Motorcraft® TA-32 Clear Silicone Rubber to the front RH roof ditch. See Figure 16. Allow the sealer to cure, then proceed to Step 27.

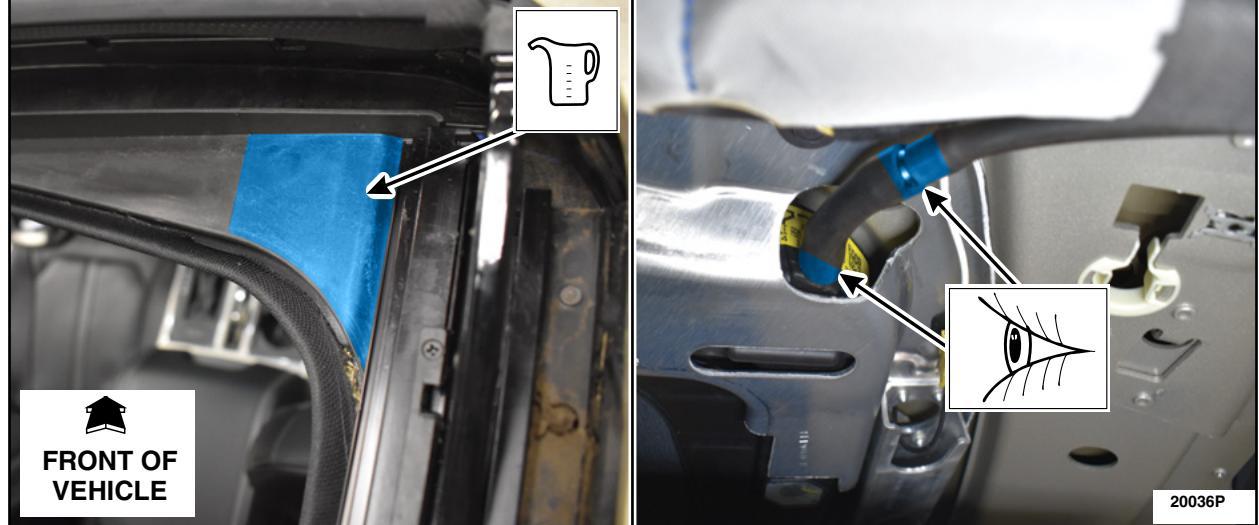
FIGURE 17

- 29. Lower the front RH corner of the headliner. See Step 14, Figure 8. Pour a glass of water into the roof opening panel drain tube channel and immediately inspect the drain tube, at the roof opening panel for water leakage. See Figure 17.
 - Is there water leakage from the roof opening panel drain tube?
 - Yes Proceed to Step 30.

- 30. Check that the roof opening panel drain tube is fully seated, then repeat Step 29. - Is the drain tube fully seated and still leaking after the second inspection?
 - Yes Proceed to Step 31. No - Proceed to Step 33.

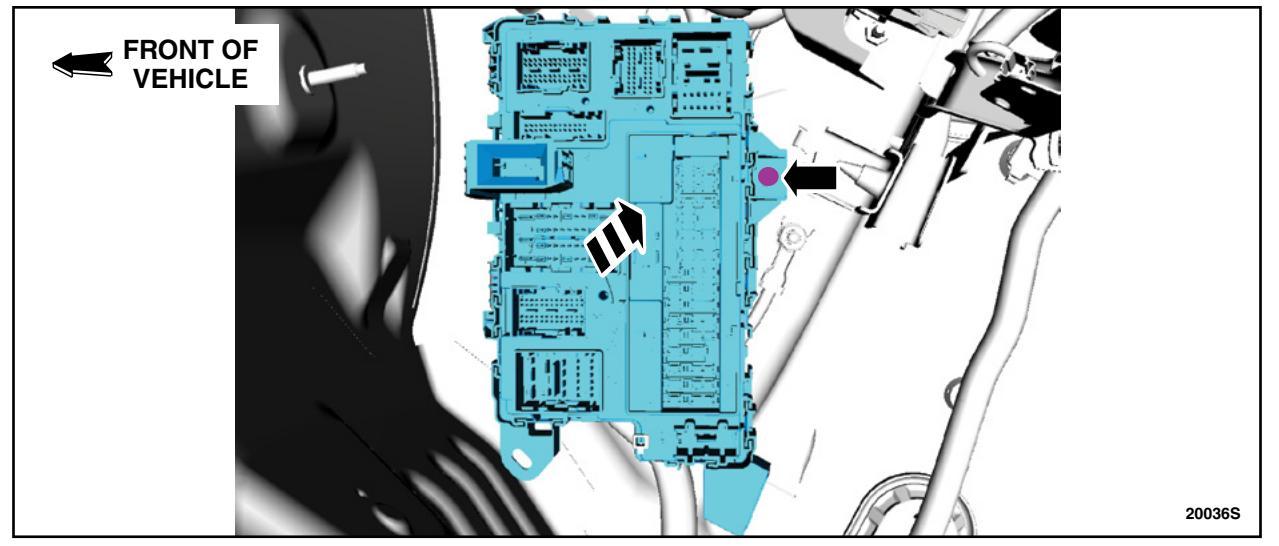
FIGURE 20

- 36. If the BCM is to be replaced due to corrosion and/or moisture, please follow the WMS procedures in Section 419-10 then transfer all fuses to a *new* BCM.
 - Replace any corroded fuses with a new one.
 - Discard the old BCM.
- 37. Install the BCM and retainer. See Figure 20.
