**PRODUCT CAMPAIGN BULLETIN**

**APPLICABILITY:** 2019-2022MY Ascent

**NUMBER:** WRL-22R

**SUBJECT:** PTC Heater Ground Bolt

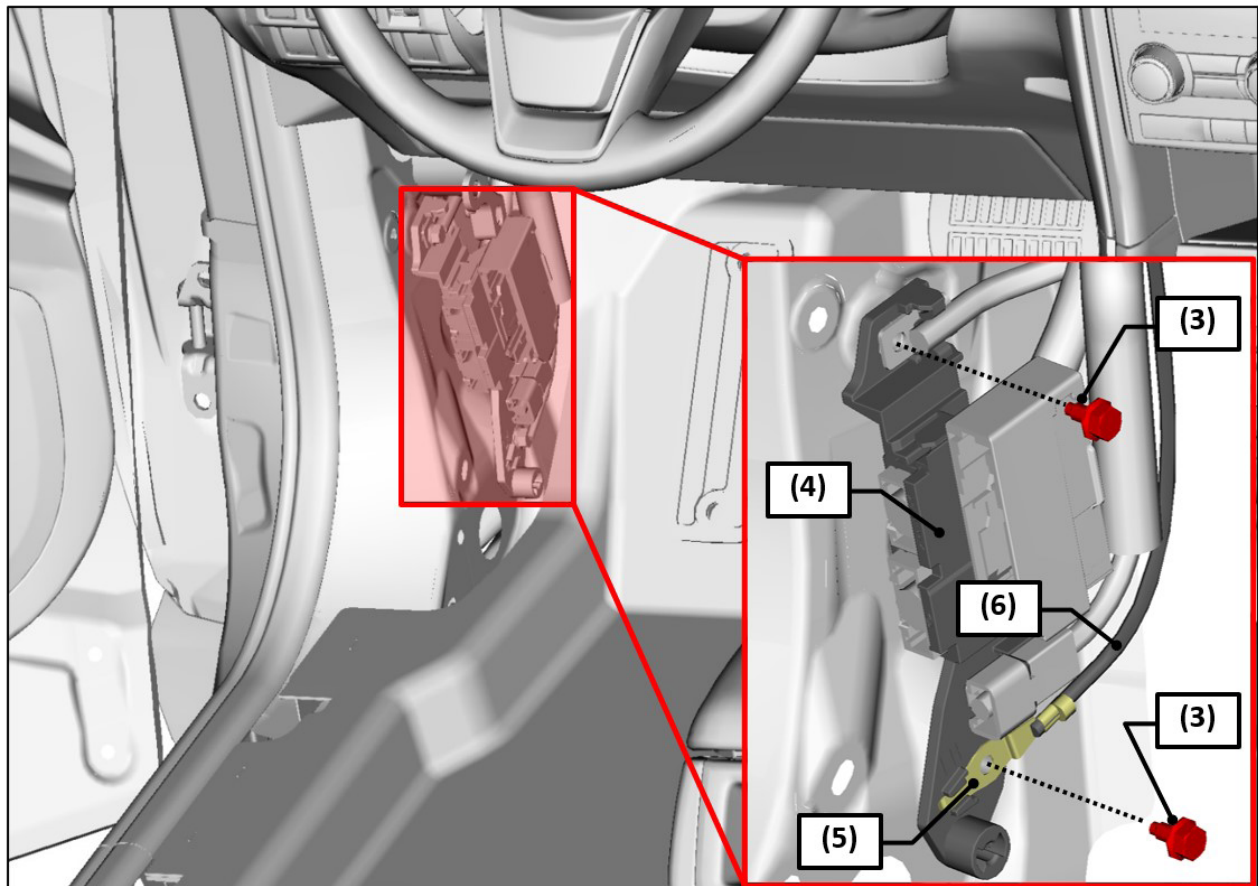
- (1) Left rear side sill cover
- (2) Left front side sill cover
- (3) Ground bolts

- (4) Connector holder
- (5) Ground terminal
- (6) Ground wire

**Tightening Torque: 13 N·m**

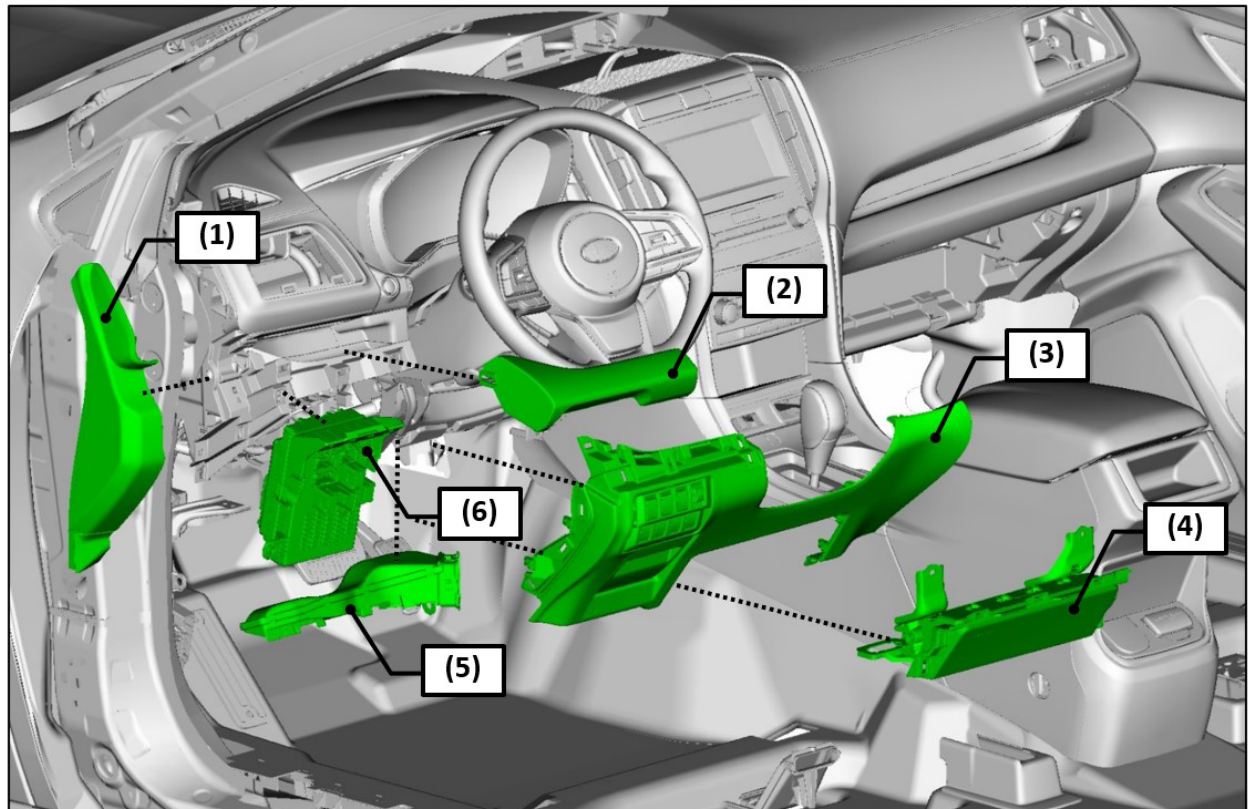
Diagram 2

**(1)** Side lid panel

**(2)** Ornament panel

**(3)** Lower cover

**(4)** Knee airbag module

**(5)** Heater duct

**(6)** Fuse box

**Tightening Torque : 7.5 N·m**
