SERVICE PROGRAM BULLETIN

APPLICABILITY: 2022MY Forester
2022MY WRX
2022-23MY BRZ

NUMBER: WRB-23

SUBJECT: Telematics Data Communications Module
Reprogramming

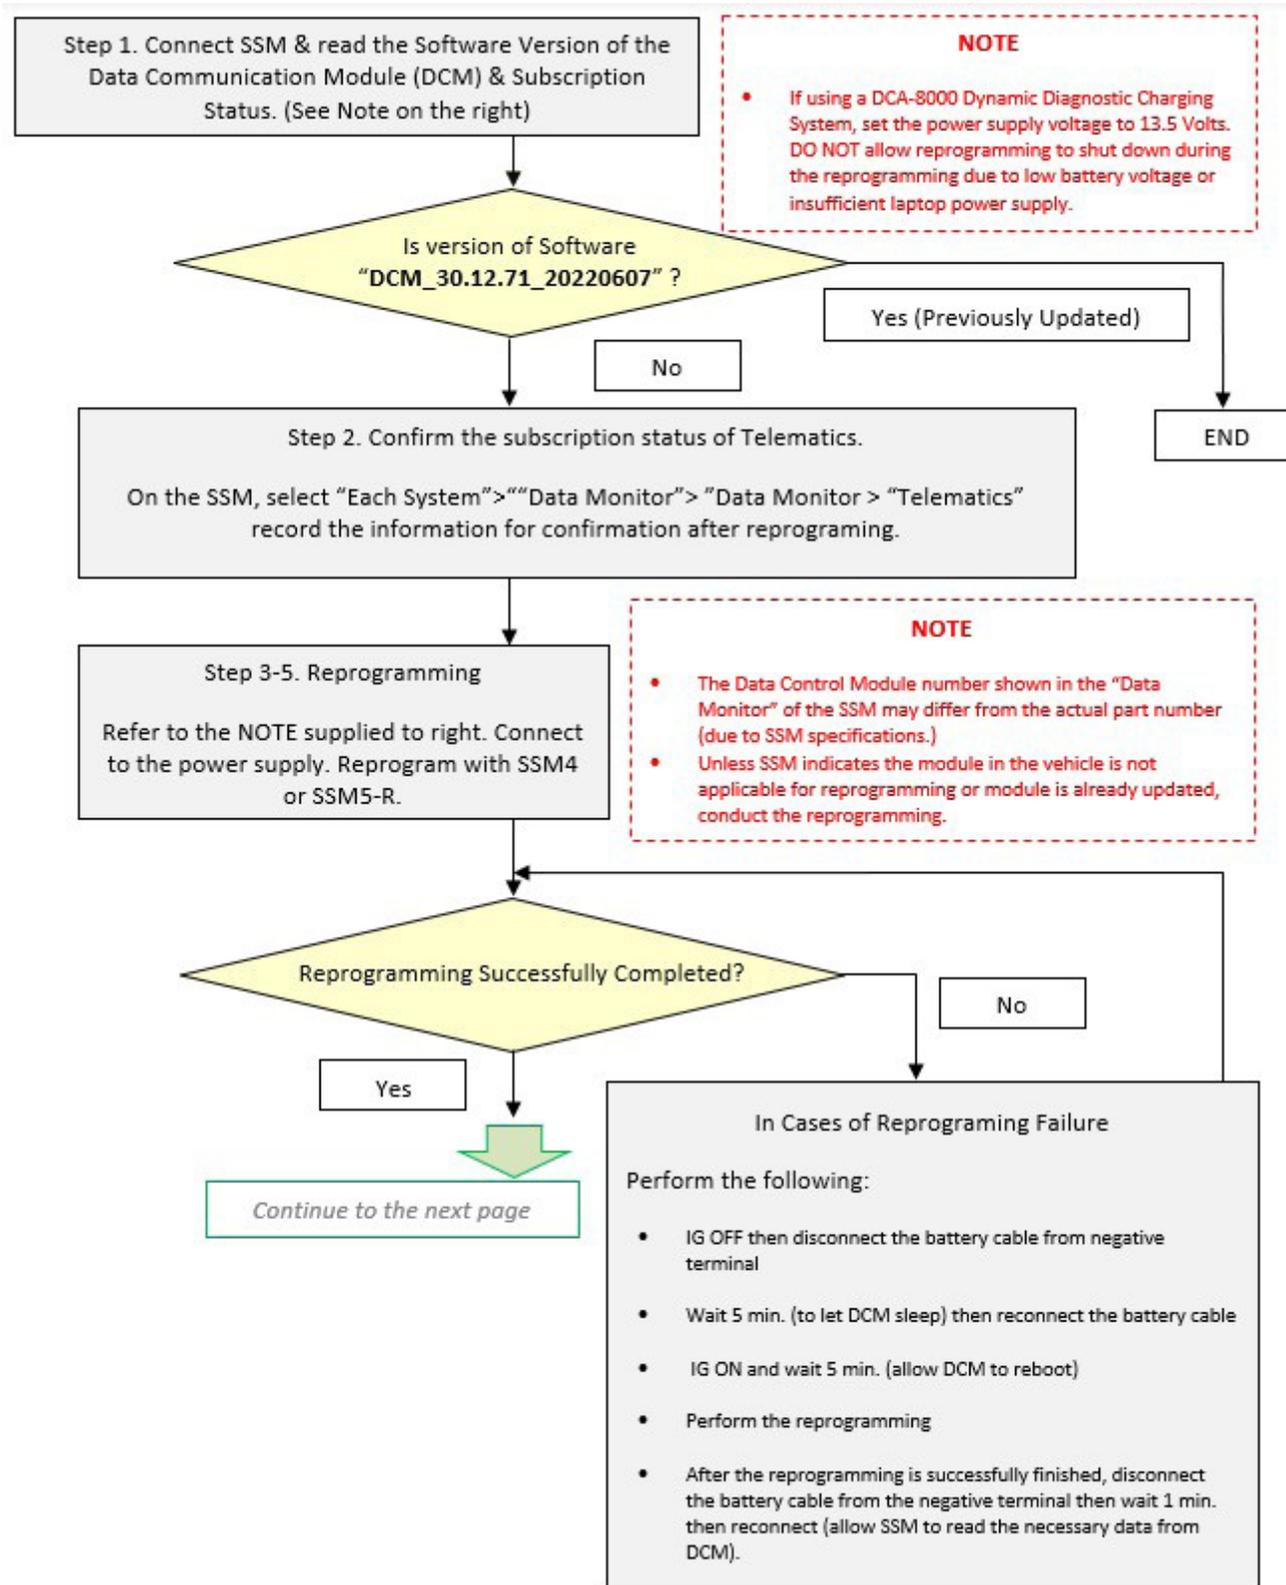
SERVICE PROCEDURE FLOWCHART:

Due to an inaccurate internal timer within the telematics data communications module (DCM), STARLINK remote services from the MySubaru app or MySubaru.com including remote engine start (RES), remote door lock/unlock request, remote horn/lights, and vehicle locator will not operate after 388 days from the date that the DCM was activated.

Subaru retailers will reprogram the telematics DCM at no cost to the customer.
