PRODUCT CAMPAIGN BULLETIN

APPLICABILITY: 2019-20MY Ascent
 2020-21MY Legacy 2.4L (turbo models)
 2020-21MY Outback 2.4L (turbo models)

NUMBER: WRK-21/22R
DATE: 07/05/22
REVISED: 03/15/23

SUBJECT: CVT Chain Guide Breakage

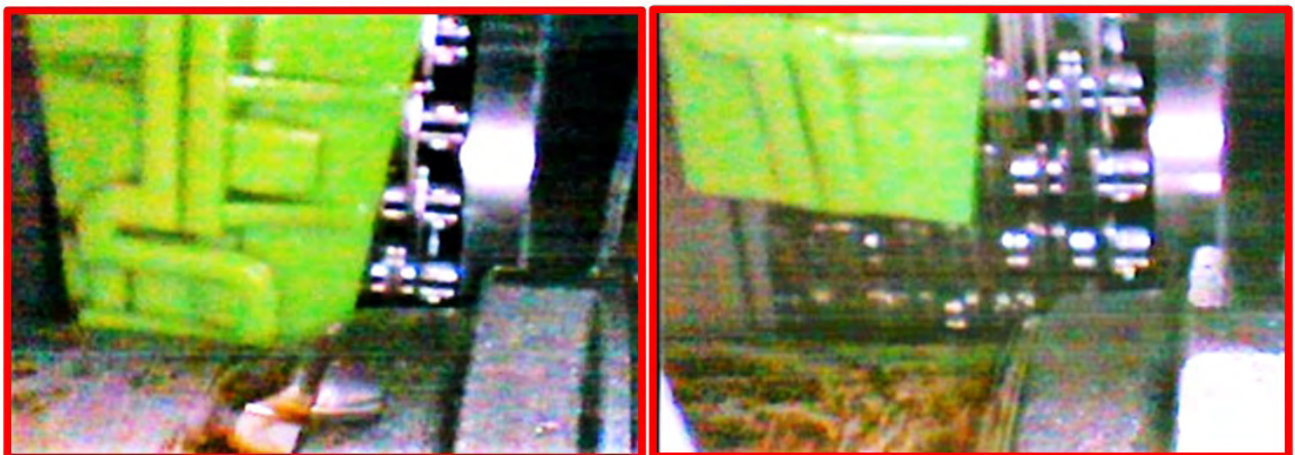
ONLY in a situation when no CVT chain slip is detected with SSM and the chain guide is found to be in the incorrect position during inspection, a clear photo or screenshot of the scope image is required to be stored and noted along with the previously mentioned items 1 through 3.

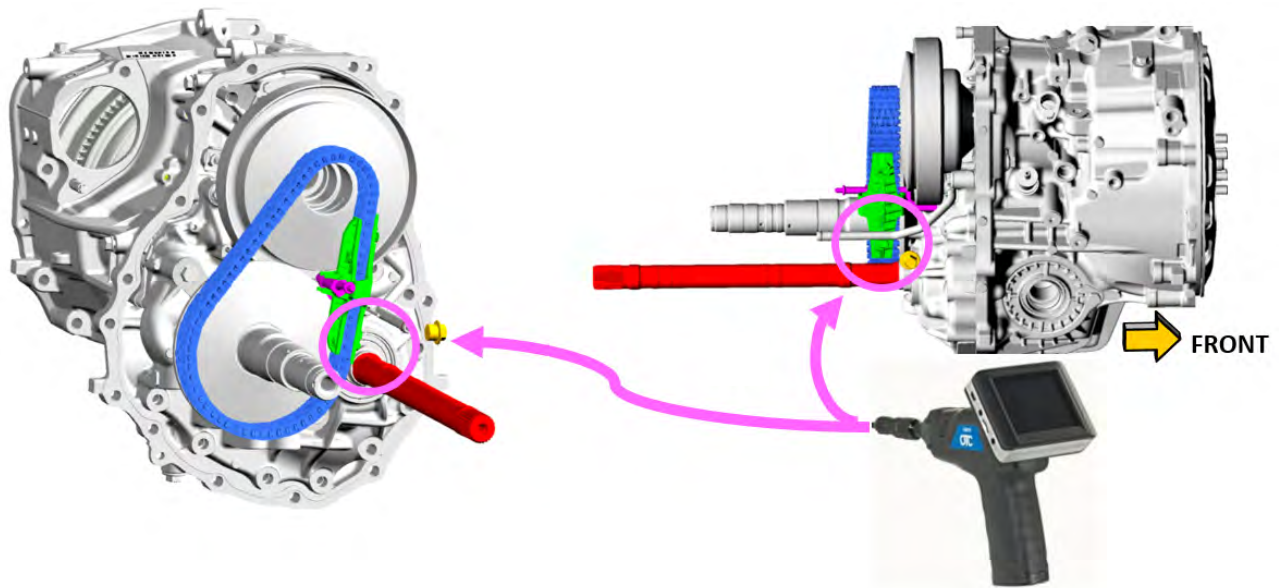
STEP 3E: Inspect the position of the lower end of the chain guide rail and the drive pinion shaft.

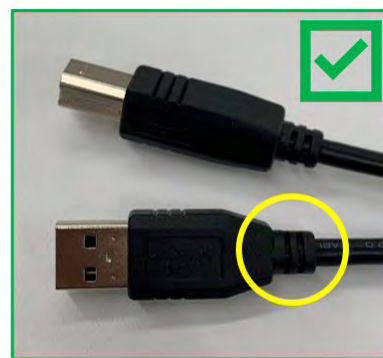
**Exposed Wiring &
Incorrect Cable**

Confirm the PC being use for reprogramming is connected to a known good power source. Turn off any screen saver settings. Make sure the PC is not in power saving mode and is set to the normal power mode. Always inspect the DST-I/DST-010 and PC cables prior to programing. Confirm the cables are CORRECT and there is no exposed wiring, corroded connections, or loose fitment. See the example images below.
