**PRODUCT CAMPAIGN BULLETIN**

**APPLICABILITY:** 2019-2022 Crosstrek Hybrid

**NUMBER:** WRD-23R

**SUBJECT:** 12V Inverter Connector Corrosion

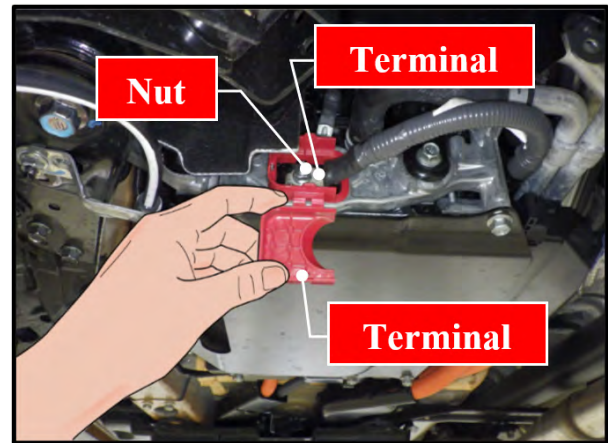
**STEP 8:** Open the terminal cap cover. Remove the 12v terminal nut. The terminal nut is a one-time use part and must not be reused.

**CAUTION:** Some vehicles may have a protective rubber boot installed in place of the terminal cap. If found, remove and discard the rubber boot.

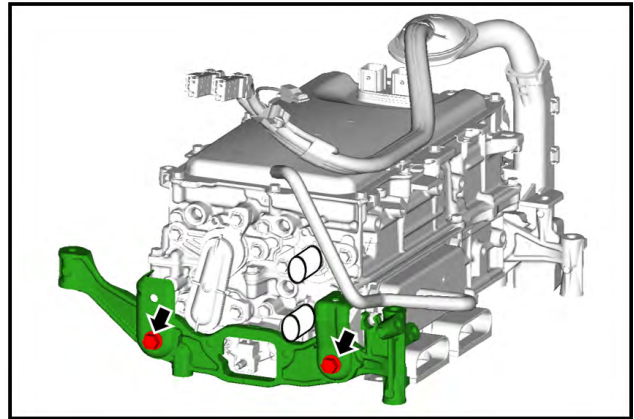
**STEP 9:** Remove the mounting bolts and stays holding the rear inverter bracket. The rear bracket assembly can then be removed.

**IMPORTANT NOTE:** The mounting bolts are one-time use parts and can be discarded. The stays are NOT to be discarded and MUST be re-used.

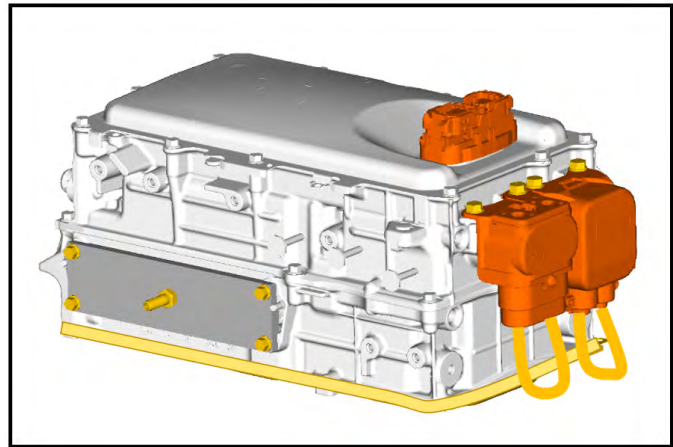
**CAUTION:** Clean any wax that has made contact with resin portion of the 12v terminal and/or the mounting surfaces of the front & rear brackets.

**STEP 47:** Confirm there is a sufficient application of the rustproof wax. Remove all leakage testing tools and masking tape.
