PRODUCT CAMPAIGN BULLETIN

APPLICABILITY: 2023 Ascent

NUMBER: WRJ-23R

SUBJECT: Lower Control Arm Castle Nut / Improper Torque

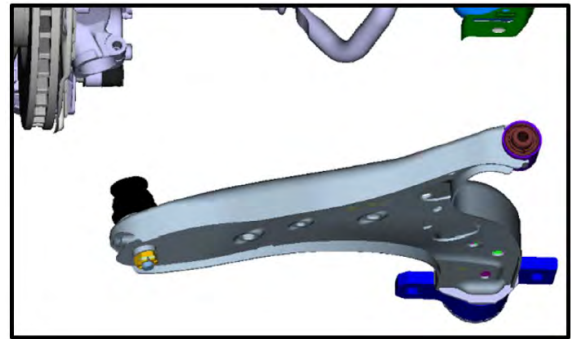
- The lower control arm assembly comes complete with the ball joint and control arm bushings previously installed as an assembly.

STEP 7: Replace the affected front lower control arm assembly as per the applicable Service Manual. Refer to STIS [Suspension > FRONT SUSPENSION > Front Arm](#)

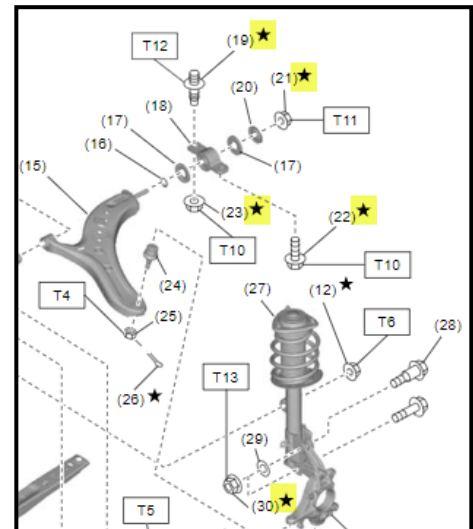
- **IMPORTANT:** The Service Manual uses a **black star (★)** in the component breakdown illustrations to indicate one-time use parts which **MUST** be replaced.
