SUBJECT: **Customer Satisfaction Program 22N19**
 Certain 2021 Model Year Expedition and Lincoln Navigator Vehicles
 Battery Junction Box One-Time Replacement

Customer Satisfaction Program 22N19
Certain 2021 Model Year Expedition and Lincoln Navigator Vehicles
Battery Junction Box One-Time Replacement

CERTAIN 2021 MODEL YEAR EXPEDITION AND LINCOLN NAVIGATOR VEHICLES — BATTERY JUNCTION BOX ONE-TIME REPAIR

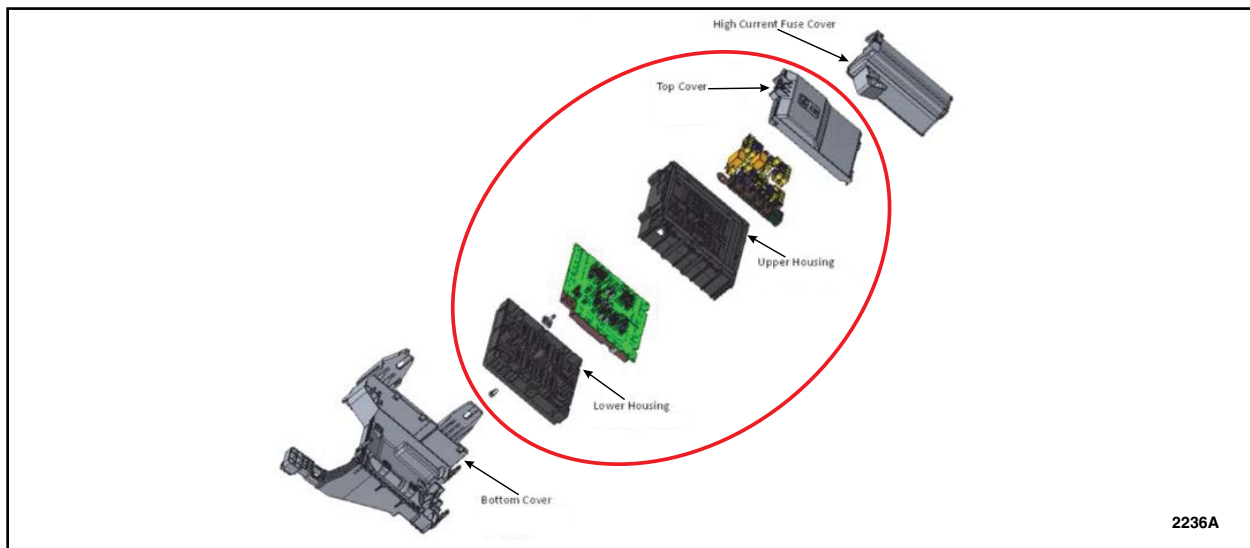
FIGURE 1

Figure 1 is a breakdown of the Battery Junction Box (BJB).

NOTE: Items circled in red are included with a new BJB. Covers can be ordered independently of the BJB.

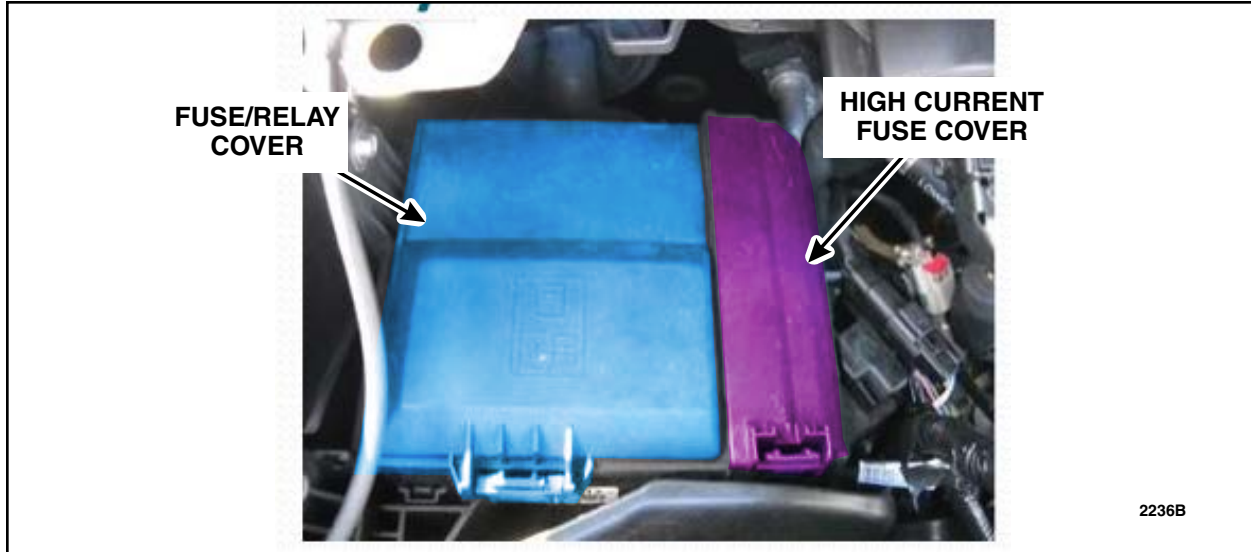
FIGURE 2

1. Are both the fuse/relay cover and the High Current fuse cover present. See Figure 2.
Yes - Proceed to Step 2.
No - Install new cover(s). Proceed to Step 2.

**IMPORTANT:** New cover(s) can be ordered WITHOUT ordering a new BJB.

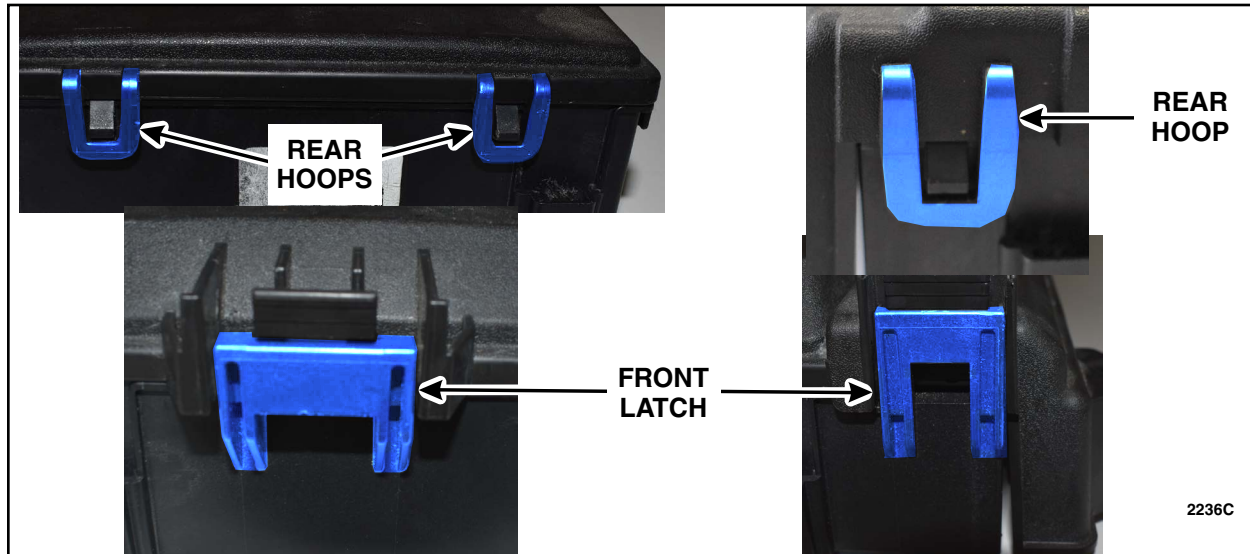
FIGURE 3

2. Check to make sure that the covers are properly installed. On the fuse box cover there are three attachment features securely engaged, two hoops in the rear and one latch in the front. On the High Current cover there are two attachment features securely engaged, one hoop in rear fully engaged and one latch in the front fully engaged. See Figure 3. Are both covers properly installed?

No - Ensure that the covers latch and install properly. Proceed to Step 3.

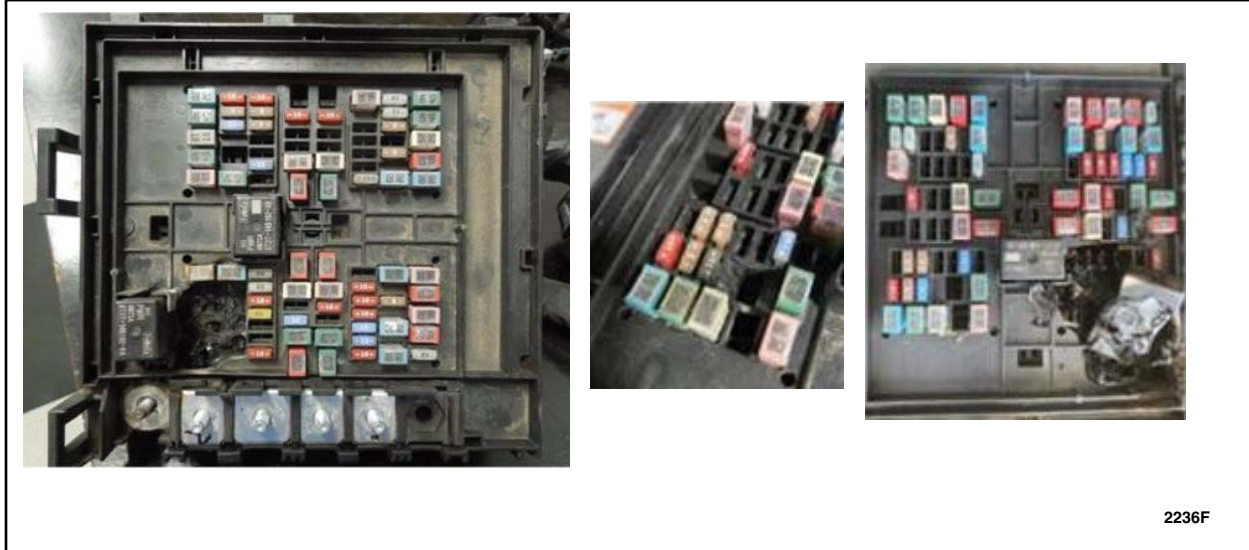
FIGURE 5

4. Remove covers and inspect BJB. Is there any evidence of melted fuse(s), melted relay(s), or melted plastic in the BJB? See Figure 5.

Yes - Replace BJB. Proceed to Step 6.
