A total of 59,934 U.S. WRX STI vehicles will be affected by this recall, as listed below:

Model Year	Carline	Production Date Range
2015-2021	WRX STI	November 14, 2013 – October 21, 2021

**Subaru Safety Recall WRE-22  
NHTSA ID 22V-522  
September 2022**

Your vehicle may contain a defective back-up lamp switch, which may cause the back-up lamps to not illuminate, the rear-view camera (if equipped) to not display an image, and the select lever/gear position indicator in the combination meter to not display 'R' when driving in reverse.

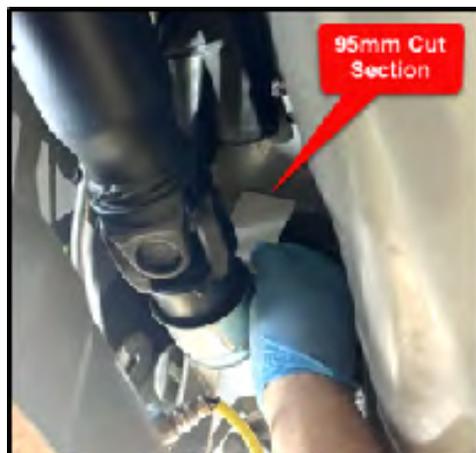
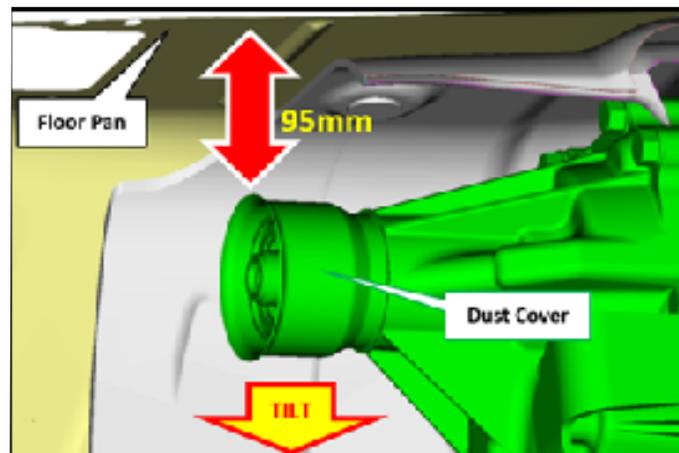
**CAUTION: DO NOT increase the distance beyond 95mm. This may cause damage to the transmission and propeller shaft.**

**STEP 17:** Slowly lower the transmission jack. Using the 95mm cut section as a gauge, confirm the distance between the transmission output dust cover and the floor pan is 95mm.
