SUBJECT: Recall Campaigns No. 92V-071, 92V-072 and  
92V-073

**REF. NO. 147  
FUEL INJECTION LINES**

Ferrari S.p.A., the manufacturer of Ferrari automobiles, has determined that certain defects exist in certain 1989, 1990 and 1991 model year Ferrari vehicles.

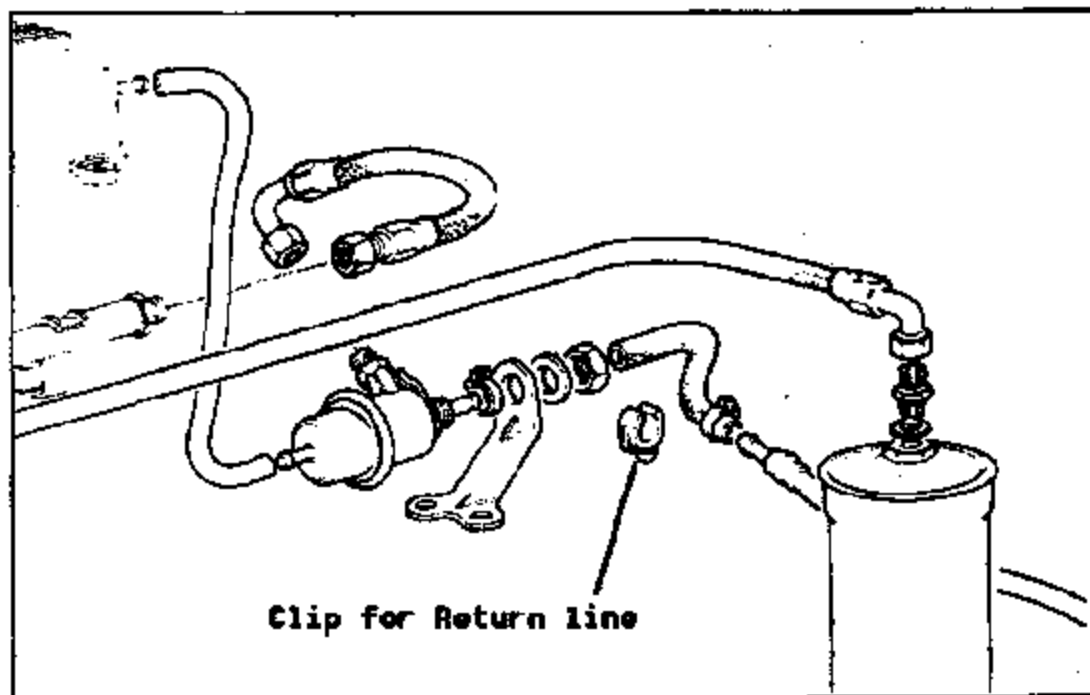
Fig.#3

- 5) Remove both fuel lines "A & B" as shown in Fig.# 1 and replace with new lines.
- 6) Inspect 1/4 bank Fuel Injection return line for any damage due to contact with the timing cover. If damage is found the line must be replaced using the procedure "C - Procedure for replacement of fuel return line" found on page # 7 of this booklet. If no damage is found, please insure that the return line is secured on the clip found on the timing cover (Fig.#3). Also the Return Fuel line must not contact the Timing cover or A/C Compressor lines.
