Dealer Service Instructions for:

Safety Recall S24 / NHTSA 16V-202 CAN-C Bus Connector

2015-2016 (VM) RAM ProMaster City

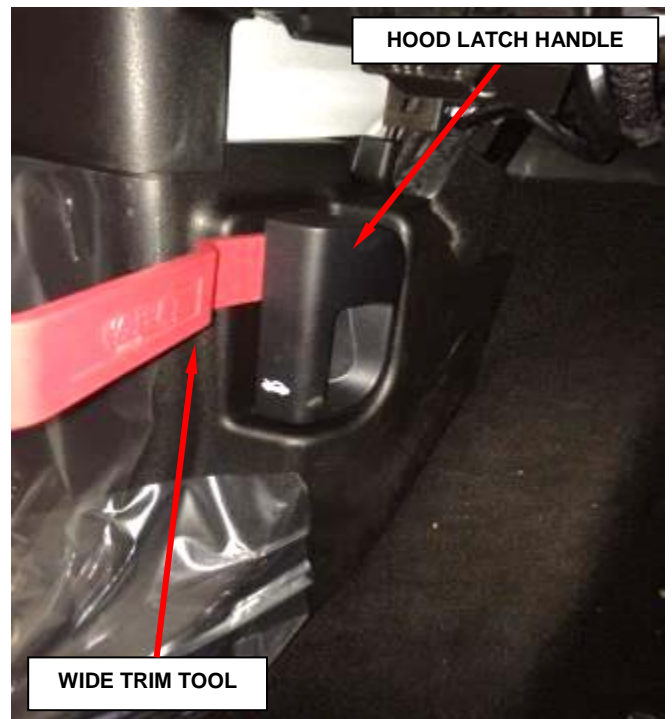
Figure 2 – Hood Latch Handle

NOTE: Revised Step 4 and Figure 2 in Section A. Inspect CAN – C Bus Connector.

1. Move the driver's front seat to the full rearward position.
 2. Disconnect the negative battery cable.
 3. Remove and save the screw located behind the hood latch handle (Figure 1).
 4. Using a wide trim tool or equivalent, remove the hood latch handle (Figure 2).
- NOTE: Apply even pressure across the top and bottom of the hood latch handle to prevent damage to the hood release cable.**
5. Remove the driver's side floor mat.
