Service Bulletin

SB-10058750-8543

SUBJECT: Special Coverage Adjustment – Daytime Running Lamp Inoperative

**MODELS: 2007-2012 GMC Acadia
Equipped with High-intensity Discharge Headlamps (RPO TVD)**

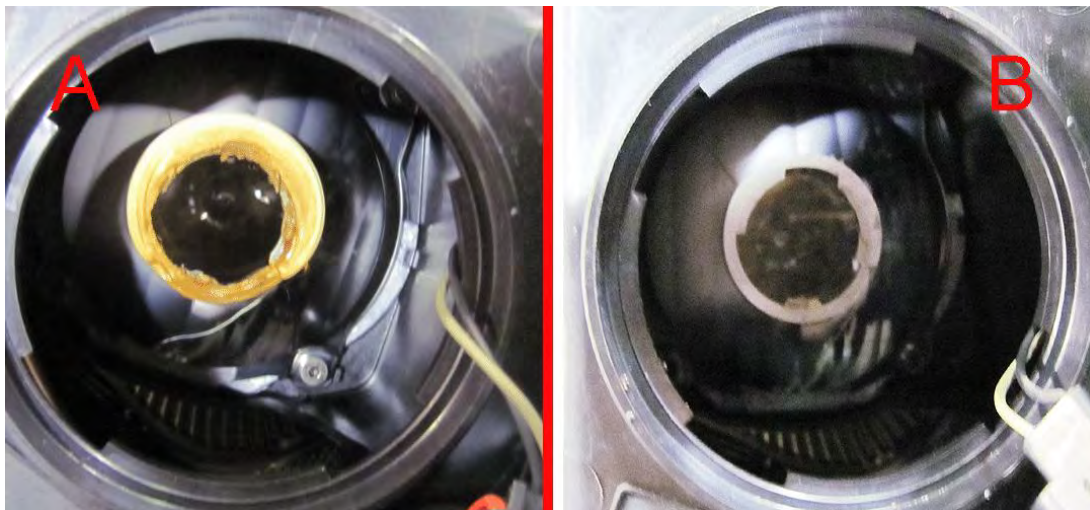
3034812

The “A” portion of the illustration shows the old gasket. The “B” portion of the illustration shows a clean bulb reflector.

2. Remove headlamp bulb accessory cover.
3. Disconnect the electrical connector from the bulb socket.
4. Disconnect the bulb socket from the headlamp assembly.

- 5. Remove old gasket on the bulb reflector using a shop towel and cleaner.

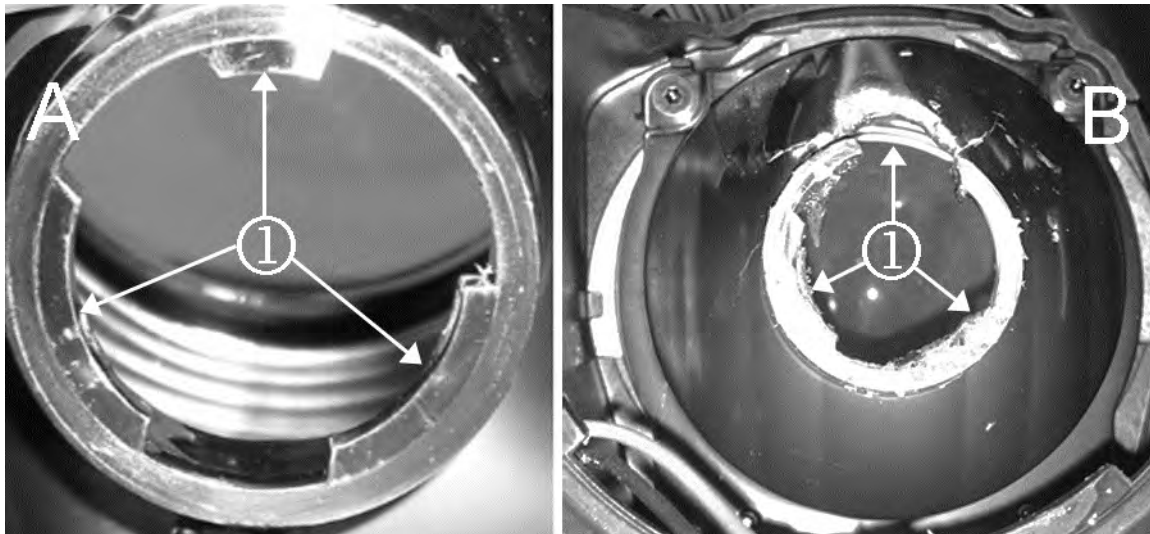
4140611

7. Inspect the reflector lugs (1) for damage, such as cracking, warping, or looseness.
 - If the headlamp reflector lugs (1) are NOT cracked, warped, loose or missing, install the reinforcement plate kit. Refer to 'A' portion of the photograph. The 'A' portion of the photograph shows usable reflectors lug. Do NOT replace the headlamp. Proceed to step 8.
 - If the headlamp reflector lugs (1) are cracked, warped, loose or missing, replace the headlamp. Refer to the 'B' portion of the photograph. The 'B' portion of the photograph shows an unusable reflector lug. The upper lug missing. Proceed to step 13.

Note: Only replace the headlamp if the reflector lugs are damaged or missing.
