Service Bulletin

SUBJECT: Service Update for Inventory and Customer Vehicles
Underhood Electrical Center (UEC) Missing Fuses and Relays
Expires with Base Warranty

MODELS: 2015 Chevrolet Silverado
2015 GMC Sierra
Equipped with Accessory Wiring Junction Block (RPO 9L7)

Subject: 15411 – Service Update Bulletin
Underhood Electrical Center (UEC) Missing Fuses and Relays

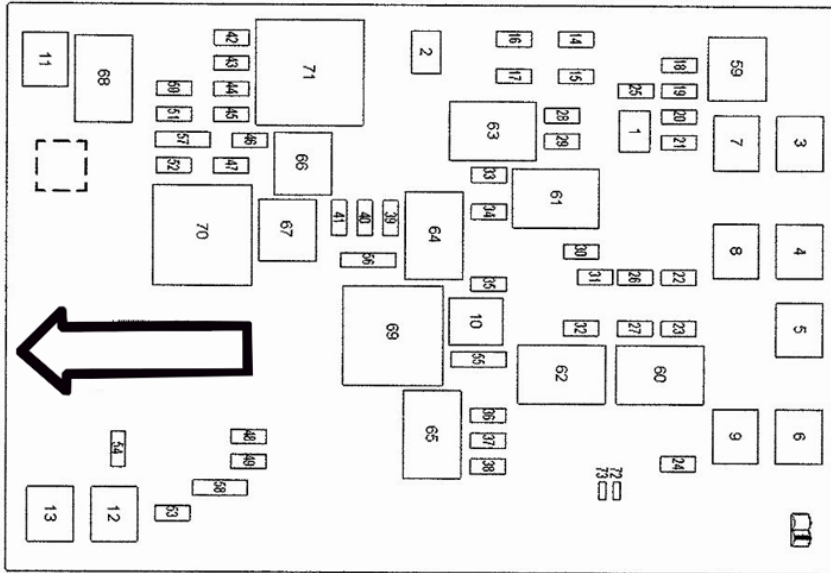
4216856

UEC fuse block component locations viewed from left side of vehicle

1. Remove the cover from the Underhood Electrical Center (1).
