SERVICE INFORMATION BULLETIN

NUMBER: 07-116-16R

SUBJECT: Supplemental Service Procedure Information to be Used in Conjunction with Campaigns WQP-51, WQR-53R and TKA, B, C-16R

DATE: 11/11/16

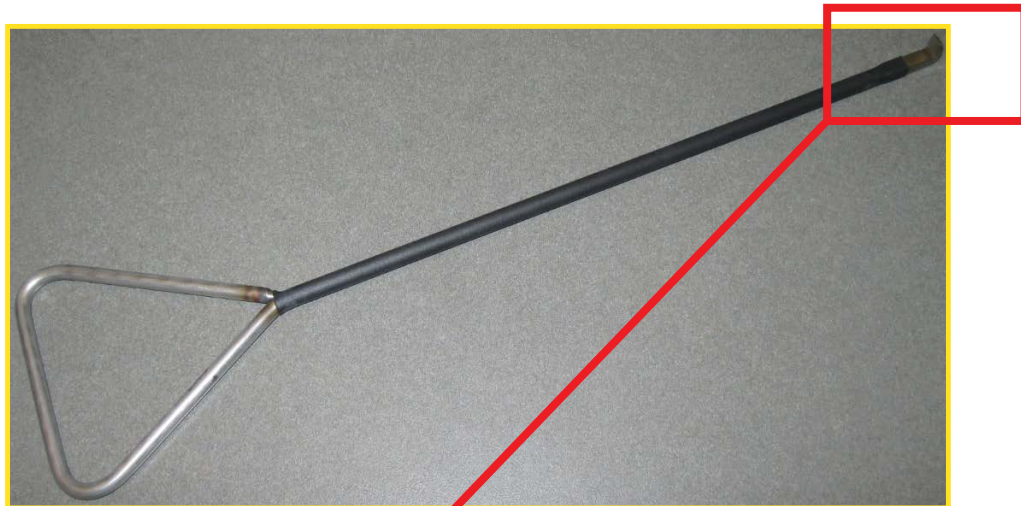
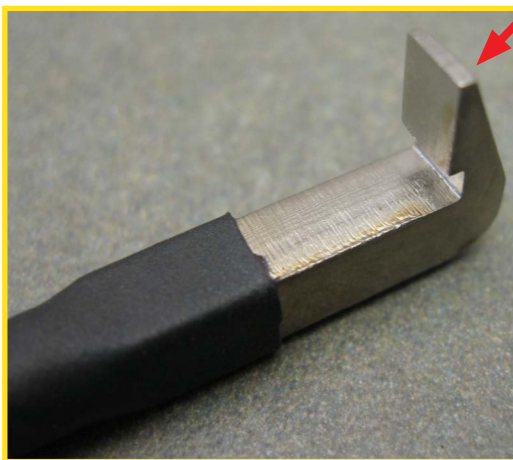
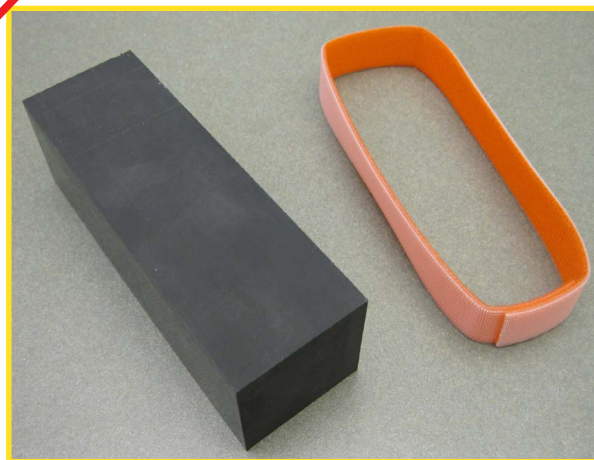
- To help make these repairs easier, two new tools as shown below have been developed and sent to Retailers automatically. Each retailer will be supplied two sets of these tools at no charge. A new removal tool, p.n. SOA635145 for removing the IP's outside and center vent assemblies and, a resin block to support the IP on 2005-2009 Legacy and Outback models, p.n. SOA635146. There is also a velcro strap supplied along with the resin block to help hold it in position if needed when supporting the IP.

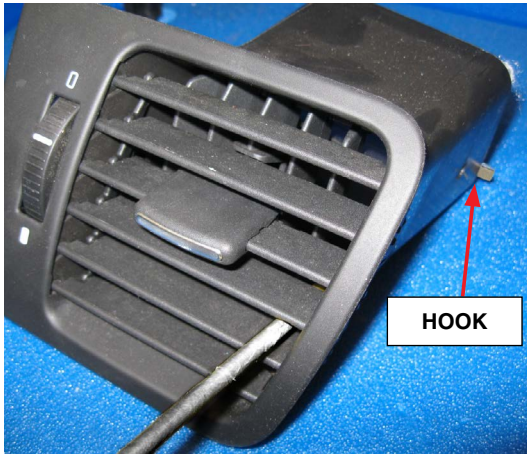
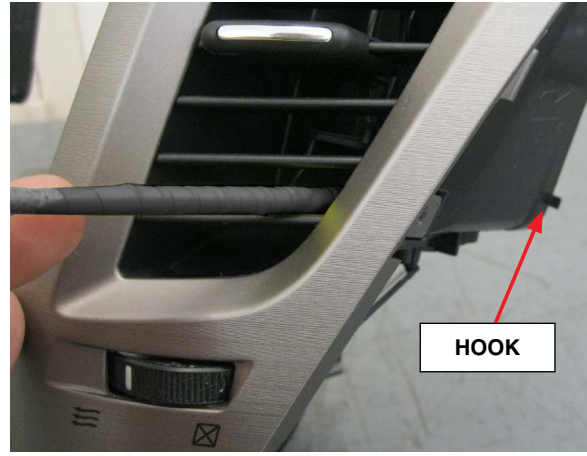
Once the inner lip / edge of the vent being removed is found (or “hooked”), pull firmly on the tool while applying outward force to keep it from slipping off. Once the first corner of the vent is released, move to the upper (or lower) corner and repeat. At this point, a plastic trim tool can be **CAREFULLY** used on the front of the vent trim as shown below to release and remove the vent the rest of the way. As stated previously, there will be trial and error until a “feel” for the tool is developed. **PATIENCE** is key!
