SERVICE BULLETIN

APPLICABILITY: 2015MY WRX Models with 2.0L DIT Engine
 2015MY Legacy and Outback 2.5L

NUMBER: 09-59-14R

SUBJECT: Rust Treatment Procedure for Heat Shield Retaining Bolt Heads

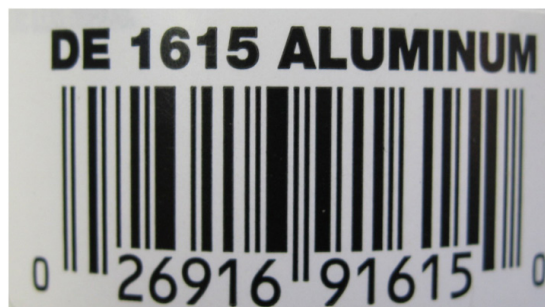
- 1 - 12 ounce aerosol can of silver or aluminum color High Heat Engine Enamel. During the development of this bulletin, Dupli-Color® # DE1615 Aluminum Engine Enamel aerosol spray was used. This product is available at most major auto parts retailers.

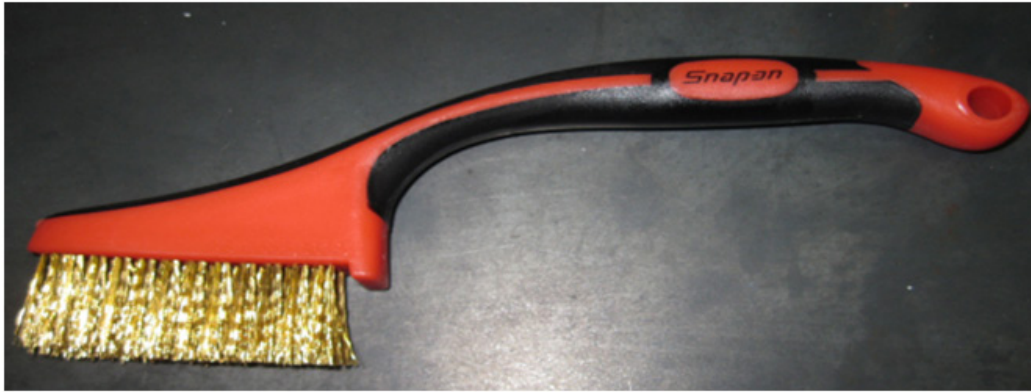
- 1 - **BRASS** wire bristle detail brush. **CAUTION:** Stainless bristles are likely to be too aggressive and may damage the coating applied to the surrounding heat shield material.

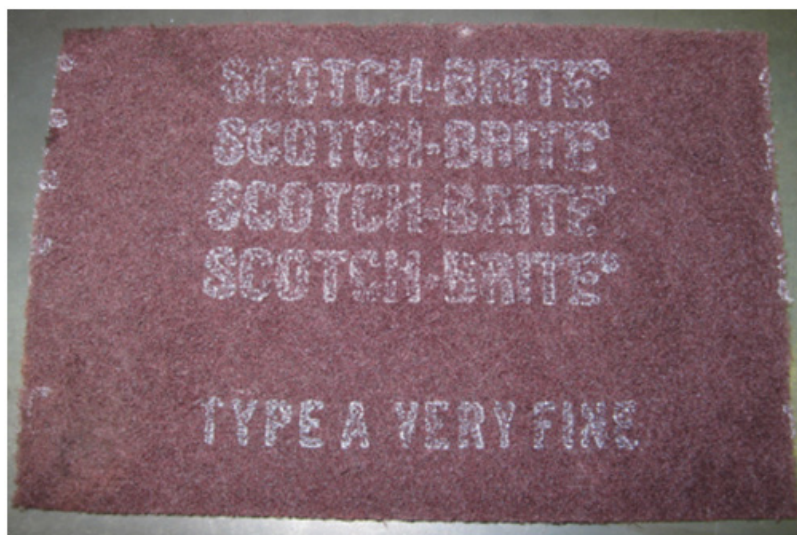
- 1 - Scotchbrite® surface conditioning pad.

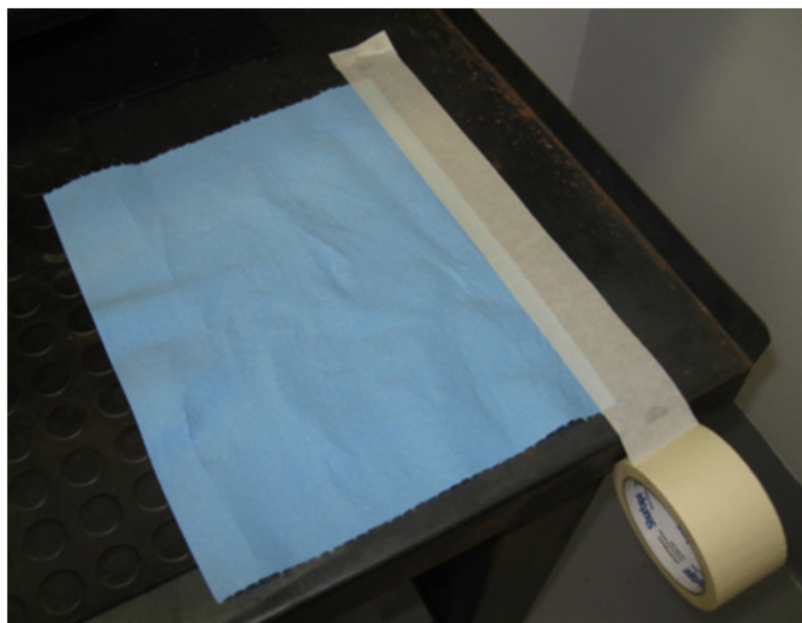
Paint Masking materials consisting of masking tape and paper to protect the surrounding components from overspray.
