Subject Rear drive shafts

Group 140.3.07 Date 21.05.2007

Rear drive shafts

Gallardo (Coupè and Spyder) from VIN 4460 to VIN 5690

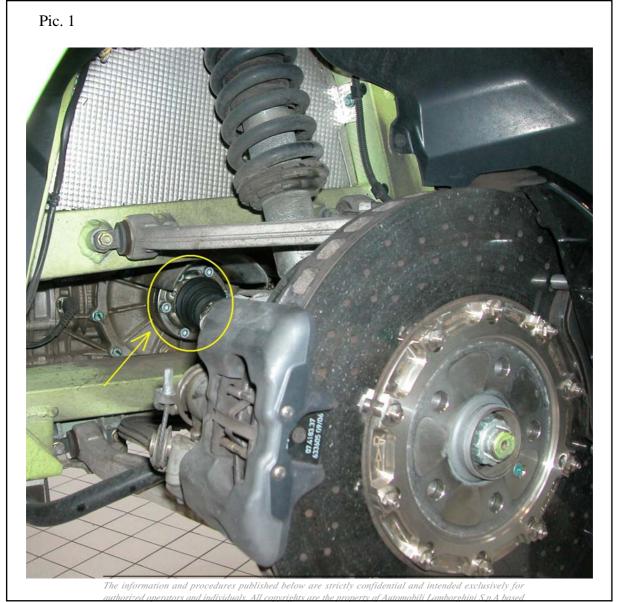
- **1.1** Adopt all precautions to prevent car damages and to work safe. This rework must be done when the engine is cold.
- **1.2** Use the hand brake to block the brake disk.
- **1.3** Raise the car on the lift.
- 1.4 Is not necessary to disassemble the wheels from the car for the bolts replacement. We did it only to show in this procedure clear photos as in the below picture (1).
